GROUP	NUMBER
RECALL	24-01-040H
DATE	MODEL(S)
MAY 2024	Elantra (CN7) Venue (QX) Kona (SX2)

EGR VALVE ASSEMBLY& GASKET REPLACEMENT (RECALL 260)

Description: The exhaust gas recirculation ("EGR") valve assembly in certain vehicles (listed below) may contain a sensor that was contaminated with solder flux during manufacturing, which could potentially result in an electrical short. An electrical short within the EGR valve could lead to a malfunction of the EGR valve or crank position sensor, both of which reside on the same power circuit, resulting in Malfunction Indicator Lamp illumination (P240F, P404, P0405, P049D, P0642, P0652) and/or a sudden loss of motive power during operation. Follow the information below to replace the EGR valve assembly and gasket.

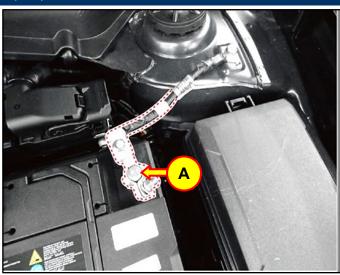
1. Turn **OFF** the ignition and disconnect the negative (–) battery terminal (A). Record customer preset stations if applicable.

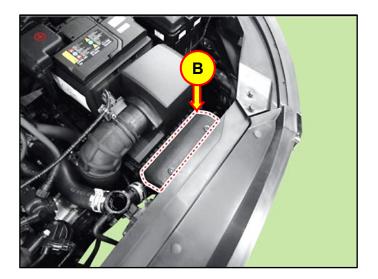
2. Remove the air duct (B).

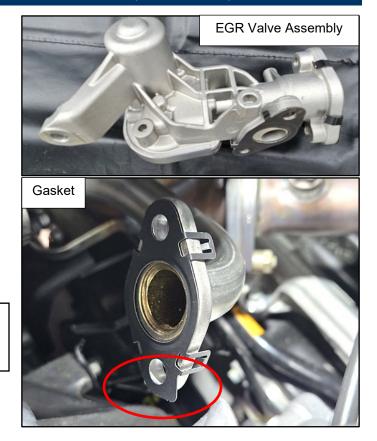
Orient the EGR pipe gasket as shown in photo.

10. Install the supplied EGR valve and gasket.

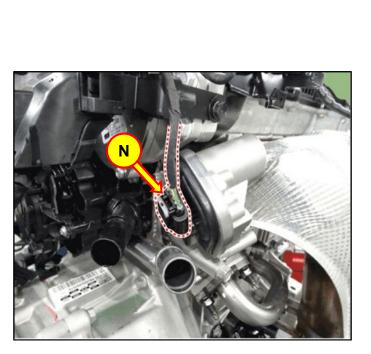
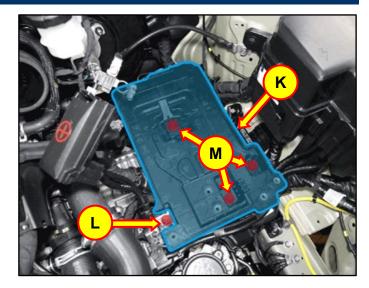
11. Disconnect the EGR control valve connector (N).

12. Remove the EGR cooler pipe mounting nuts (O).

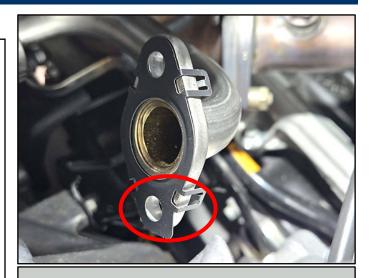
Orient the EGR pipe gasket as shown in photo.

Mount the EGR pipe gasket before installing the EGR valve assembly.

Tighten the EGR control valve to the specified torque.

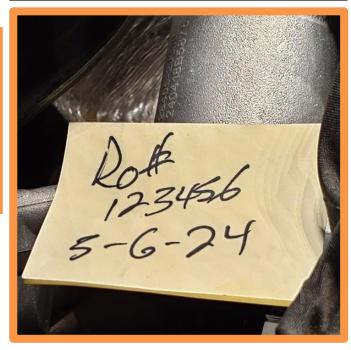
Using STUI, take a photo of the newly installed EGR Valve capturing the production stamp with the last 6 digits of the VIN and the date of the repair on piece of paper.
