Safety Recall: 2020–24 Ridgeline Rearview Camera Harness

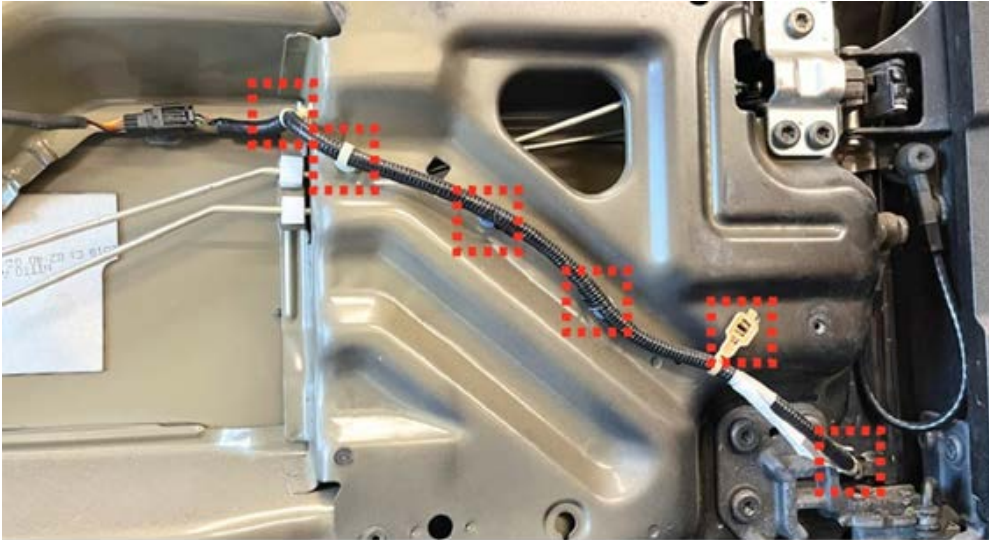
11. With the help of an assistant, lift the tailgate up slightly to allow clearance between the left tailgate lower hinge and the tailgate for the harness to be removed.

NOTE: Be careful of pinch points when lifting the tailgate. Remove the tailgate harness, then remove the harness clips.
