# Recall Campaign Bulletin

Campaign No. 2024060007, July 2024

SUBJECT: **Model EQB (243 platform)**  
**Model Year 2022**

## **Replace Front Axle Electric Drivetrain**

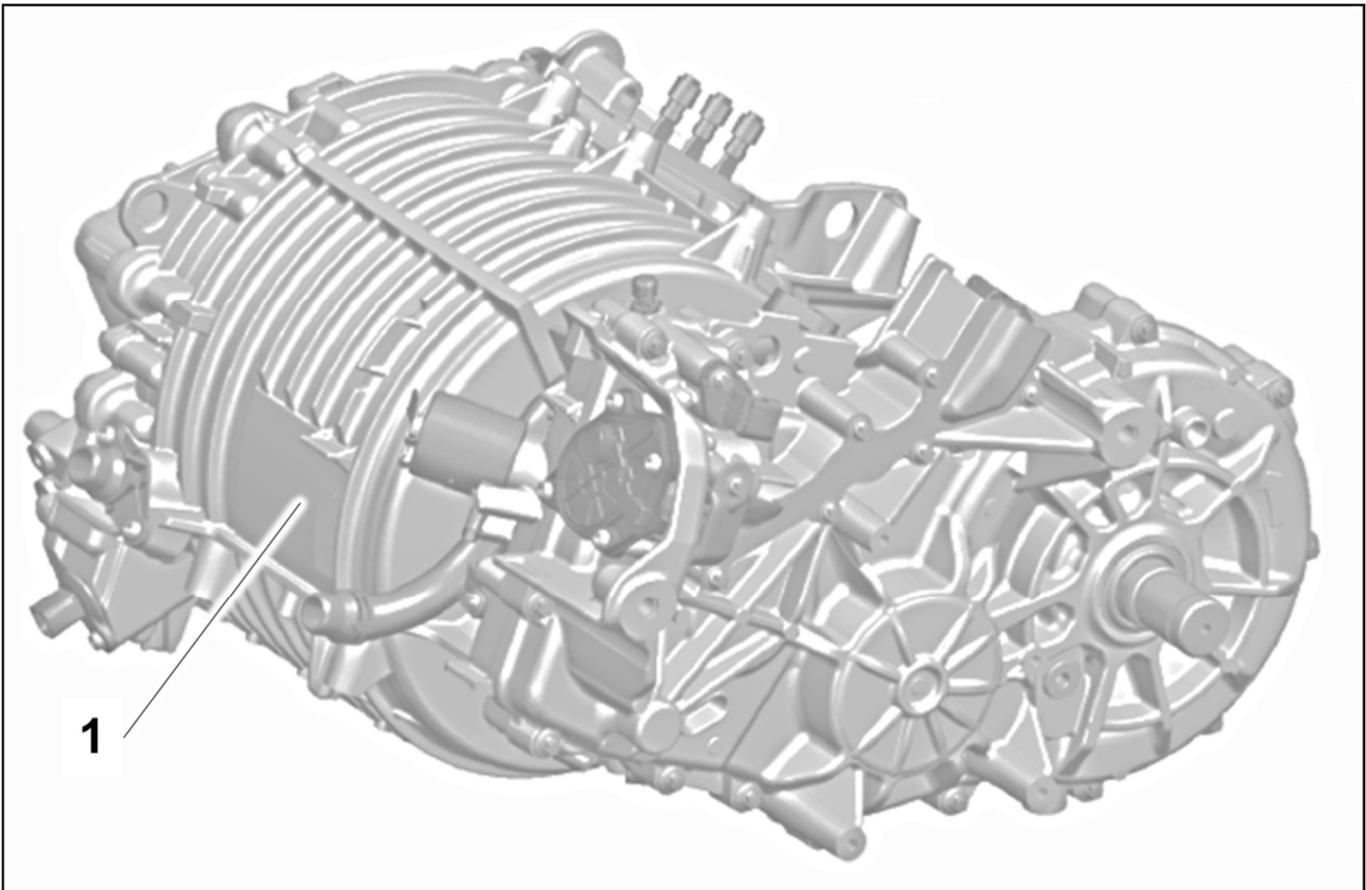
Figure 1

Mercedes-Benz AG, the manufacturer of Mercedes-Benz vehicles, has determined that on certain MY 2022 EQB (243 platform) 4MATIC vehicles, the welded spur gear within the front axle electric drivetrain might not meet current production specifications. In this case, the weld might fail, allowing the spur gear to rotate freely from the differential assembly. As a result, the park pawl located in the front axle electric drivetrain might not function as specified. If the parking brake is engaged, the vehicle will remain stationary even if the park pawl malfunctions. The parking brake is automatically activated by switching off the vehicle or opening the driver-side door. In the event of a weld failure, when the parking brake or service brake are not engaged, the vehicle might not be secured against rollaway even if the gear selector is in the "Park" position, thus increasing the risk of a crash. When the issue occurs, the driver might notice loud and clearly perceptible rattling noises during driving or while changing gears. An authorized Mercedes-Benz dealer will replace the front axle electric drivetrain on the potentially affected vehicles.

1. Replace front axle electric drive module (Figure 1, 1).
