## **Recall Repair Instructions**

**NHTSA Recall # 24V-337**

**Tiffin Motorhomes Recall # TIF-139**

**Models Involved:** 2024 – 2025 Byway Motorhomes, floor plans 38 BL and 38 CL **only**

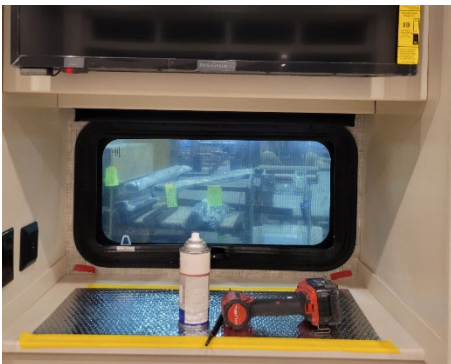
Figure 1

1. Determine the window across from the foot of bed. See Figure 1.
