L636-  
R.02.24

**Campaign code:**  
L636-R.02.24

**Campaign Name:**  
Carbon Engine Hood

**Model:**  
Urus S, Urus Performante

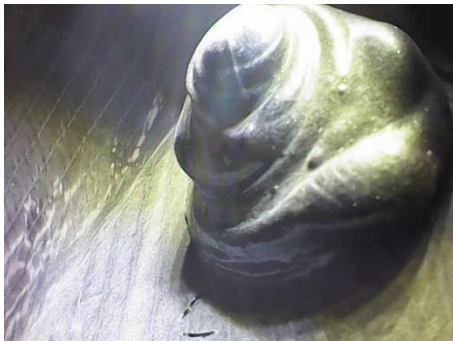
- Using an endoscope, check for the presence of resin on the fixing inserts of the striker in part inside the engine hood.

If resin is present, the procedure can be completed; the strikers on the hood are safe.

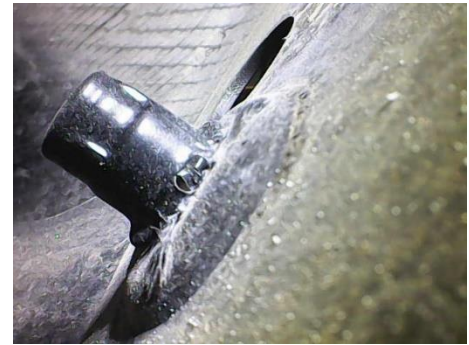
If resin is not present, it is necessary to continue the checking operations, operation B.

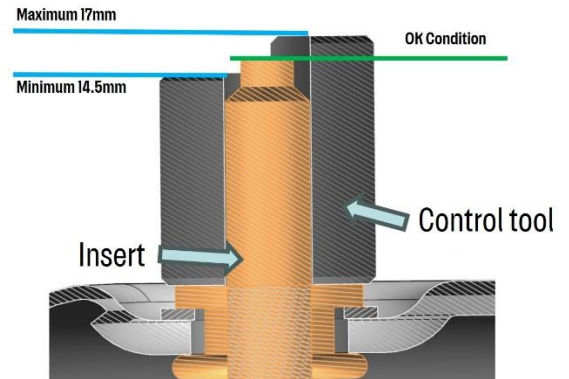
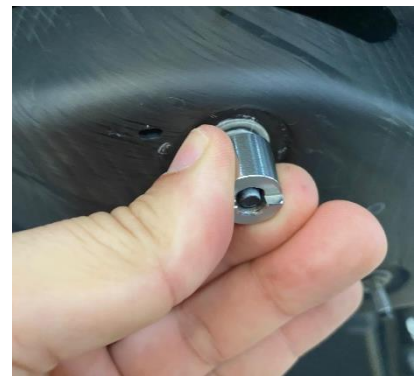
**Positive:** if the thread is correctly found between the two shoulders of the tool.

If all rivets are correctly within the tolerance (positive result), the plates can be re-installed while replacing the nuts.

Nut tightening torque: 8 Nm (5.9 lbf ft) ± 5%.

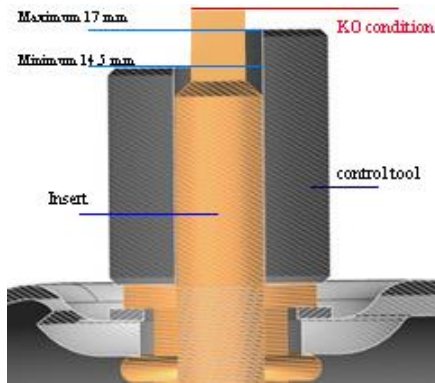
**Negative-case 1:** if the thread is above the upper shoulder, go straight to operation C-repair method.

All that is needed to go to operation C is a single rivet being negative-case. Both supplementary brackets will be installed.

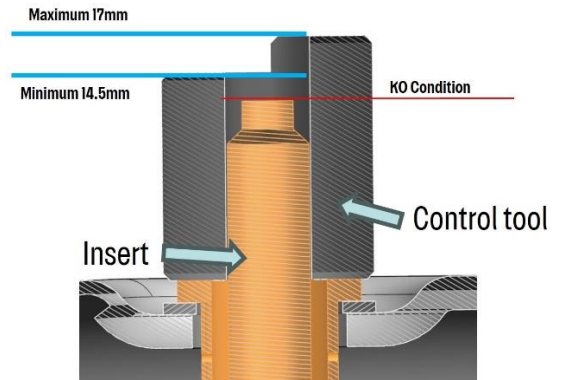
**Negative-case 2:** if the thread is under the lower shoulder, use the riveting tool (point 8).

If the riveting tool is not yet available on your dealership go straight to operation C-repair method.

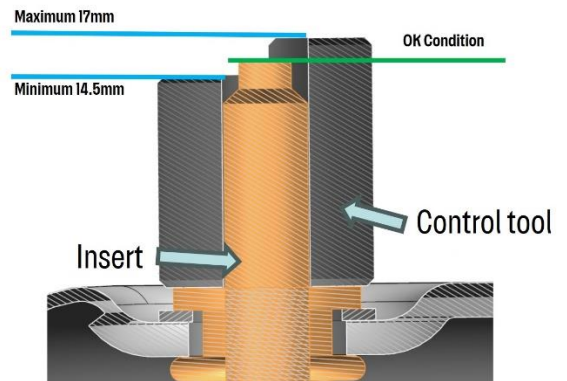
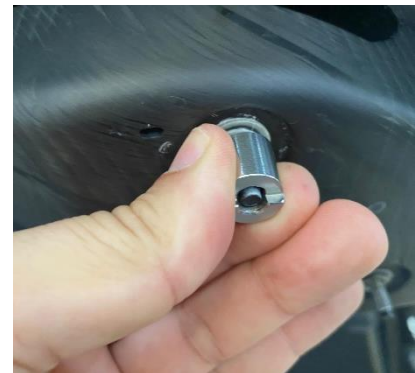
**Positive:** if the thread is correctly found between the two shoulders of the tool.

If all rivets are correctly within the tolerance (positive result), the plates can be re-installed while replacing the nuts.

Nut tightening torque: 8 Nm (5.9 lbf ft) ± 5%.

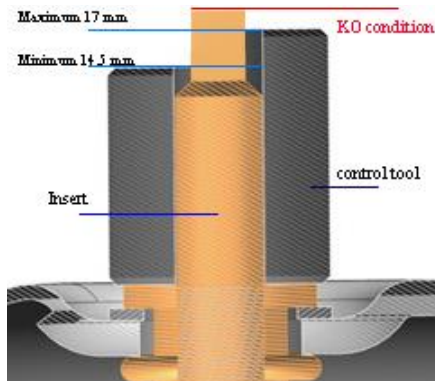
**Negative-case 1:** if the thread is above the upper shoulder, go straight to operation C-repair method.

All that is needed to go to operation C is a single rivet being negative-case. Both supplementary brackets will be installed.

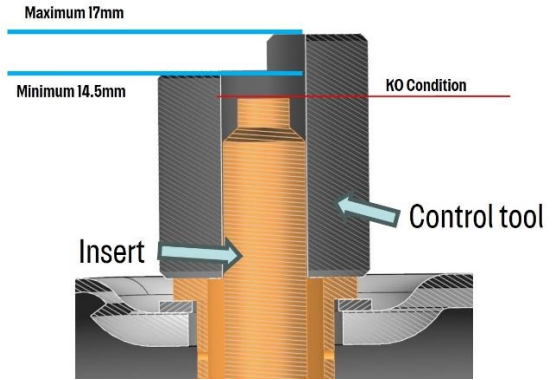
**Negative-case 2:** if the thread is under the lower shoulder, pull again using the *riveting tool* (point 12).

12. Set the tool at 13 Nm (9.59 Lbf ft).

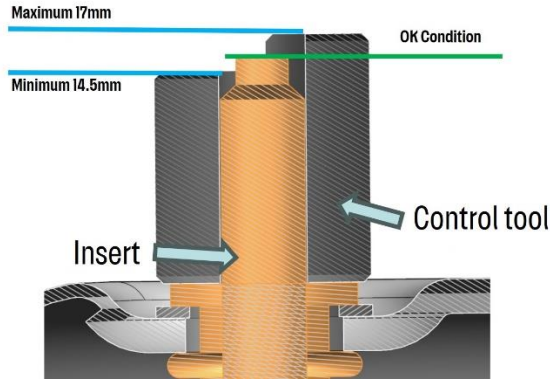
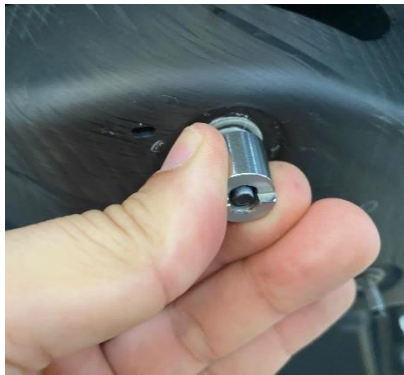
**Positive:** if the thread is correctly found between the two shoulders of the tool.

If all rivets are correctly within the tolerance (positive result), the plates can be re-installed while replacing the nuts.

Nut tightening torque: 8 Nm (5.9 lbf ft) ± 5%.

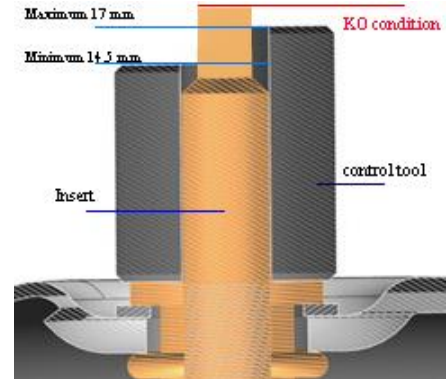
**Negative-case 1:** if the thread is above the upper shoulder, go straight to operation C-repair method.

All that is needed to go to operation C is a single rivet being negative-case1. Both supplementary brackets will be installed.

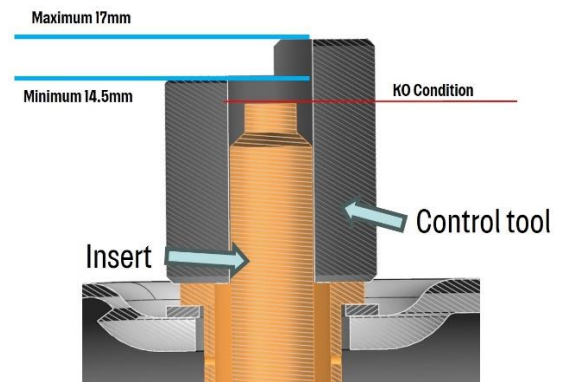
**Negative-case 2:** if the thread is under the lower shoulder even after the second pull, go directly to operation C-repair method.

All that is needed to go to operation C is a single rivet being negative-case2. Both supplementary brackets will be installed.

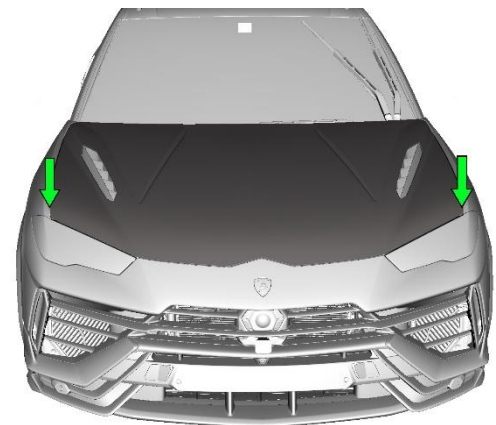
**26.** Remove the guards on the engine compartment and try to close the engine hood. If the hood properly closes, check the distance (hood/fenders) in the two points seen in the image using a thickness gauge. Maximum gap 3 mm (0.12 In.). Check that the distance coincides on both sides for perfect hood alignment.

27. In the case of severe misalignment, adjust the strikers while checking that the previously traced reference marks have been observed.  
If necessary, follow the instructions in the workshop manual.
