August 22, 2024 – Clarified required Collect Diagnostic Information (Manual) ODR Upload.
*****All Dealers: Please watch for updates to this procedure.*****

Section B : Repair Procedure Recall 6624E

Section B : Repair Procedure Recall 6724E & SSPD6 – **You only need to update the VCM once if both campaigns are Open, then Collect Diagnostic Information (Manual) ODR Upload, then input a claim for 6724E and SSPD6 separately.**

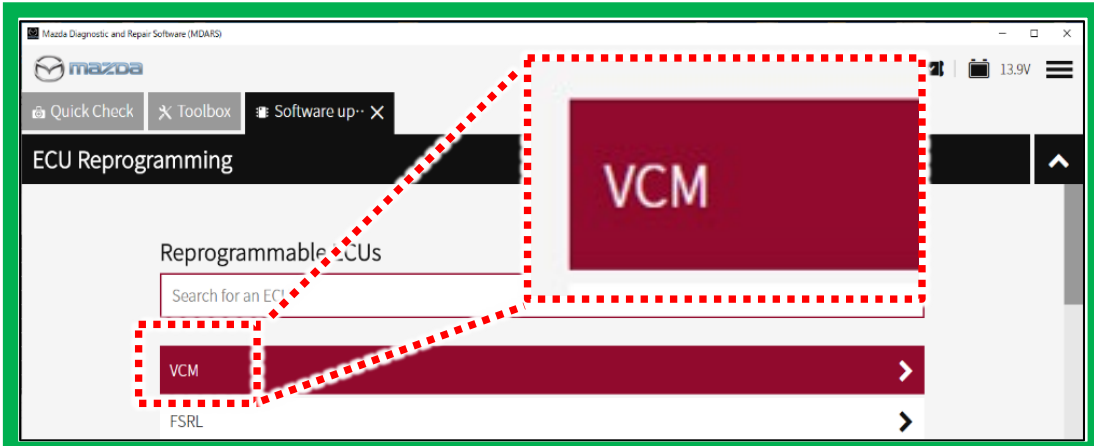
GOOD

IMPORTANT: VCM and VMC modules have similar names but have different functions. When reprogramming, check carefully to avoid making mistakes in the reprogramming module.
