# Compliance Recall

## Code: 941L

<b>Subject</b>	<b>Headlamp Control Unit Software</b>																													
<b>Document History</b>	<table border="1"> <thead> <tr> <th style="background-color: #c00000; color: white;">Date</th> <th colspan="4" style="background-color: #c00000; color: white;">Summary</th> </tr> </thead> <tbody> <tr> <td>05/29/2024</td> <td colspan="4">Original publication</td> </tr> </tbody> </table>					Date	Summary				05/29/2024	Original publication																		
Date	Summary																													
05/29/2024	Original publication																													
<b>Affected Vehicles</b>	<table border="1"> <thead> <tr> <th style="background-color: #c00000; color: white;">Country</th> <th style="background-color: #c00000; color: white;">Beginning Model Year</th> <th style="background-color: #c00000; color: white;">Ending Model Year</th> <th style="background-color: #c00000; color: white;">Vehicle</th> <th style="background-color: #c00000; color: white;">Vehicle Count</th> </tr> </thead> <tbody> <tr> <td>USA</td> <td>2022</td> <td>2024</td> <td>Q4 SPORTBACK E-TRON</td> <td>3,683</td> </tr> <tr> <td>USA</td> <td>2022</td> <td>2024</td> <td>Q4 E-TRON</td

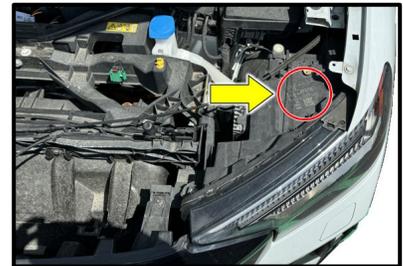
- Connect battery charger.
- Switch off all consumers, air conditioning, heater blower motor, lights, heated seats, etc.
- Ensure the latest version of ODIS is downloaded.
- Ensure diagnostic head is connected to ODIS tester via USB cable.
- Move selector lever to P.
- Use operating mode, **DIAGNOSIS**.
- Select “Special Functions”.
- Select “SVM – Code Input”.
- Enter SVM code **941LA016** and follow the on-screen prompts.
- After the SVM has completed, locate the “BCI” numbers on the top of **both** headlamp assemblies <arrow>.

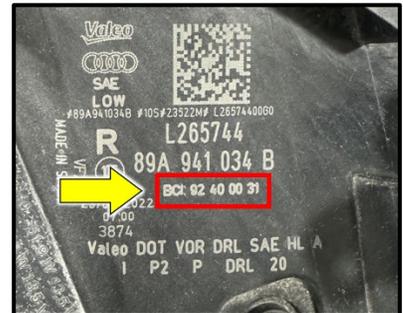
- Record the “BCI” number <arrow> from both headlamp assemblies.

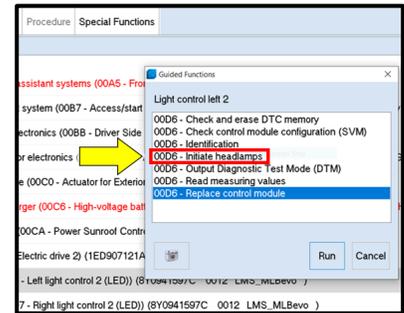
- Under Guided Functions for DA 00D6 and DA 00D7, perform the test plans for “00D6 – Initiate headlamps” and “00D7 – Initiate headlamps”.
  - DA 00D6 = Driver side headlight.
  - DA 00D7 = Passenger side headlight.
- Follow the on-screen prompts and enter the BCI numbers when asked by the test plan.
  - When the test plan asks if any components were replaced, select the option for “No”.
- Clear the fault memory by exiting the GFF session.
- When exiting GFF, ensure the diagnostic log is sent to GFF Paperless.
