# SAFETY RELATED RECALL

Global Recall Action  
Number: N901

<b>Subject:</b>  <b>Rear Surround Camera Bezel Water Ingress</b>	Publication No.: N901
	Model: Range Rover Sport (LW)
	Model Year: 2018 - 2022
	Date of Issue: 29 May 2024

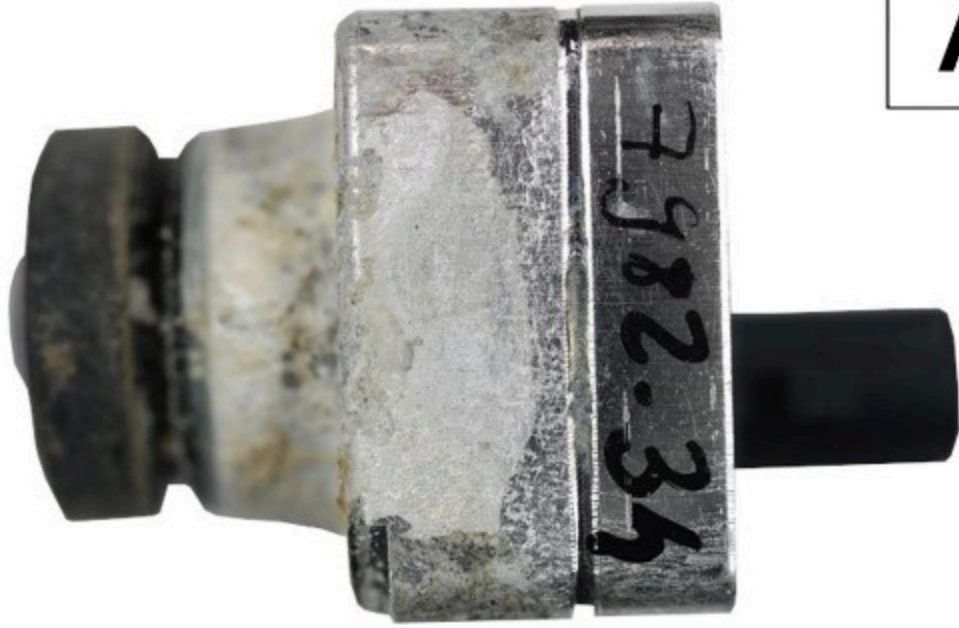
**A**

- Inspect the rear surround camera housing and lens adhesive for corrosion. If there **ARE** any signs of corrosion on the rear surround camera housing, as shown in the illustration marked 'A' the rear surround camera has **FAILED** the inspection. **Continue to step 7.**
- Inspect the rear surround camera lens for water ingress. If there **ARE** any signs of water ingress on the rear surround camera lens, as shown in the illustration marked 'B' the rear surround camera has **FAILED** the inspection. **Continue to step 7.**
- If there are no signs of corrosion or water ingress on the rear surround camera housing the rear surround camera has **PASSED** the inspection. **Continue to step 6.**

If the rear surround camera has failed **ANY** of the inspections from steps 5 and 6, a new rear surround camera must be installed.

Renew the rear surround camera.

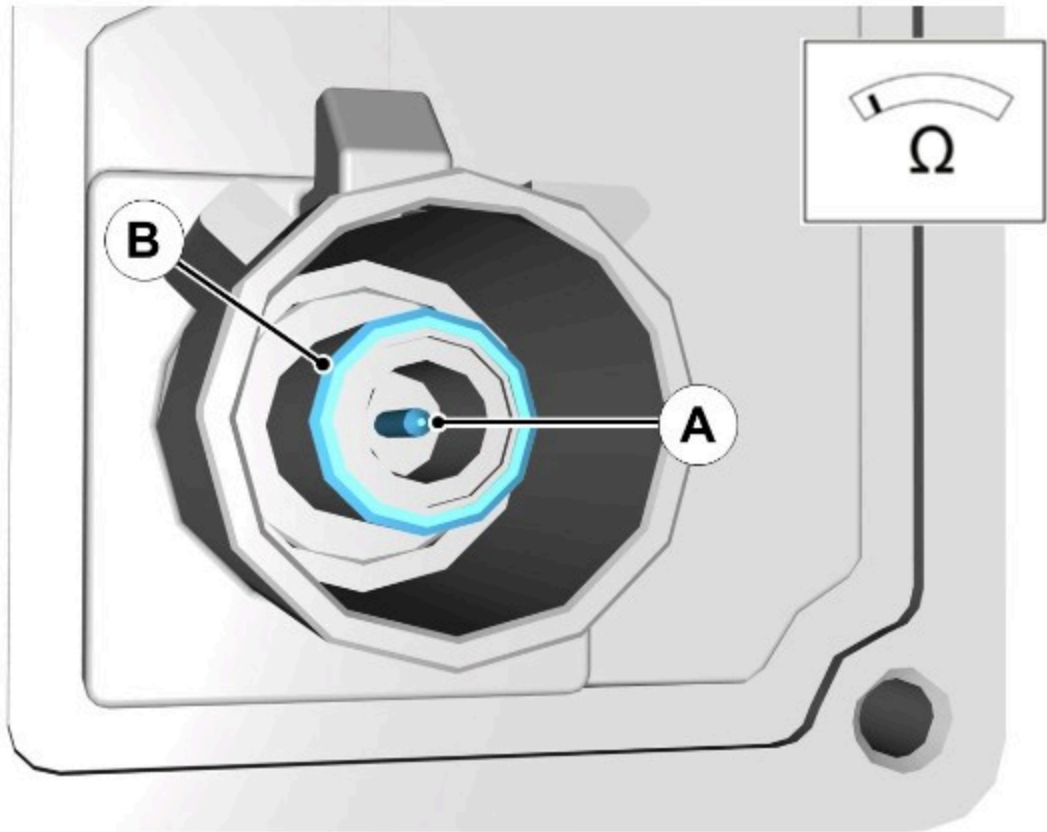
E354270

- Using a suitable digital multimeter place a probe on the center pin (A) of the electrical connection and a probe on the outer shield of the electrical connection (B), as shown in the illustration.
- If the multimeter indicates a closed circuit the rear surround camera has **FAILED** the inspection. **Continue to step 7.**
- If the multimeter indicates an open circuit the rear surround camera has **PASSED** the inspection. **Continue to step 8.**

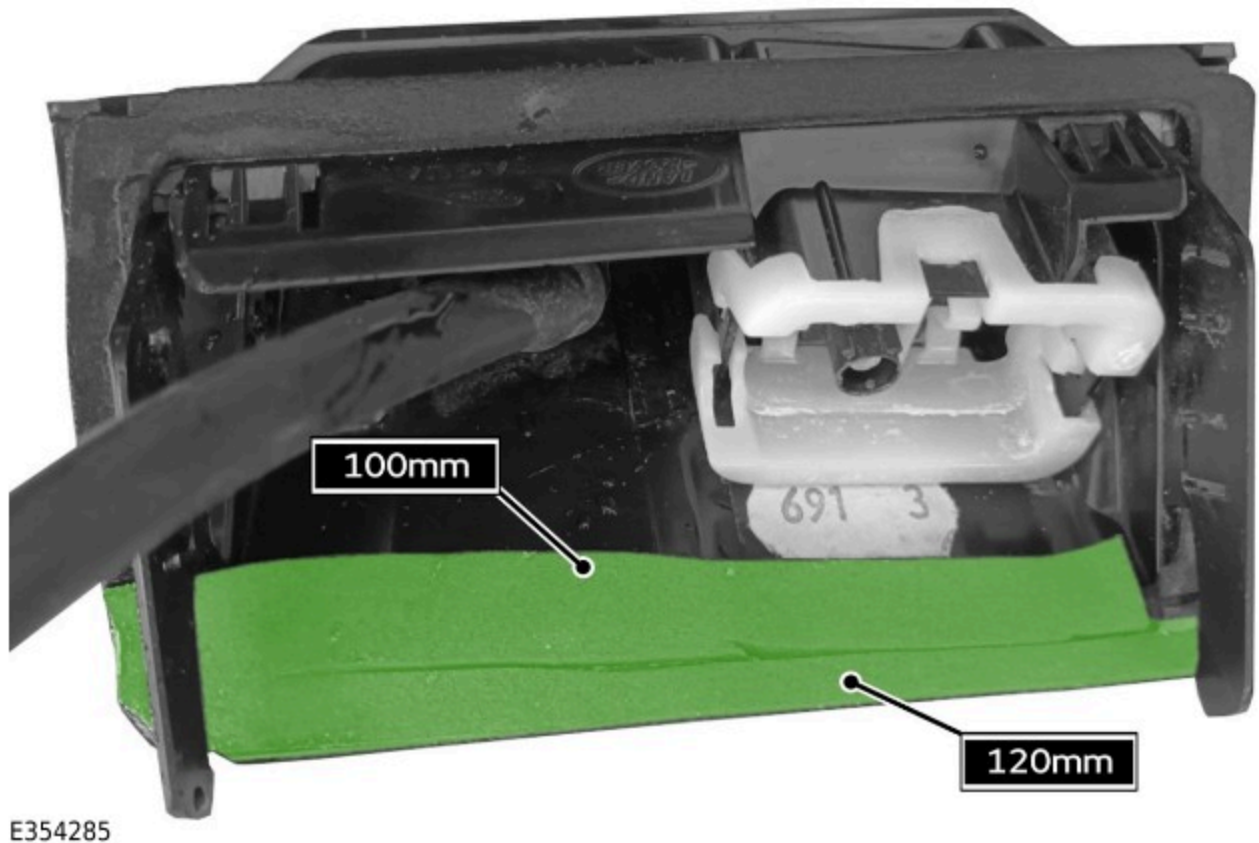
E354285

There must be no gaps between the new and existing Nitto foam. Failure to follow this instruction will lead to water ingress.

Install the 2 pieces of Nitto foam to the rear surround camera bezel as shown in the illustration.
