Recall Campaign Bulletin

Campaign No. 2024060009, June 2024

SUBJECT: **Model C-Class (206 platform)**
Model Year 2023

Check AMG Performance Seat Wiring Harness Routing

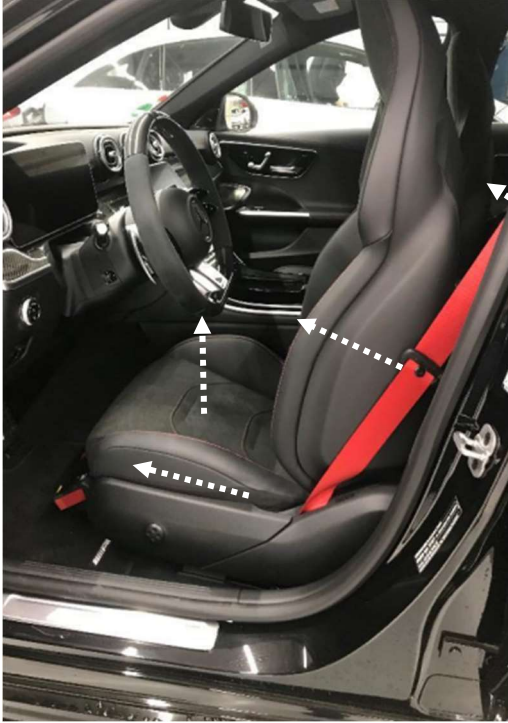
Figure 1

1. Position front seats and backrests as far forward and upward as they will go (**Figure 1**).

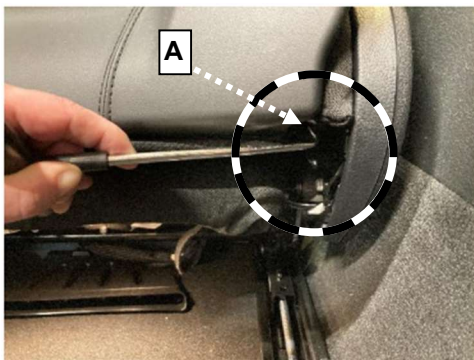
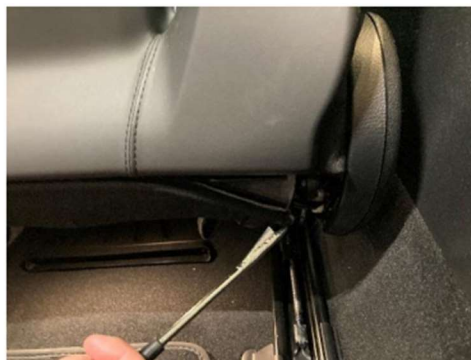
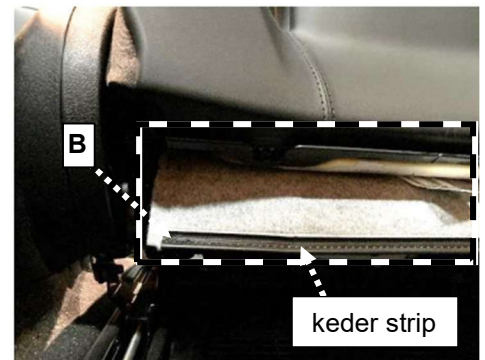
Figure 2

2. Insert a hook behind the keder strip (**Figure 2, A**) on the seat backrest cover and carefully pull the keder strip out of the securing channel (**Figure 2, B**).

i Start on the side closest to the center console and work your way outward towards the door (**Figure 2**).
