Recall Campaign Bulletin

Campaign No. 2024060002, June 2024

SUBJECT: **Model EQE and EQS (294, 295, 296, and 297 platform)**
Model Year 2023 – 2025

Update Battery Management System Software – Wave 1

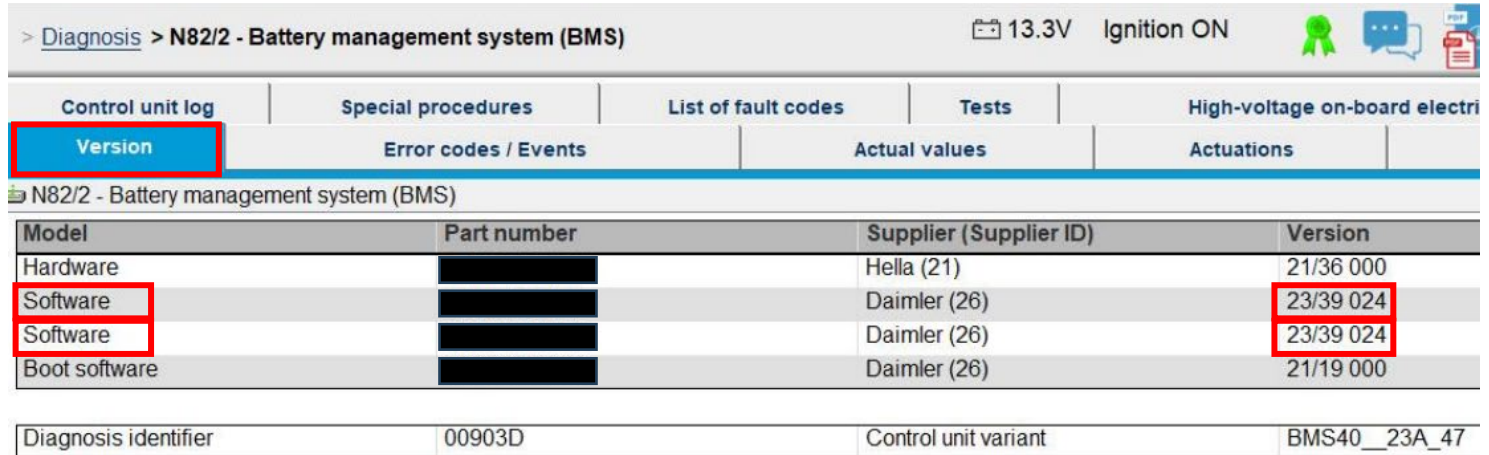
Figure 1

NOTE: To confirm the new BMS software, the Software **Version** will read "**23/XX XXX**" in XENTRY Diagnosis (**Figure 1**).

1. Connect XENTRY Diagnosis.
2. Update **Battery Management System (BMS)** control unit software.
 - i** To do this, select menu item "Quick test view – N82/2 Battery management system (BMS) – Adaptations – Control unit update – Update of control unit software".
 - i** Then follow the user guidance in XENTRY Diagnosis.
