MODEL: Revero GT and GTS, and GS-6

Type: Safety Recall Campaign

TITLE: Headlamp Control Unit Replacement Safety Recall Campaign

APPLICABILITY: Model Year 2020-2022 Karma Vehicles

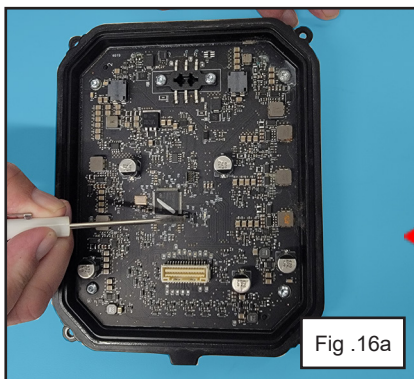
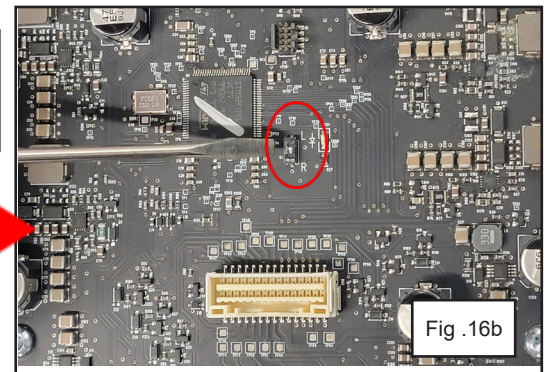
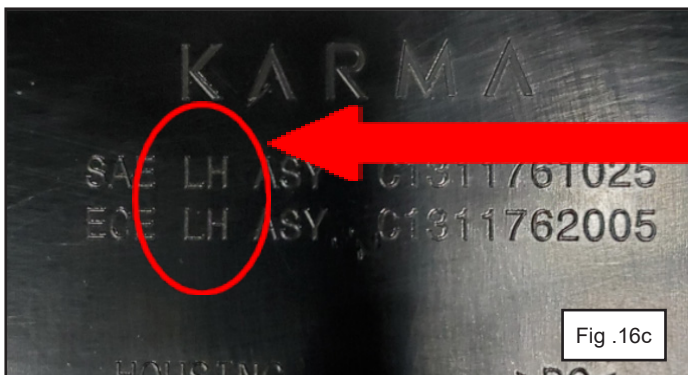
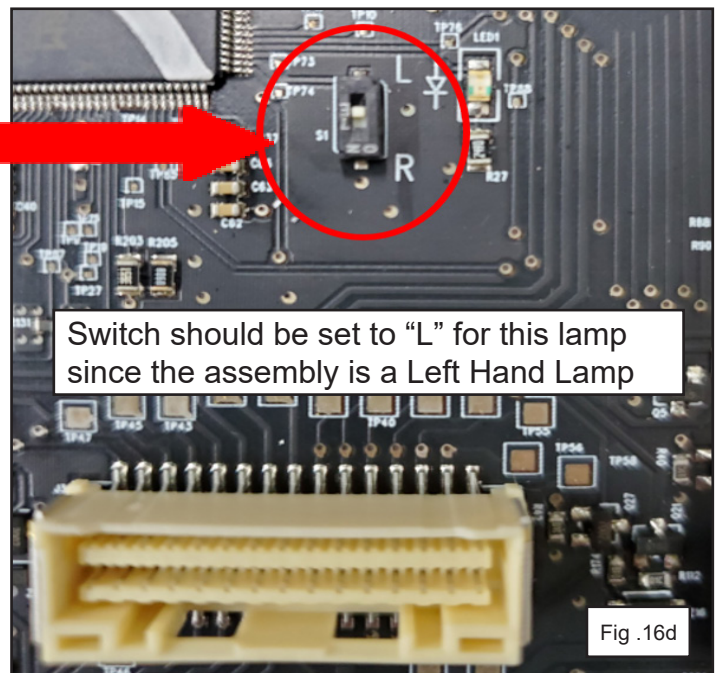
Switch should be set to “L” for this lamp since the assembly is a Left Hand Lamp

22. Again verify and match the lamp side (fig. 16c), to the switch found on the control module. The module here (fig. 16d) is showing the switch on the RH position and should be adjusted to match with the LH lamp.

21. Upon removal of control module assembly from headlamp – remove new replacement control module from provided electro-static discharge sensitive bag. Verify lamp side, the replacement control module is being installed and the DIP switch on the driver circuit board are in alignment. (LH lamp and switch moved to Left of “L” setting. This is a very small white switch (Fig.16a), it may be covered in tape, remove to access the switch and verify the switch to be in the correct position using a non-magnetized tool, or wood toothpick (Fig. 16b). **Again a left hand lamp should have the DIP switch set to L, a right side lamp should have DIP switch set to R.**

IMPORTANT: Before installation verify switch position to the appropriate letter to match lamp being repaired – this ensures appropriate directional indicator control. (L for LH lamp and R for the RH Lamp) If it is not set, move the switch into the corresponding lamp position.

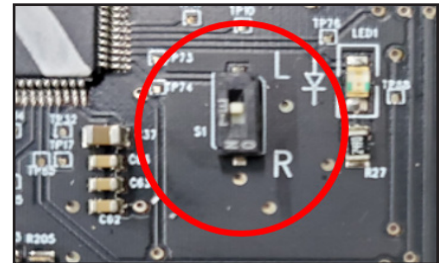
If the control module position switch is in the incorrect position for the lamp side it is installed on the respective turn Indicator will not respond on request from the driver. Please note again, the Left-Hand headlamp module will be set to "L". The Right-Hand headlamp module will be set to "R", for proper function.
