GROUP	MODEL
Non-Compliance Safety Recall Campaign	2024MY EV9 Light (MV)
NUMBER	DATE
SC317	June 2024

HEADLINER IMPACT ABSORBING PLATE REPLACEMENT (SC317)

This bulletin provides information to replace the impact-absorbing plates mounted on the headliner with improved ones on certain 2024MY EV9 (MV) Light trim model vehicles produced from September 25, 2023 through March 21, 2024. In the event of a crash where an occupant's head contacts the headliner, the headliner may not absorb an adequate amount of the impact. As a result, these vehicles fail to comply with the performance requirements of Federal Motor Vehicle Safety Standard (FMVSS) 201 "Occupant Protection in Interior Impact". This condition increases the risk of injury if the occupant's head were to impact the headliner in the event of a crash. Follow the procedure outlined in this publication to replace the impact-absorbing plates mounted on the headliner with improved parts on the applicable vehicle. Before conducting the procedure, verify that the vehicle is included in the list of affected VINs.

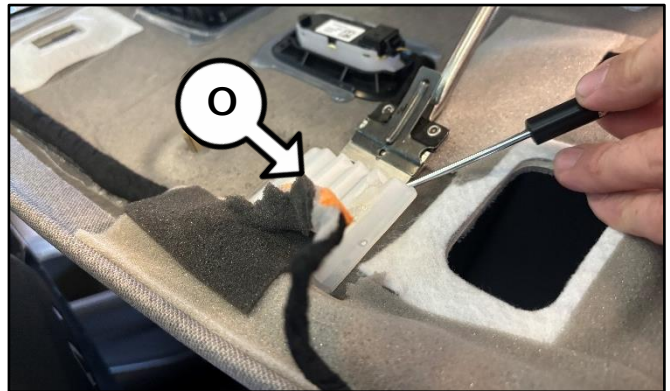
18. Remove/cut-off the inner padding (N) to access the existing plastic impact absorbing shield (O).

- 19a. Using a flat chisel/blade scraper, gently lift up on the plastic impact absorbing shield (O) to detach and remove from the headliner surface.

- 19b. Repeat for the opposite (LH or RH) side.
