Safety Recall Campaign

SC316

2020-2024MY  
Telluride (ON)

### FRONT POWER SEAT CONTROL SWITCH REPAIR/REPLACEMENT (SC316)

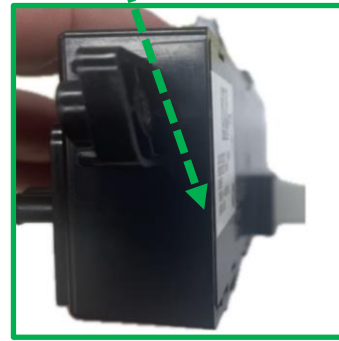
4. Confirm if the power seat control switch (B) backing plate IS or is NOT popped out.

- If the power seat control switch backing plate has is NOT popped out (OK), proceed to step 5.

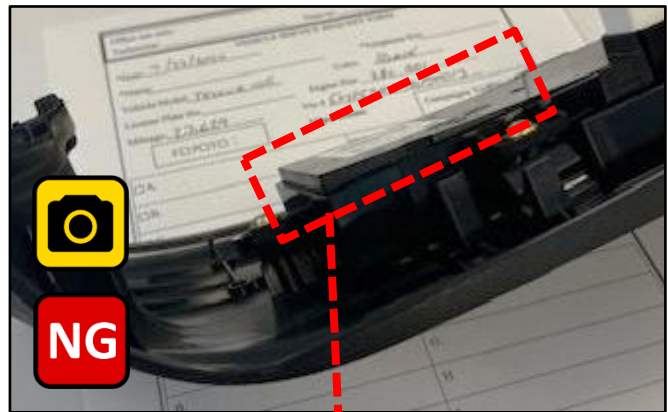
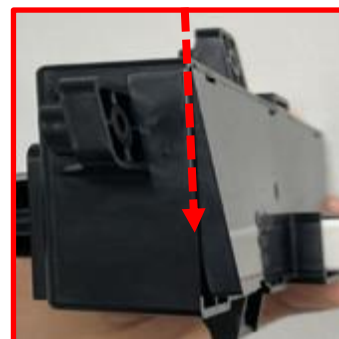
- If the power seat control switch backing plate IS popped out (NG), take one clear KVID photo of the NG switch including RO information, and then replace the power seat control switch by proceeding to 'Replacement Procedure' on page 7. then replace the power seat control switch by proceeding to 'Replacement Procedure' on page 7.
