GROUP	MODEL
Safety Recall Campaign	2020-2024MY Telluride (ON)
NUMBER	DATE
SC316 (Rev 2, 8/27/2024)	July 2024

FRONT POWER SEAT CONTROL SWITCH REPAIR/REPLACEMENT (SC316)

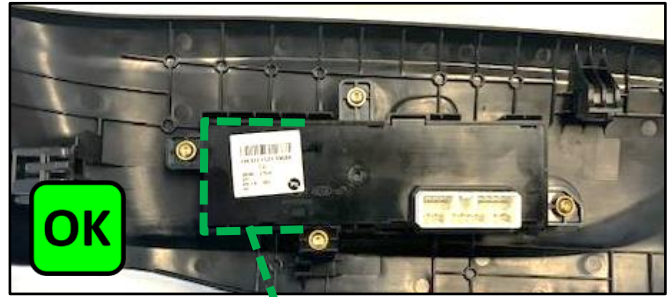
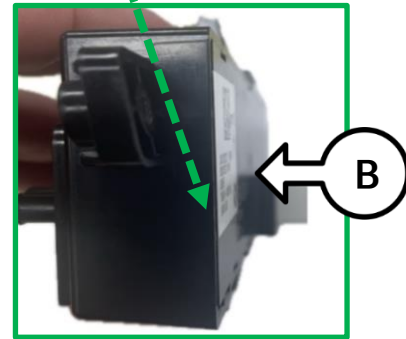
4a. Inspect the back cover of the power seat control switch (C) is not detached/separated from the control switch case.

- If the power seat control switch back cover is not detached or separated from the switch case (OK), proceed to the 'Repair Procedure' on page 5.

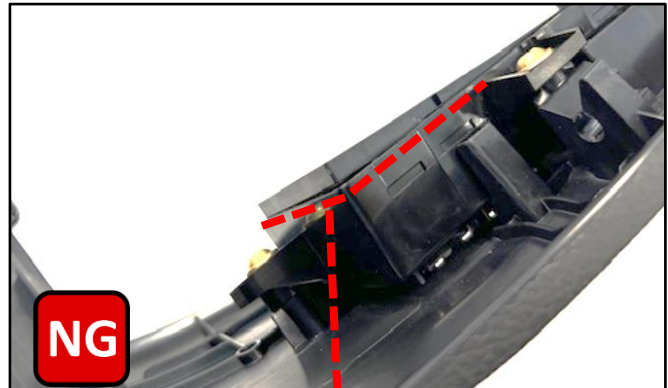
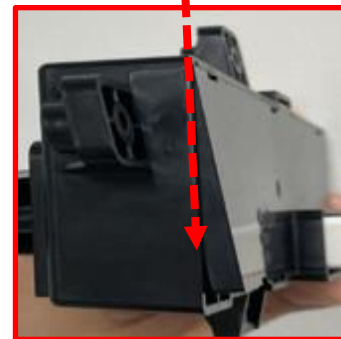
4b. • If the power seat control switch back cover is detached or separated from the switch case (NG), skip to the 'Replacement Procedure' on page 6.

Replacement Procedure: (Front Power Seat Control Switch & Slide Knob)

1. Replace the front power seat control switch by referring to "Body Electrical System → Seat Electrical → Removal and Installation" in the applicable Shop Manual on KGIS.
2. Install a **new** switch slide knob (D).
3. Confirm normal operation.
