GROUP	MODEL
Safety Recall Campaign	2020-2024MY Telluride (ON)
NUMBER	DATE
SC316 (Rev 1, 8/01/2024)	July 2024

### SUBJECT: FRONT POWER SEAT CONTROL SWITCH REPAIR/REPLACEMENT (SC316)

This bulletin provides information to install a bracket on the power seat control switch or if necessary, replace the power seat switch and replace the seat slide knob(s) on certain 2020-2024MY Telluride (ON) vehicles produced from January 9, 2019 through May 29, 2024. If there is an external impact with excessive force to the front power seat side cover and/or seat slide knob, the power seat switch back cover can dislodge resulting in an internal misalignment of the seat motor control switch. A misaligned seat motor control switch with a stuck seat slide knob can lead to continuous operation of a seat motor. Over time, this can result in overheating of the seat motor, thereby increasing the risk of a fire while driving or while parked. A fire increases the risk of injury. Warnings associated with this issue that customers may experience include the seat slide knob sticking (e.g., inability to adjust power seat or power seat continues moving even after seat slide knob is released), a burning or melting

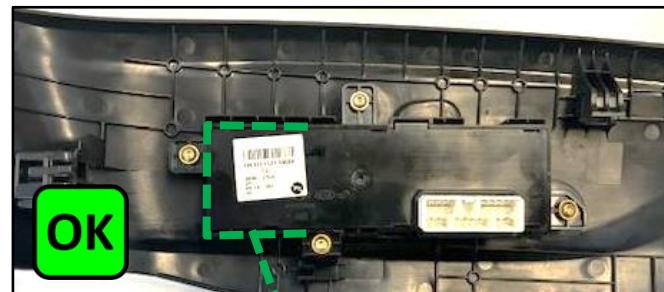
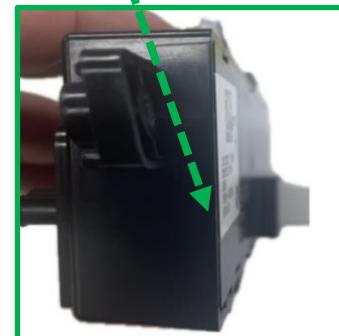
4. Confirm if the power seat control switch (B) backing plate IS or is NOT popped out.

- If the power seat control switch backing plate has is NOT popped out **(OK)**, proceed to step 5.

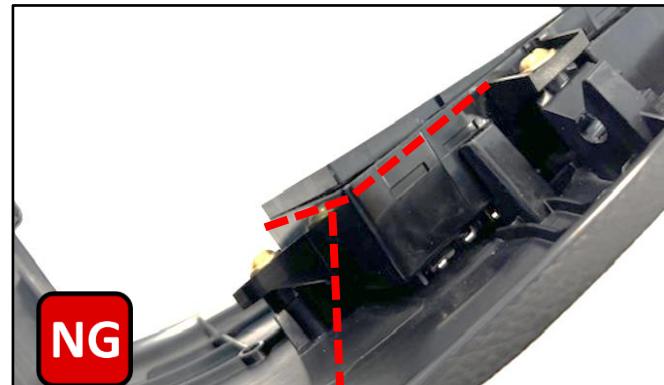
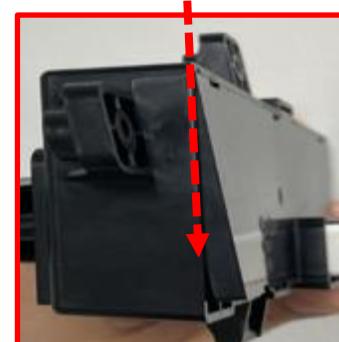
- If the power seat control switch backing plate IS popped out **(NG)**, then replace the power seat control switch by proceeding 'Replacement Procedure' on page 7.
