RAM

SAFETY RECALL

8HP75 TCU Weld

Reference: 63B / NHTSA 24V-413

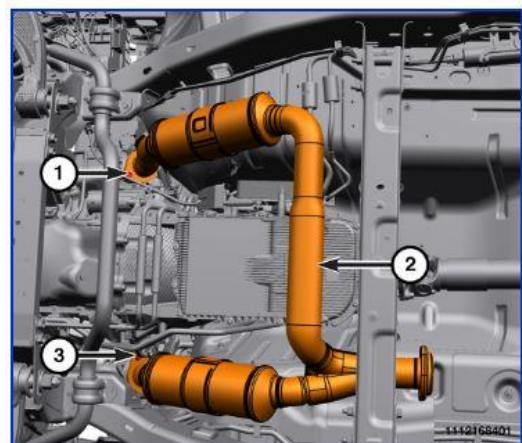
Figure 1 – Exhaust Bolts

- 1 - Left Catalytic Converter To Exhaust Manifold Bolts
2 - Catalytic Converter
3 - Right Catalytic Converter To Exhaust Manifold Bolts

6. Remove the left and right catalytic converter to exhaust manifold bolts (1,3) (Figure 1).
7. Remove the two nuts securing the Y-pipe to the exhaust system.
8. Reposition the exhaust Y-pipe out of the way.
9. Drain the transmission fluid (Refer to 21 - Transmission and Transfer Case/Automatic – 8HP75/FLUID and FILTER/Standard Procedure).

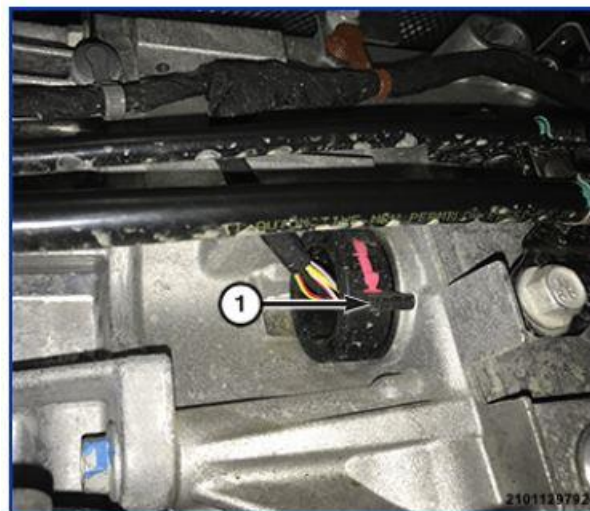
Figure 2 – Harness Connector

1 - Transmission Wire Harness Connector

10. Disconnect the transmission wire harness connector (1) from the transmission by rotating the connector counter-clockwise (Figure 2).

17. Connect the transmission wire harness connector (1) (Figure 2).
 18. Turn the locking mechanism of the transmission wire harness connector clockwise to lock it in place.

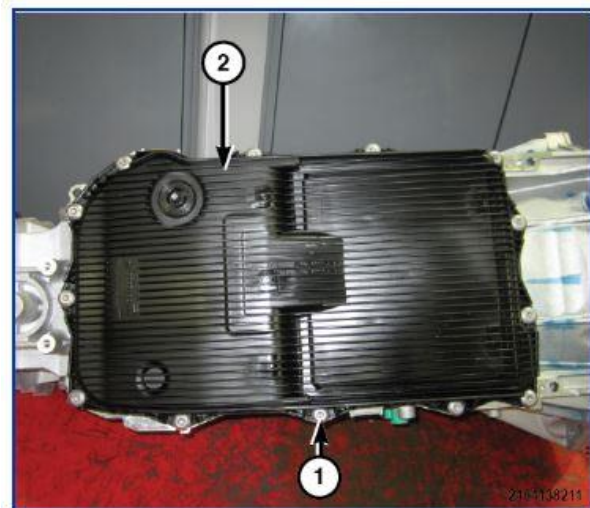
Figure 3 – Transmission Oil Pan Bolts

1 - Transmission Oil Pan Bolts

2 - Transmission Oil/Filter Pan Assembly

11. Remove the transmission oil pan bolts (1) (Figure 3).
12. Remove the transmission oil/filter pan assembly (2) and gasket (Figure 3).

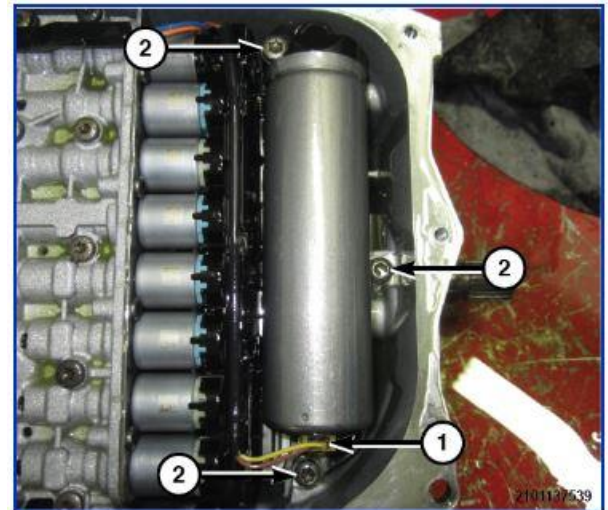
Figure 4 – HIS Connector and Bolts

- 1 - Hydraulic Impulse Solenoid (HIS) Wire Harness Connector
- 2 - HIS Bolts

13. If equipped, disconnect the Hydraulic Impulse Solenoid (HIS) wire harness connector (1) (Figure 4).
14. If equipped, remove the three HIS bolts (2) and remove the HIS accumulator (Figure 4).

12. If equipped, install the **NEW** HIS accumulator.
 13. Tighten the **NEW** HIS bolts (2) to 8 N·m (71 in. lbs.) (Figure 4).
 14. Connect the HIS wire harness connector (1) (Figure 4).

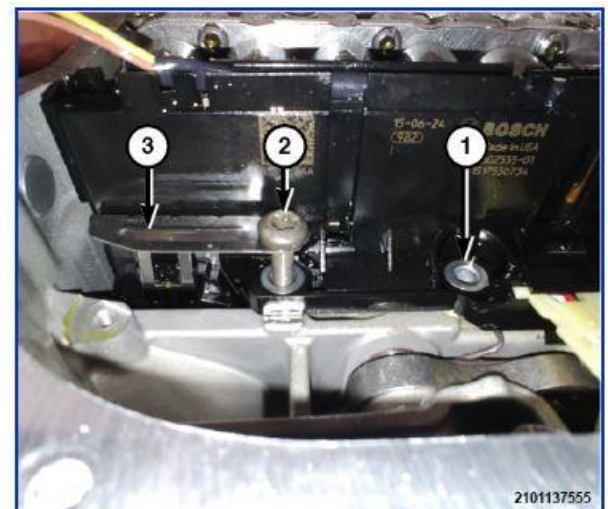
Figure 5 – Valve Body End Bolts and Connector Lock

- 1 - Valve Body Assembly End Retainer Bolt
- 2 - Valve Body Assembly End Retainer Bolt
- 3 - Electrical Connector Lock

15. Remove the valve body assembly end retainer bolts (1, 2) (Figure 5).
16. Lift the electrical connector lock (3) to release the internal harness end from inside the transmission for valve body assembly removal (Figure 5).

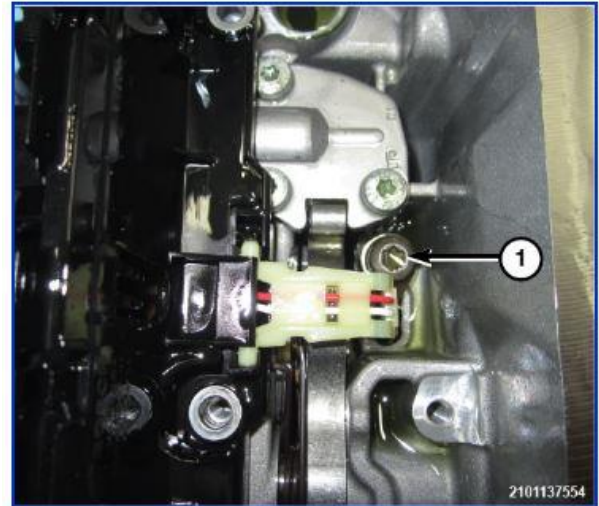
Figure 6 – OSS Bolt

1 - Output Speed Sensor (OSS) Bolt

17. Remove the Output Speed Sensor (OSS) bolt and pull the sensor loose from the case (Figure 6).

10. Install the OSS and install the **NEW** OSS bolt and tighten to 8 N·m (71 in. lbs.) (Figure 6)
 11. Tighten **ALL** of the valve body bolts to 8 N·m (71 in. lbs.) in the sequence shown (Figure 9).

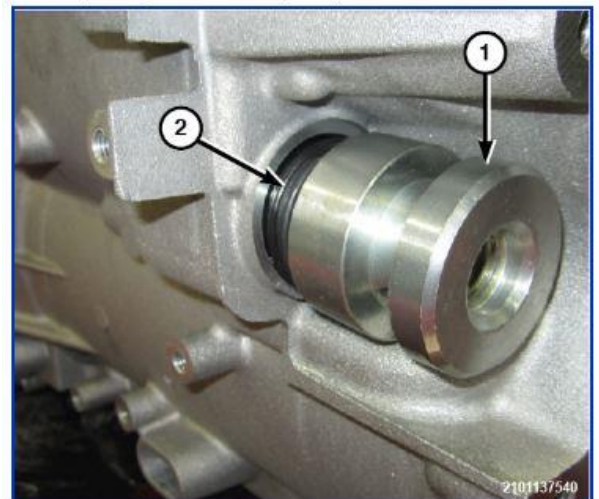
Figure 7 – Guide Sleeve Removal and Installation

1 - Remover/Installer, Guide Sleeve 10377

2 - Transmission Harness Guide Sleeve

18. Using the Remover/Installer, Guide Sleeve 10377, pull the transmission harness guide sleeve straight out from the transmission case (Figure 7).
19. Disconnect the Manual Park Release (MPR) cable end from the MPR lever. Remove the bracket bolts and remove the MPR cable and bracket from the transmission for easier removal and installation of the valve body.

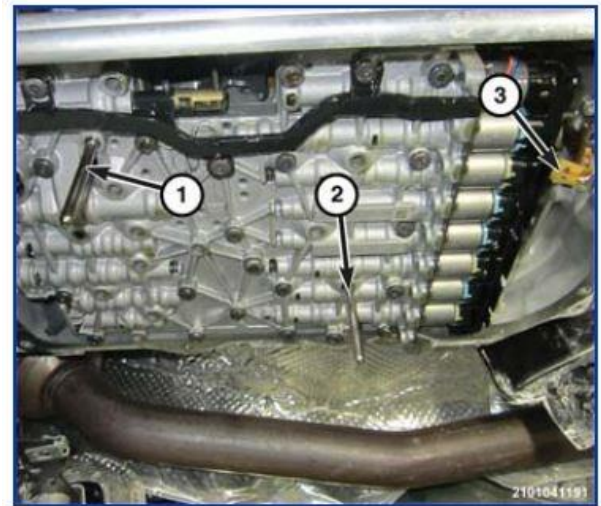
Figure 8 – Valve Body Alignment Pins

- 1 - Pin, Valve Body Alignment 10379
- 2 - Pin, Valve Body Alignment 10379
- 3 - Output Speed Sensor (OSS) Wire Harness Connector

20. Remove two valve body assembly retaining bolts in the positions shown and hand install the Pins, Valve Body Alignment 10379 (1,2) (Figure 8).
21. Use an appropriate tool on one of the alignment pins to assist in holding the valve body in position while removing the remaining fasteners.

1. Install the fluid transfer port with **NEW** O-rings (Figure 10).
2. Install the **NEW** valve body assembly to the transmission using the previously installed Pins, Valve Body Alignment 10379 as a guide (Figure 8).

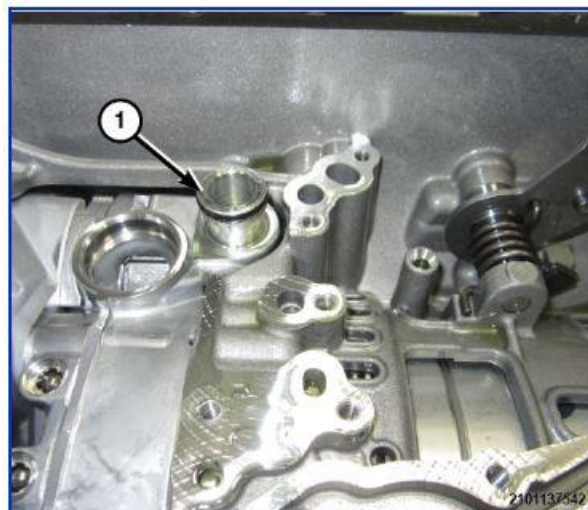
Figure 10 – Fluid Transfer Port

1 - Transfer Port

24. Remove the fluid transfer port from the transmission if it did not come out with the valve body (Figure 10).
25. Remove and **DISCARD** the fluid transfer port O-rings.

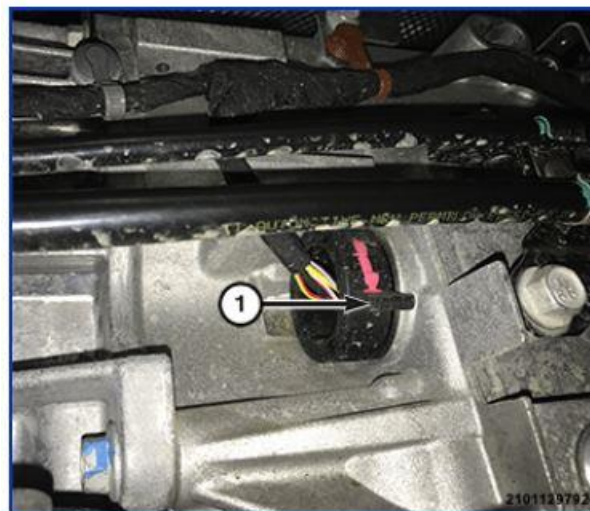
Figure 14 – Harness Connector

1 - Transmission Wire Harness Connector

6. Disconnect the transmission wire harness connector (1) from the transmission by rotating the connector counter-clockwise (Figure 14).

38. Connect the transmission wire harness connector (1) (Figure 14).
39. Turn the locking mechanism of the transmission wire harness connector clockwise to lock it in place.

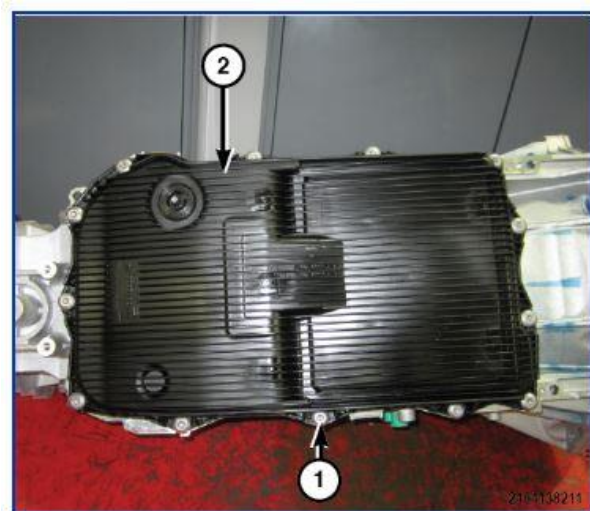
Figure 15 – Transmission Oil Pan Bolts

1 - Transmission Oil Pan Bolts

2 - Transmission Oil/Filter Pan Assembly

7. Remove the transmission oil pan bolts (1) (Figure 15).
8. Remove the transmission oil/filter pan assembly (2) and gasket (Figure 15).

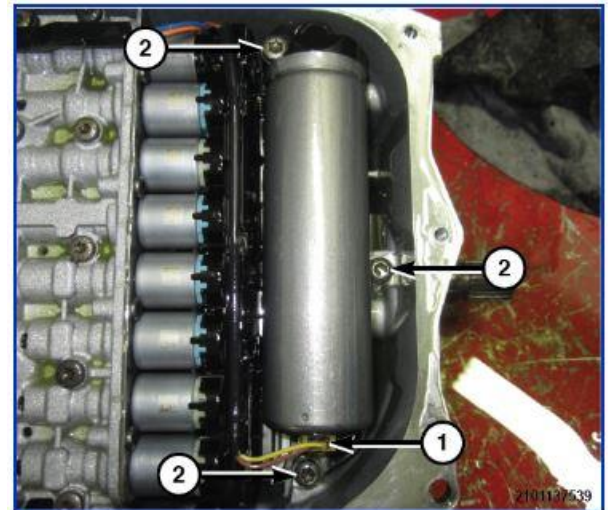
Figure 16 – HIS Connector and Bolts

- 1 - Hydraulic Impulse Solenoid (HIS) Wire Harness Connector
- 2 - HIS Bolts

9. If equipped, disconnect the Hydraulic Impulse Solenoid (HIS) wire harness connector (1) (Figure 16).
10. If equipped, remove the three HIS bolts (2) and remove the HIS accumulator (Figure 16).

33. If equipped, install the **NEW** HIS accumulator.
34. Tighten the **NEW** HIS bolts (2) to 8 N·m (71 in. lbs.) (Figure 16).
35. Connect the HIS wire harness connector (1) (Figure 16).

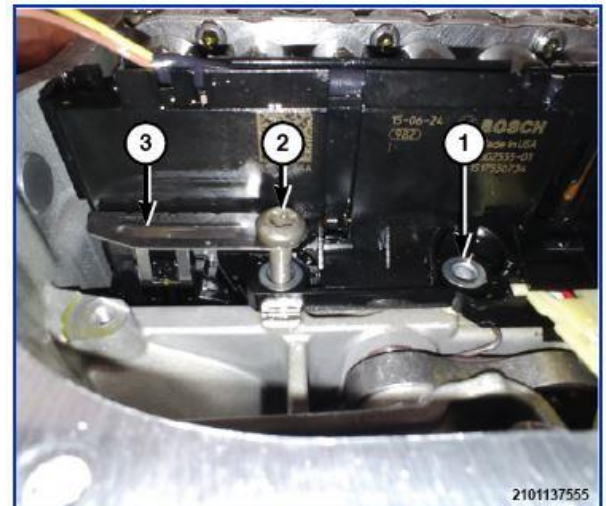
Figure 17 – Valve Body End Bolts and Connector Lock

- 1 - Valve Body Assembly End Retainer Bolt
- 2 - Valve Body Assembly End Retainer Bolt
- 3 - Electrical Connector Lock

11. Remove the valve body assembly end retainer bolts (1, 2) (Figure 17).
12. Lift the electrical connector lock (3) to release the internal harness end from inside the transmission for valve body assembly removal (Figure 17).

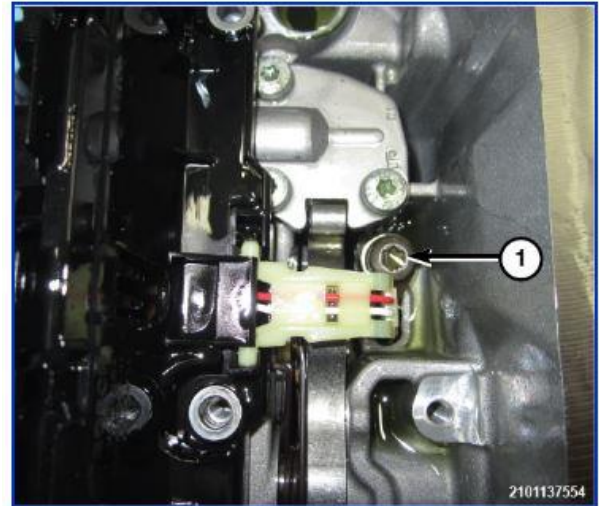
Figure 18 – OSS Bolt

1 - Output Speed Sensor (OSS) Bolt

13. Remove the Output Speed Sensor (OSS) bolt and pull the sensor loose from the case (Figure 18).

31. Install the OSS and install the **NEW** OSS bolt and tighten to 8 N·m (71 in. lbs.) (Figure 18)
32. Tighten **ALL** of the valve body bolts to 8 N·m (71 in. lbs.) in the sequence shown (Figure 21).

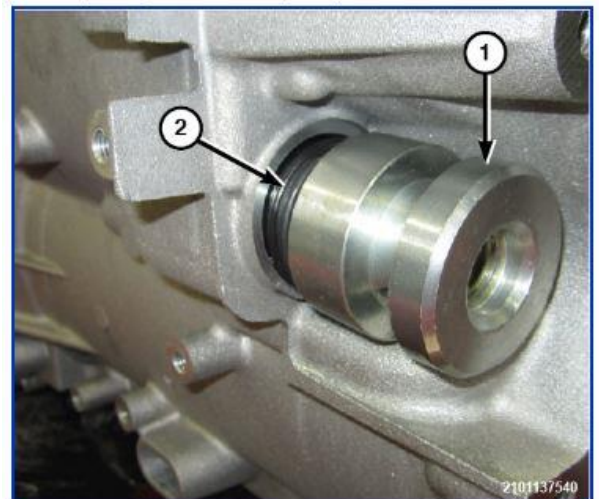
Figure 19 – Guide Sleeve Removal and Installation

1 - Remover/Installer, Guide Sleeve 10377

2 - Transmission Harness Guide Sleeve

14. Using the Remover/Installer, Guide Sleeve 10377, pull the transmission harness guide sleeve straight out from the transmission case (Figure 19).
15. Disconnect the Manual Park Release (MPR) cable end from the MPR lever. Remove the bracket bolts and remove the MPR cable and bracket from the transmission for easier removal and installation of the valve body.

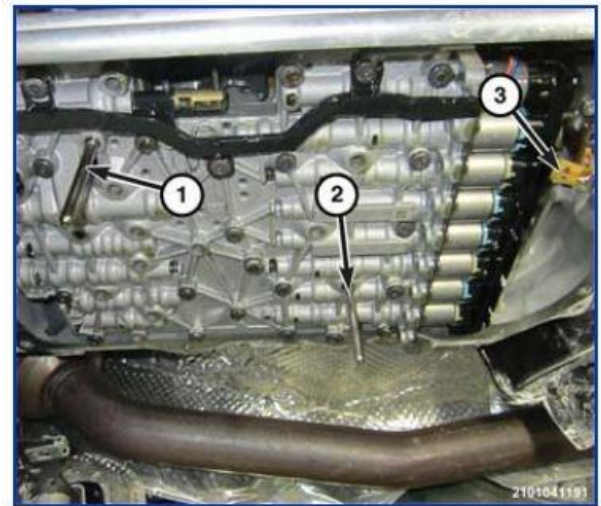
Figure 20 – Valve Body Alignment Pins

- 1 - Pin, Valve Body Alignment 10379
- 2 - Pin, Valve Body Alignment 10379
- 3 - Output Speed Sensor (OSS) Wire Harness Connector

16. Remove two valve body assembly retaining bolts in the positions shown and hand install the Pins, Valve Body Alignment 10379 (1,2) (Figure 20).
17. Use an appropriate tool on one of the alignment pins to assist in holding the valve body in position while removing the remaining fasteners.

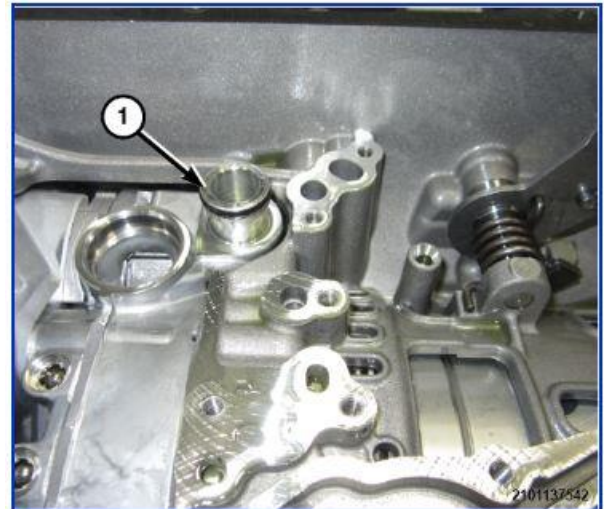
Figure 22 – Fluid Transfer Port

1 - Transfer Port

20. Remove the fluid transfer port from the transmission if it did not come out with the valve body (Figure 22).
21. Remove and **DISCARD** the fluid transfer port O-rings.

22. Install the fluid transfer port with **NEW** O-rings (Figure 22).
23. Hold the **NEW** valve body up while an assistant installs the Pins, Valve Body Alignment 10379 as a guide (Figure 20).
NOTE: Check that the manual park release lever is aligned.
24. Use an appropriate tool on one of the alignment pins to assist in holding the valve body in position while installing the remaining fasteners.
25. Install the **NEW** valve body assembly retaining bolts 1-14 and hand tighten the valve body bolts (Figure 21).
26. Remove the pins and install the remaining bolts.
27. Using the Remover/Installer, Guide Sleeve 10377 carefully install the transmission harness guide sleeve to the transmission case (Figure 19).
28. Push the wire harness connector lock down to lock it to the internal wire harness connector end and install the **NEW** valve body end retaining bolts (Figure 17).
