SAFETY RECALL

2nd Row Seating Regulatory Compliance

Reference: 53B / NHTSA 24V-416

2021-2024 model year (VF) Ram ProMaster Crew Van

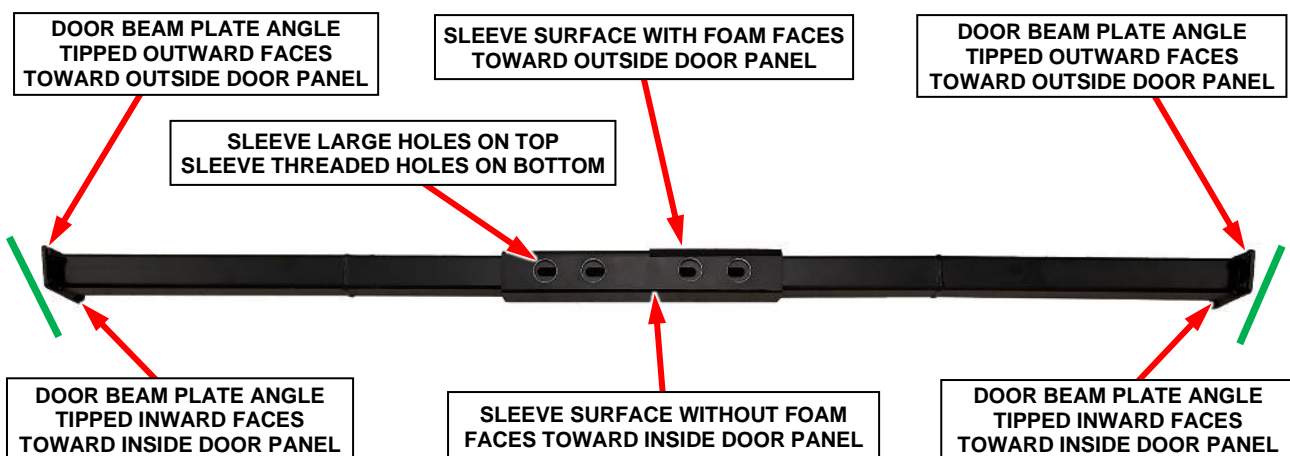
Figure 12 – Door Beam Component Orientation Within Door Cavity

NOTE: This image (Figure 12) is provided for visual reference. Both door beams are the same, either may be used for right or left side. Pay attention to component orientation during assembly within the door cavity.

19. Place foam strip on the right-hand side/rearward end of the middle sleeve. This to prevent issues with Rattle & Noise on inner door surface. Press firmly (Figures 12 and 13).
20. Select one of the door beams and slide the middle connecting sleeve over it (Figure 13).
