GROUP	MODEL
Safety Recall Campaign	2024MY Sportage (NQ5a)
NUMBER	DATE
SC319	July 2024

SUBJECT: **MDPS POWER PACK ASSEMBLY REPLACEMENT (SC319)**

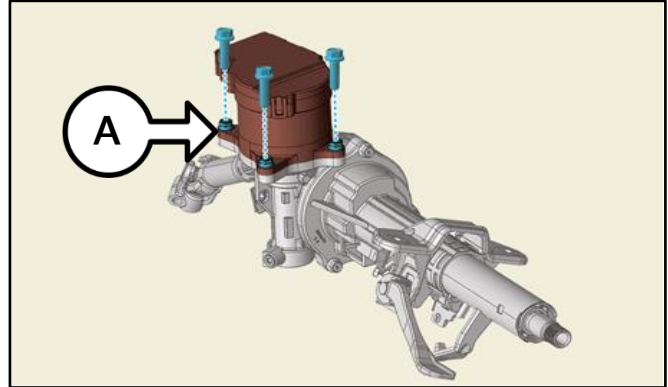
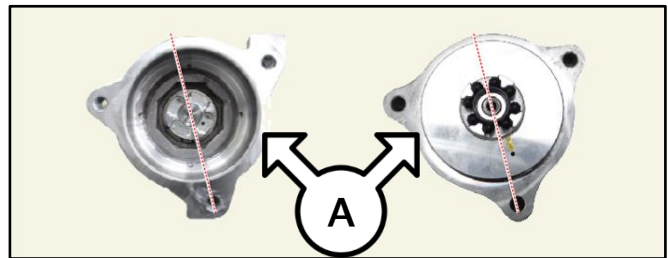
Be sure to tighten the MDPS power pack assembly retaining bolts to the torque specifications. Install the new part in the following direction shown.

1. Replace the MDPS power pack assembly (A) by referring to "Steering System → Motor Driven Power Steering (MDPS) → MDPS Power Pack Assembly → Removal and Installation" in the applicable Shop Manual on KGIS.

**Tightening torque for bolts:**  
11.1 - 16.2 lb.ft (15.0 - 22.0 N.m)
