Date
 Number
 Release
 Page

06. 2024
 SC0446
 01
 1 (5)

Tie Rod Ball Stud AN, PI

RECALL INFORMATION

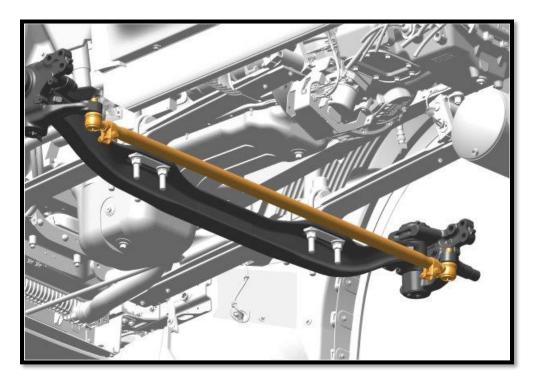
- 5. Identify the Track Rod assembly.

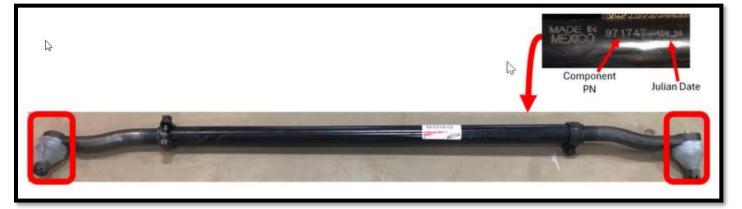
6. Locate the part number stamped or etched on the Track Rod.

- 7. Verify the part number on the track rod is 10036700.
 - a. If the build date matches to the dates on the table, the draglink is NOK and must be replaced with a new one. Proceed to Repair Instructions.
 - b. If the build date is not on the table, the draglink is OK, and the truck can be returned to service.
