Thor Motor Coach Recall Repair Instructions

Recall #	24V-426 2024-418		
Description/Title:	Heat Shield		
Affected Product Line(s):	Certain 2024 & 2025 Indigo & Luminate		
Service Campaign # :	RC000306		
Repair Code:	Inspect with Repair: TMCRC10116V	Released Date:	7/22/2024
Time Allowed:	Inspect with Repair: 0.5	Document Revision:	A

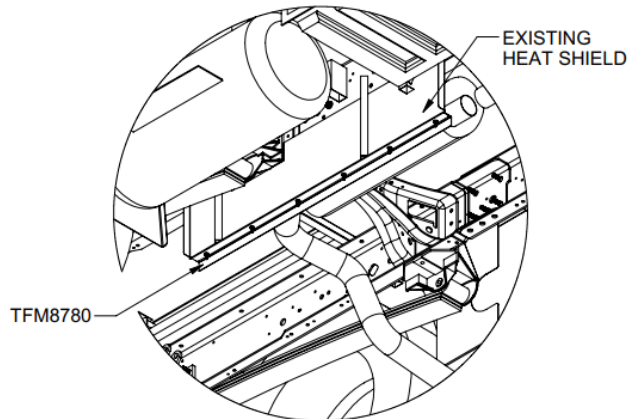
It has been discovered that on certain model year 2024-2025 Indigo & Luminate motorhomes, a heat shield is missing between the LP tank and chassis muffler. A heat shield was not properly installed in between the LP tank and chassis muffler during production. There is a potential risk for a fire and/or property damage, which could result in personal injury or death.

1. Place TFM8780 on top of the existing heat shield and hold in place.
