IMPORTANT SAFETY RECALL
Airstream Interstate Touring Coach
NHTSA 24V-432

Operation code: TCSBR8932100

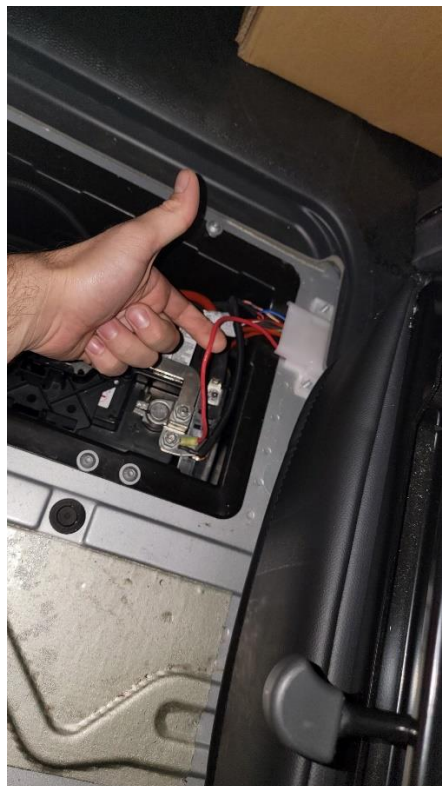
4. Identify the 12-gauge red wire connected to the Positive terminal as shown.
