SAFETY RECALL

2nd Row Middle Seatbelt Bolt Torque

Reference: 70B / NHTSA 24V-434

Remedy available for
2023 (WL) Jeep® Grand Cherokee

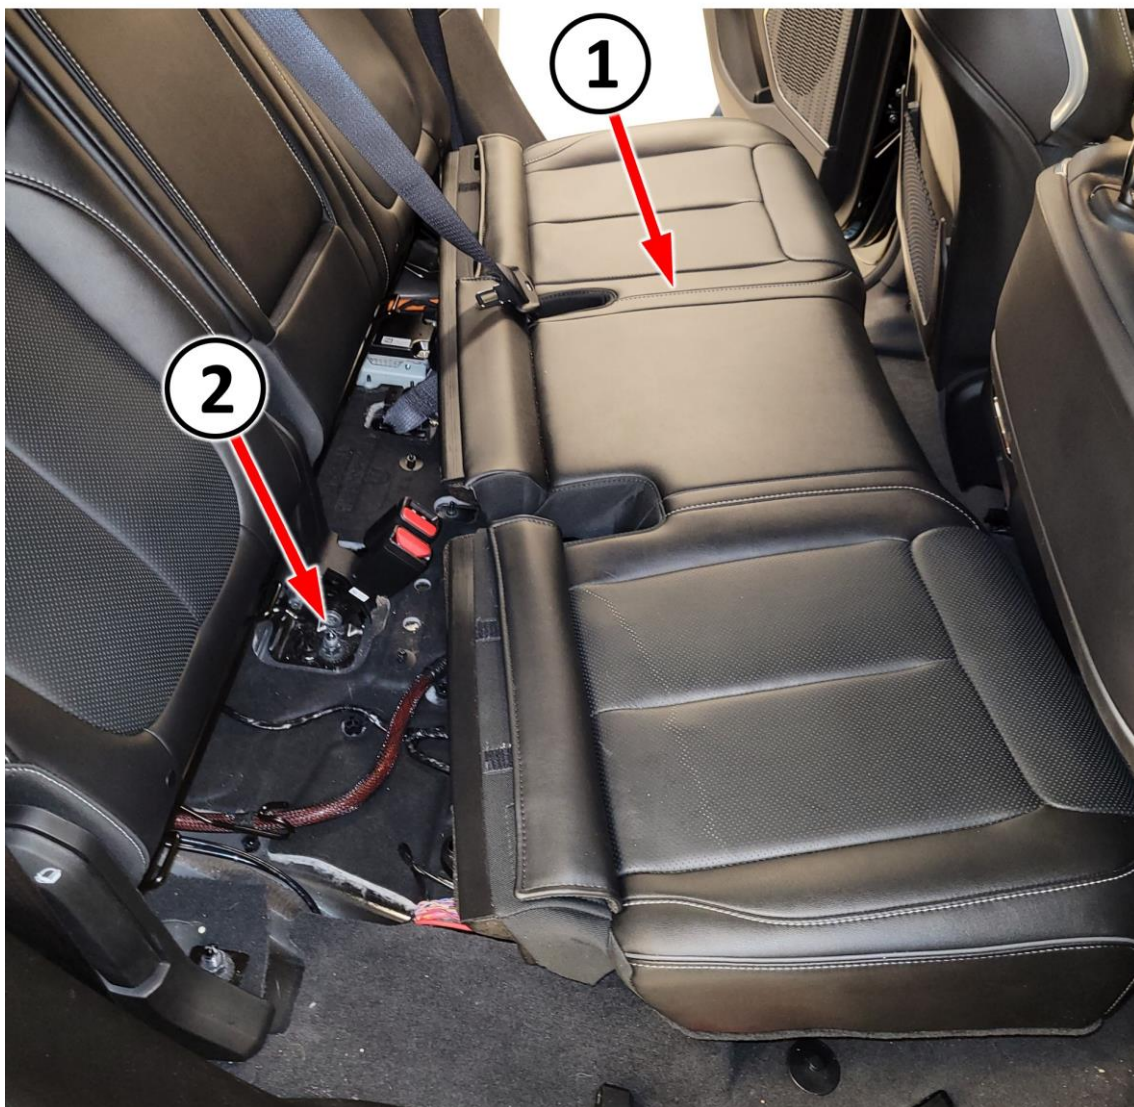
Figure 3 – Rear Seat Cushion Positioned Forward

- 1 - Seat Cushion
- 2 - Center Seat Belt Buckle Bolts

6. Position the rear seat cushion forward to gain access to the center seat belt buckle bolts (Figure 3).

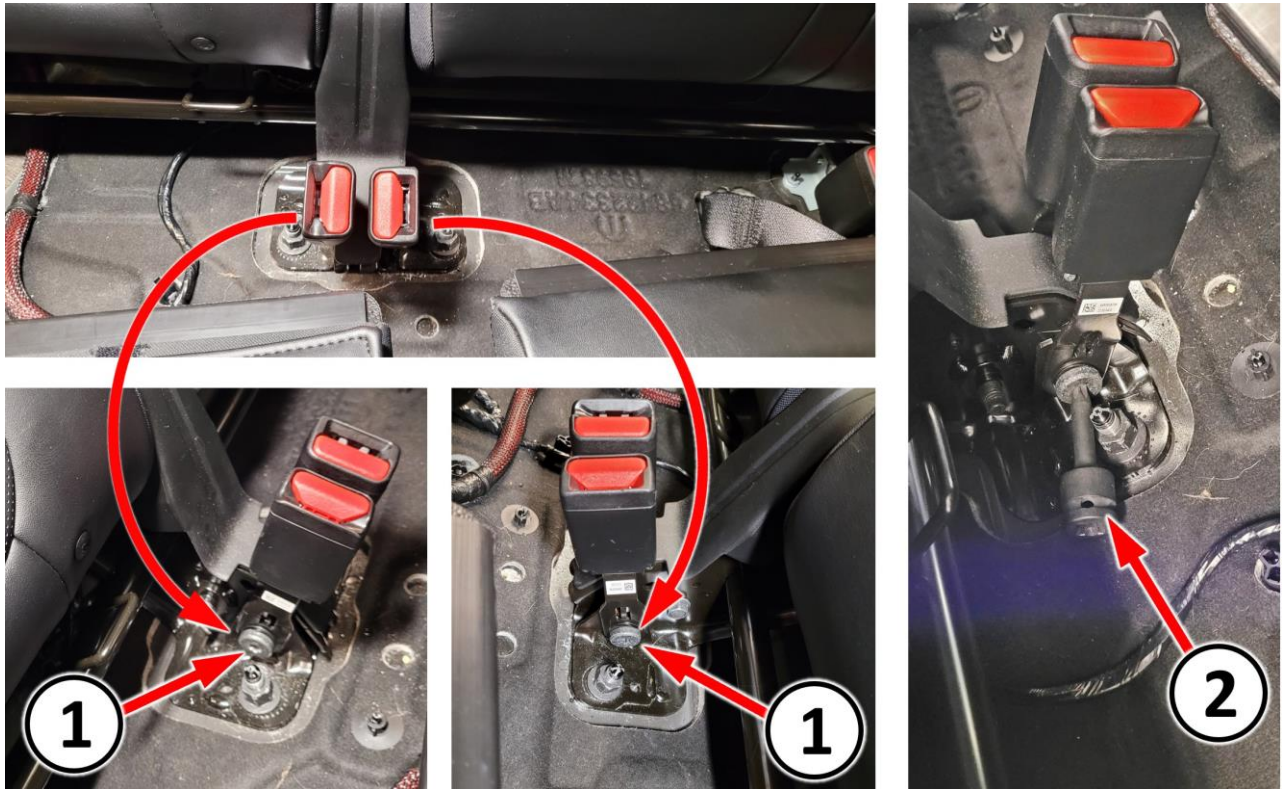
Figure 4 – Center Seat Belt Buckle Bolts

1 - Bolt

2 - Long Reach T-50 Star Bit (Torx®)

7. Using a long reach T-50 Star Bit (Torx®) to clear the floor stud, tighten both center seat belt buckle bolts to 45 N·m (33 Ft. Lbs.) (Figure 4).
