Thor Motor Coach Recall Repair Instructions

Recall #	24V441 2024-437		
Description/Title:	OM/MG Emergency Exit Window		
Affected Product Line(s):	Certain Omni/Magnitudes with a Griddle under the emergency exit window		
Service Campaign # :	RC000307		
Repair Code:	Inspect with Repair: TMCRC80544V	Released Date:	8/1/2024
Time Allowed:	Inspect with Repair: 1.0	Document Revision:	A

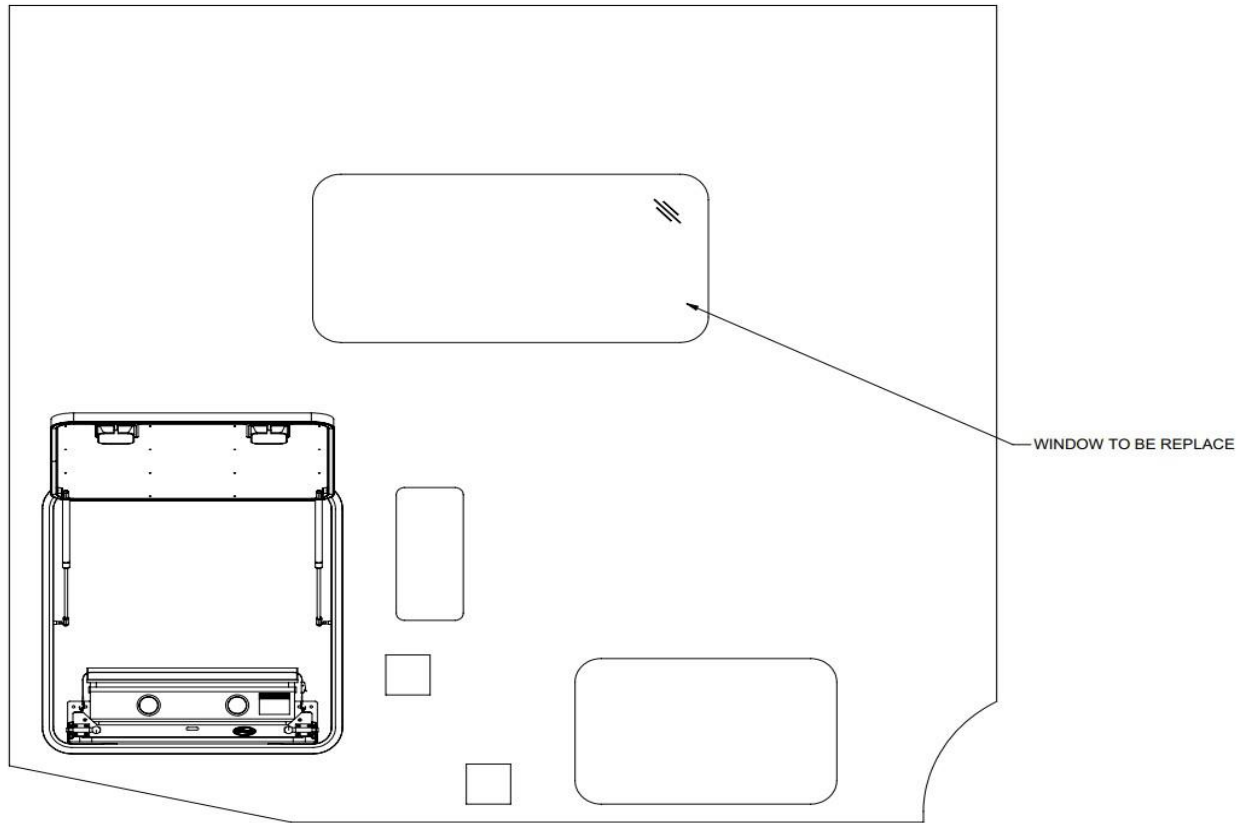
When using the outside Griddle option, the interior emergency exit window is partially blocked.

- 1) Remove the current emergency egress window on the passenger side of the unit.
- 2) Adhere the supplied bulb seal to the window before installing.
- 3) Install the replacement window.
- 4) After the window is installed, use Geocel or similar sealant to seal around the exterior of the window.
