Recall Campaign Bulletin

Campaign No. 2024070005, July 2024

SUBJECT: **Model C-Class (206 platform)**
Model Year 2022 – 2023

Check Pre-Fuse Box Wiring

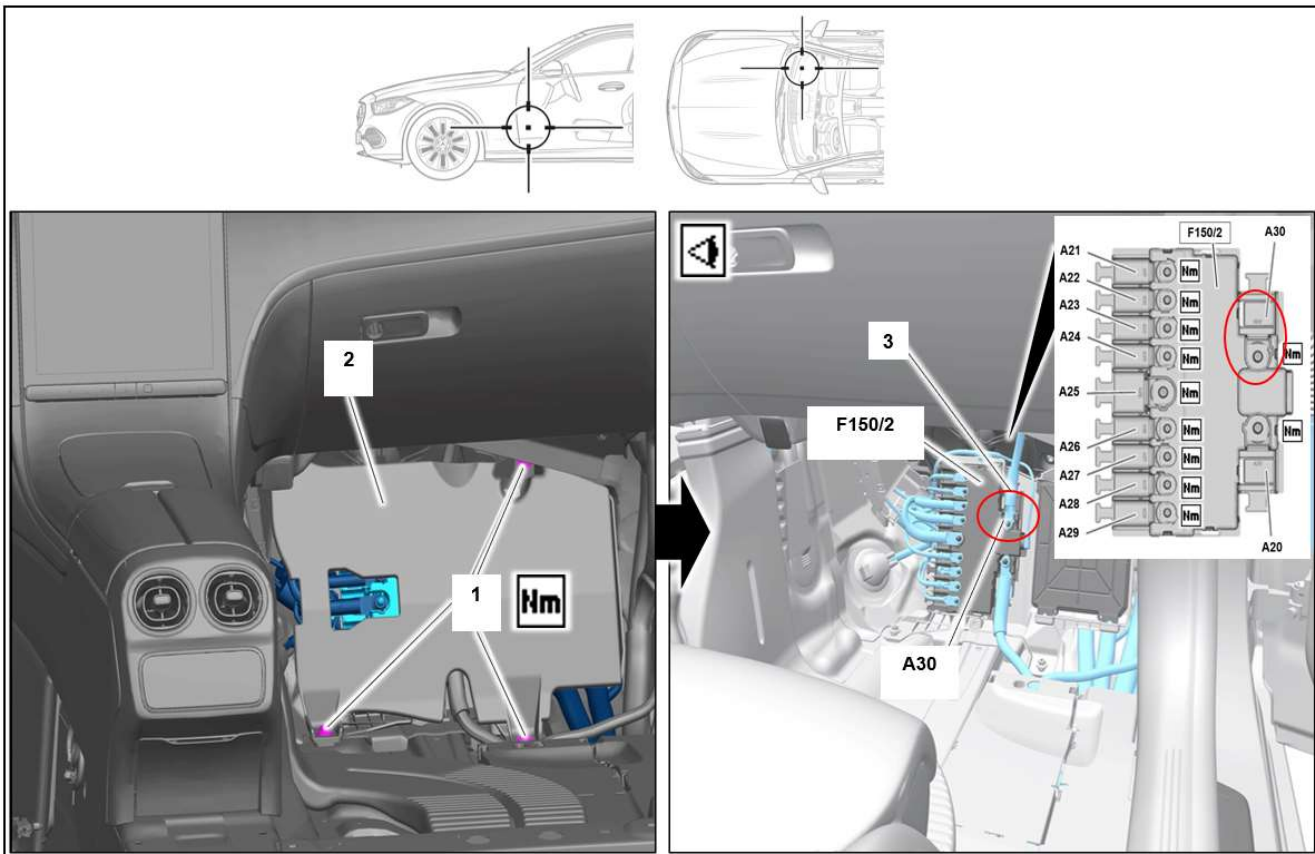
Figure 1

1. Remove floor covering on front passenger side.
i For basic information, see **AR68.80-P-0008WT**.
2. Disconnect ground line of 12 V on-board electrical system battery.
i For basic information, see **AR54.10-P-0051WT**.
3. Remove passenger side footwell support (**Figure 1, 2**).
i For this purpose, remove nuts (**Figure 1, 1**).
i For basic information, see **AR54.15-P-1350WT**.
i **Installation:** Tighten nuts (**Figure 1, 1**) with the specified tightening torque of **6 Nm**.
