Recall Campaign Bulletin

Campaign No. 2024070005, July 2024

SUBJECT: **Model C-Class (206 platform)**
Model Year 2022 – 2023

Check Pre-Fuse Box Wiring

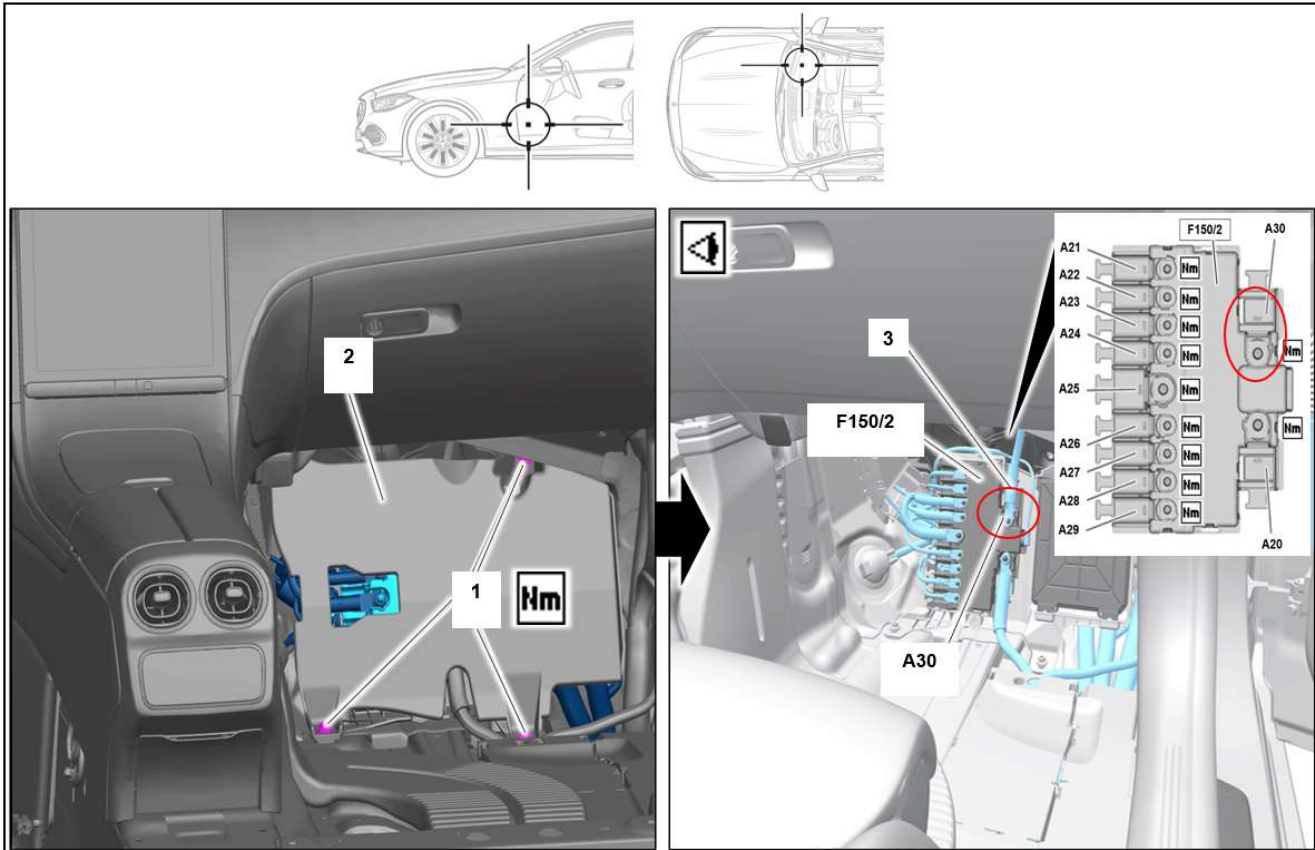
Figure 1

1. Remove floor covering on front passenger side.
 ⓘ For basic information, see **AR68.80-P-0008WT**.
2. Disconnect ground line of 12 V on-board electrical system battery.
 ⓘ For basic information, see **AR54.10-P-0051WT**.
3. Remove passenger side footwell support (**Figure 1, 2**).
 ⓘ For this purpose, remove nuts (**Figure 1, 1**).
 ⓘ For basic information, see **AR54.15-P-1350WT**.
 ⓘ **Installation:** Tighten nuts (**Figure 1, 1**) with the specified tightening torque of **6 Nm**.

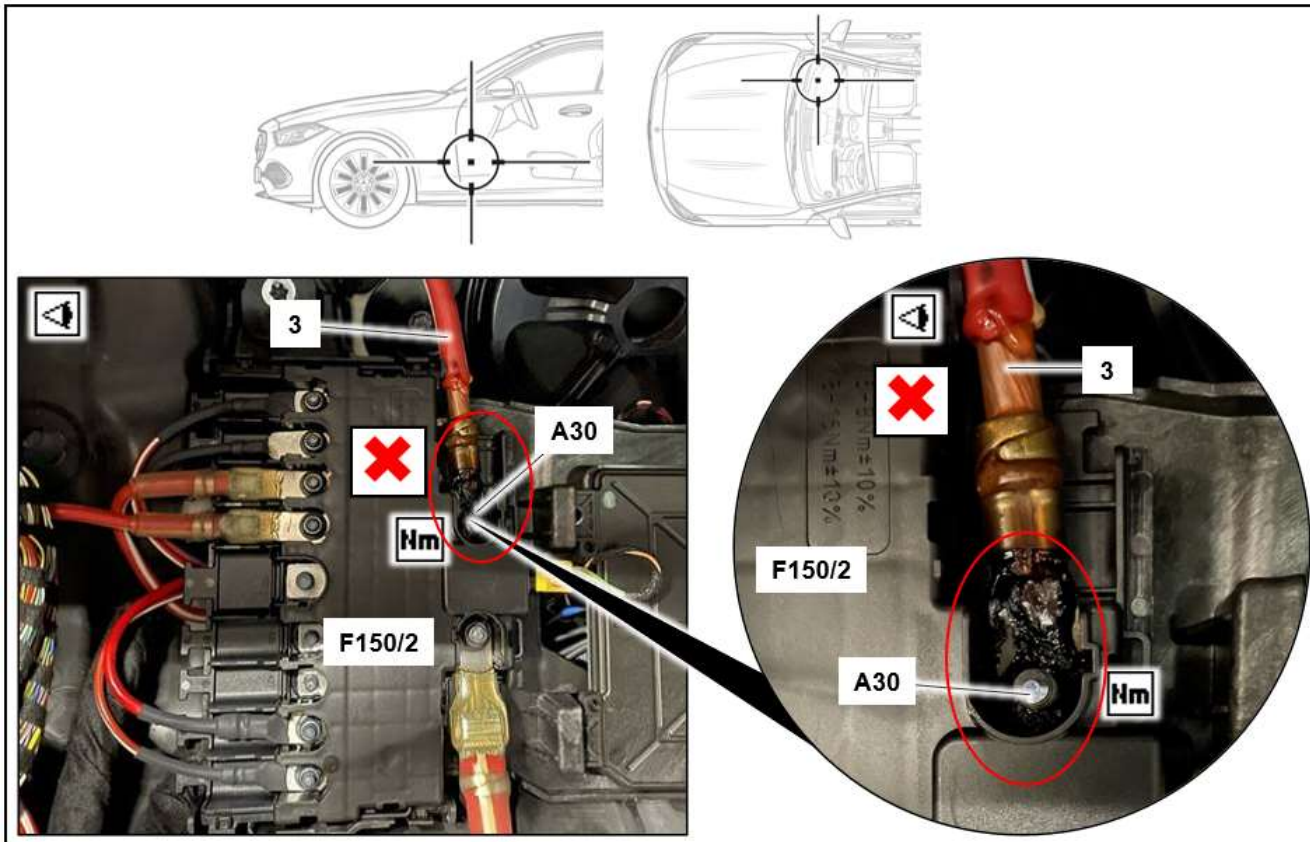
4. Inspect electrical connection (**Figure 2, A30**) of prefuse box **F150/2** visually for physical damage, such as arcing, scorch marks, melting and/or missing nut.
- If there is no damage to the electrical connection (**Figure 2, A30**), remove electric line (**Figure 2, 3**) at A30 connection and inspect the underside for damage. If there is no damage, re-install the electrical connection with nut (tightening torque of **16 Nm**) and **End Measure**.
 - If there is damage to the electrical connection (**Figure 2, A30**), carry out **Work Procedure**.
NOTE: Capture photos of damaged electrical connection to be included in Warranty claim

Figure 2 (prefuse box with thermal damage, NOK)

i Replace damaged prefuse box (Figure 2, F150/2) and/or install missing nut on electrical connection (Figure 2, A30). For basic information, see AR54.15-P-1350WT.
