SAFETY RELATED RECALL

Global Recall Action
Number: [H506v4](#)

Subject: Ingenium I6 3.0L Diesel and Petrol Oil Filter Element Cap - Renew	Publication No.: H506v4
	Model: F-PACE (X761)
	Model Year: 2024
	Date of Issue: 25 November 2024

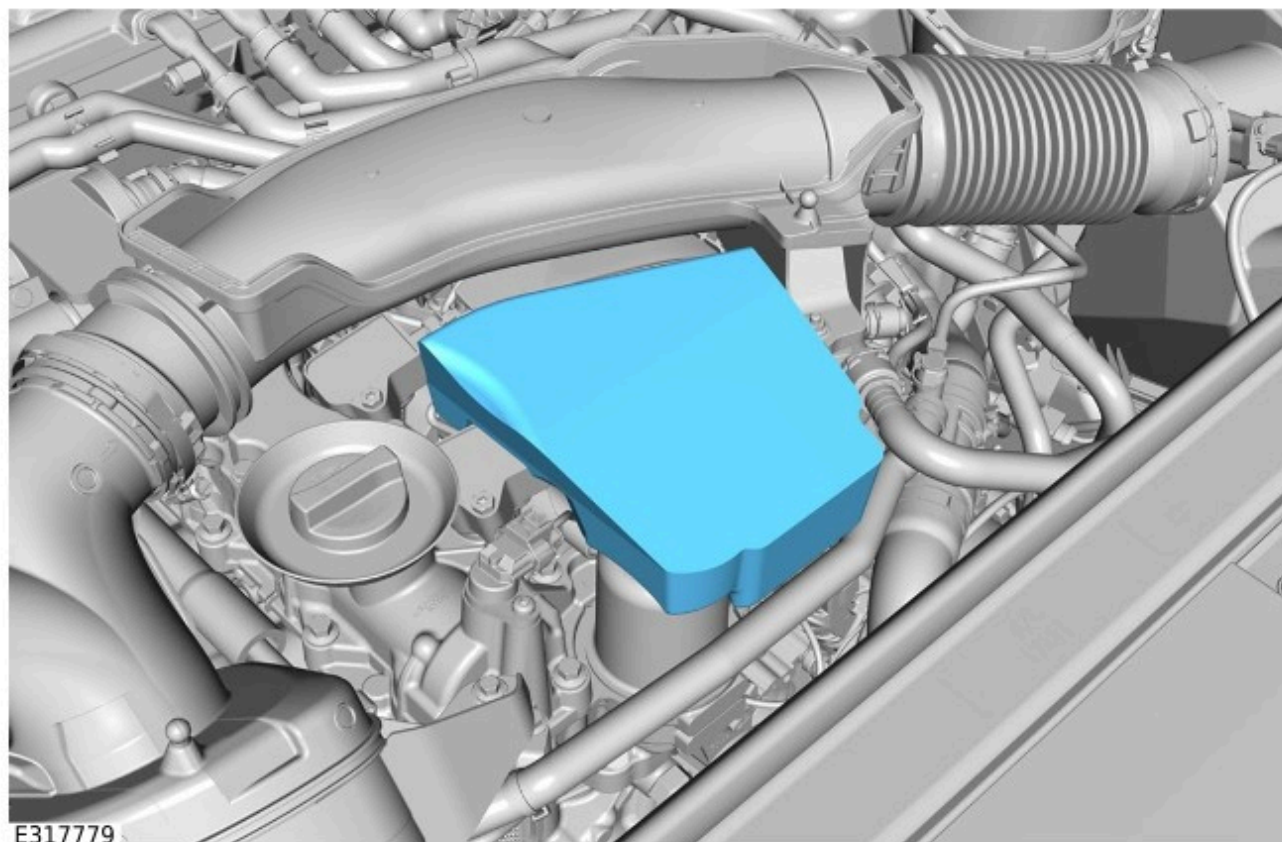
3. If equipped, remove the Noise, Vibration and Harshness (NVH) cover.
