# F/CMVSS Noncompliance Recall

## N242447941 Blank Cluster Display

**Release Date:** July 2024

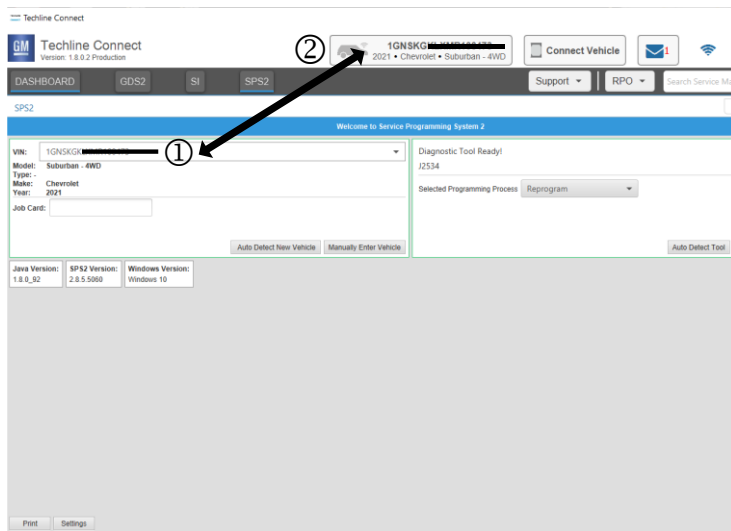
5743643

**Caution:** Be sure the VIN selected in the drop down menu (1) is the same as the vehicle connected (2) before beginning programming.

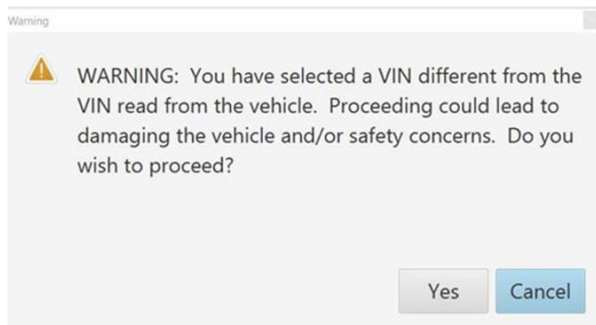
5877000

**Important:** If the vehicle VIN DOES NOT match, the message below will be shown.

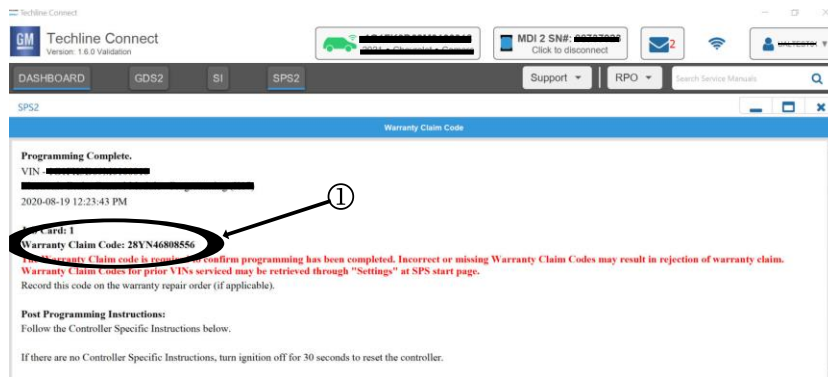
5644478

**Important:** To avoid warranty transaction rejections, you **MUST** record the warranty claim code provided on the Warranty Claim Code (WCC) screen shown above on the job card. Refer to callout 1 above for the location of the WCC on the screen.

19. Record SPS Warranty Claim Code on job card for warranty transaction submission.
