IMPORTANT INFORMATION FOR RECALL WARRANTY REIMBURSEMENT

NHTSA Recall No. **24V-501**

Campaign Service Bulletin LCAB 0524

Subject: Inboard Lower Control Arm (LCA) Bolts

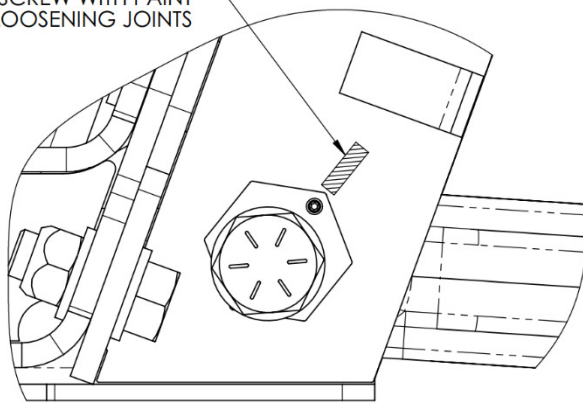
2. **Mark the orientation of all 8 alignment eccentrics, shown below.**

MARK POSITION OF ALL ECCENTRICS
IN LINE WITH SET SCREW WITH PAINT
PEN OR SIMILAR BEFORE LOOSENING JOINTS

3. Loosen all the lower control arm bolts just enough that the eccentrics can be adjusted if necessary. Note; the next step will be easier if all the eccentrics are returned to the neutral (12 O'clock position). Also a pry bar placed under the control arm can help with lining up the holes for bolt installation.
