# SAFETY RECALL

Volvo Trucks North America

Date	Number	Release	Page
07. 2024	RVXX2405	01	1 (5)

## Auxiliary Axle Tie Rod Assembly VN, VHD

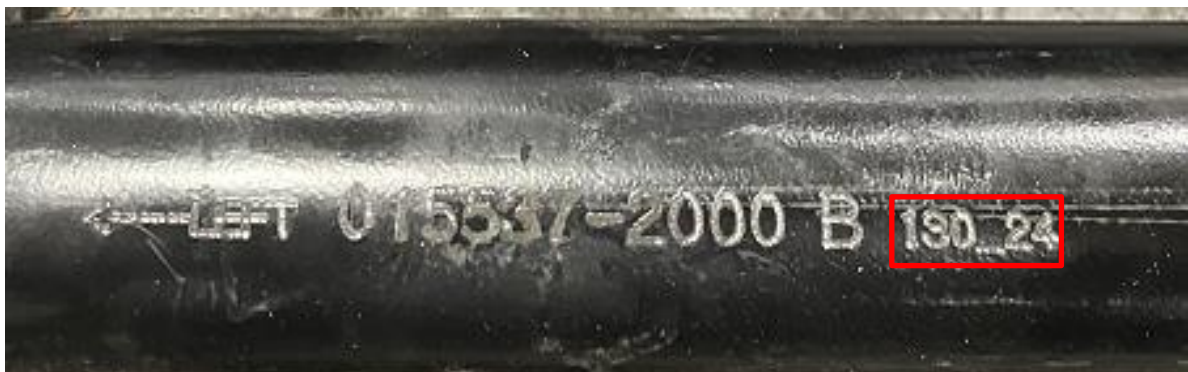
5. Hendrickson Compositite EXS20 lift axle suspension systems need to be inspected by looking for a stamped ID code on the tie rod. Please review the table below for the part numbers and date codes associated. If the tie rod does not have either of the suspect dates, return truck to service and file accordingly.

Supplier Part Number	Suspect Build Date
015537-2000	101_24
	130_24

If ID code **101\_24** or **130\_24** is present, proceed with tie rod replacement.
