SIB 65 18 24

2024-08-26

RECALL 24V-513: Check Drivers Air Bag (Conversion PSDI-5)

This Service Information Bulletin (Revision #2) replaces SI B65 18 24 **dated August 2024**.

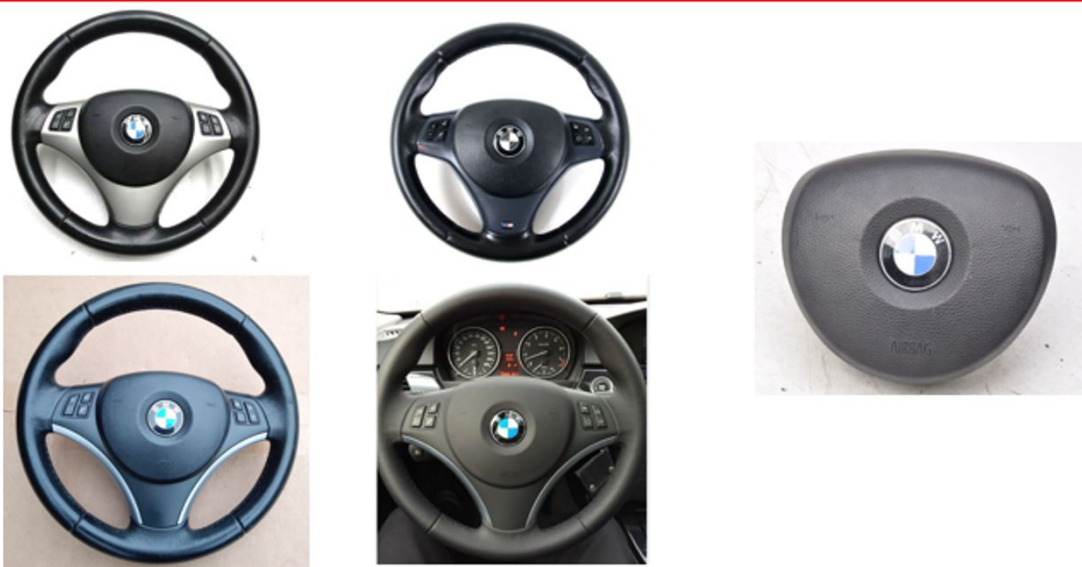
B- Here are pictures of the recalled Sport Steering wheels to use for visual identification. If you have one of the following air bags installed it must be brought into the BMW dealer for inspection and possible replacement:

If one of the above Sport steering wheels is installed, then:

1-Please record exterior cosmetic condition of air bag/steering wheel assembly on the Repair Order prior to any repair. Take pictures of any existing cosmetic damage.

2-Remove air bag to check parts label. Unless the air bag is either part number 6884664 or 6884672 (E8x, E9x) **OR** 6884661 or 6884669 (E83) then it must be replaced as per **REP 32 34 030** - Removing and installing/ replacing air bag unit (sport steering wheel)

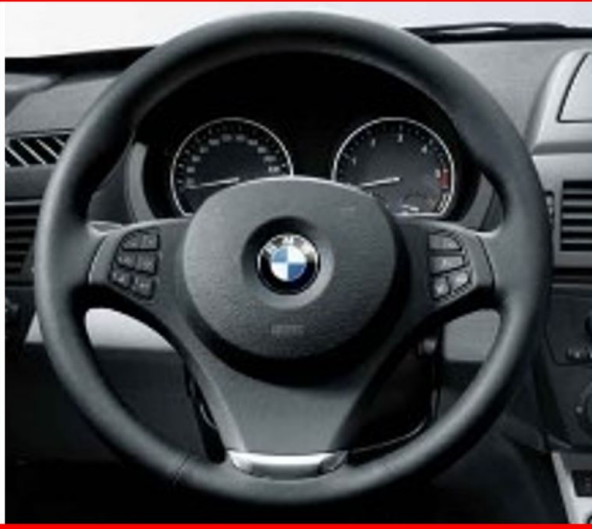
This is an E83 Sport air bag and may have been swapped into different vehicles.

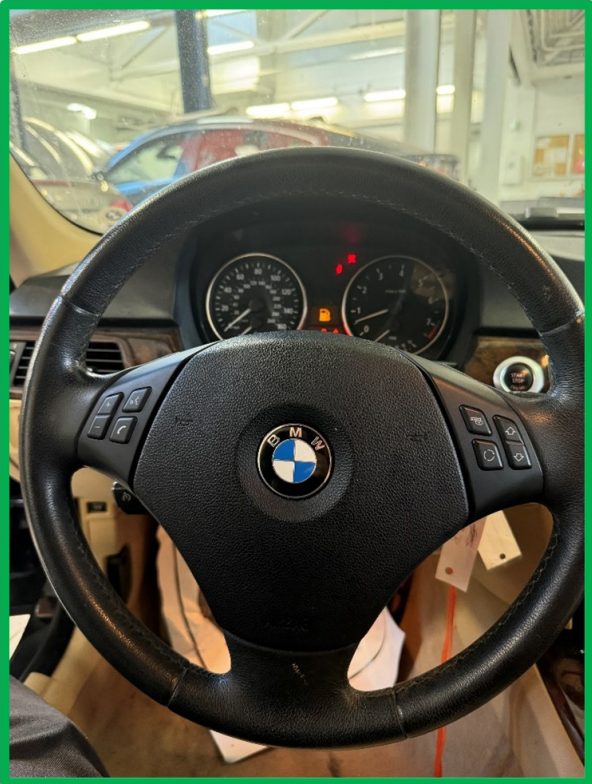
This is a TRW manufactured air bag that may be installed and is not under recall.
