SIB 65 18 24

2024-08-19

RECALL 24V-513: Check Drivers Air Bag (Conversion PSDI-5)

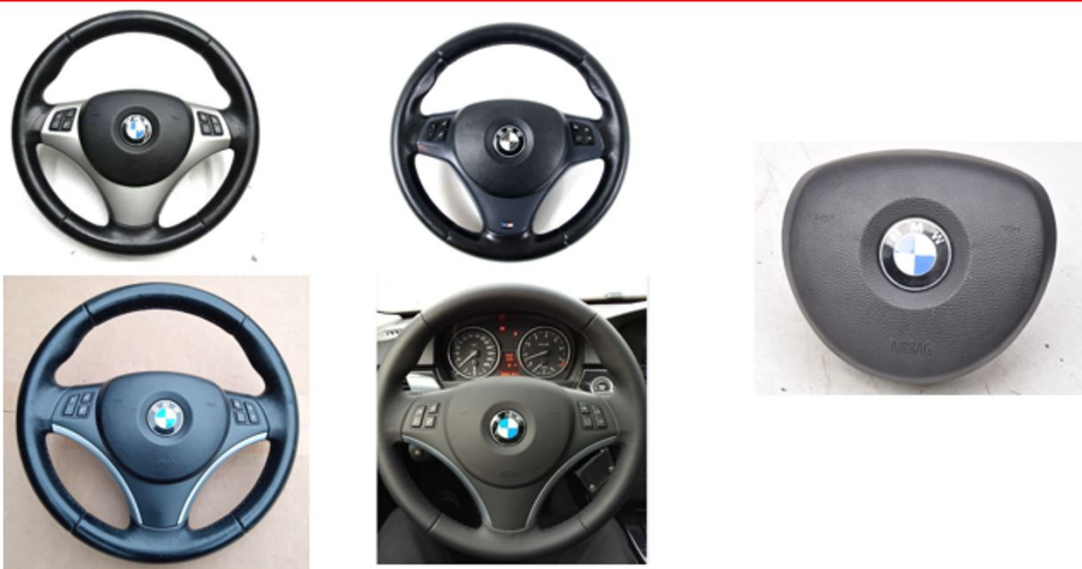
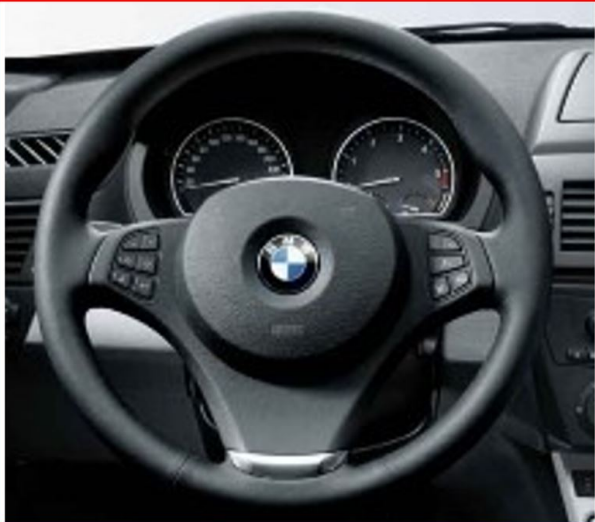
B- Here are pictures of the recalled Sport Steering wheels to use for visual identification. If you have one of the following air bags installed it must be brought into the BMW dealer for inspection and possible replacement:

If one of the above Sport steering wheels is installed, then:

1-Please record exterior cosmetic condition of air bag/steering wheel assembly on the Repair Order prior to any repair. Take pictures of any existing cosmetic damage.

2-Remove air bag to check parts label. Unless the air bag is either part number 6884664 or 6884672 (E8x, E9x) **OR** 6884661 or 6884669 (E83) then it must be replaced as per **REP 32 34 030** - Removing and installing/ replacing air bag unit (sport steering wheel)

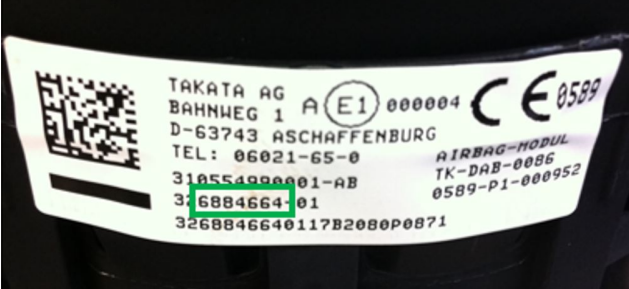
This is an E83 Sport air bag and may have been swapped into different vehicles.
