SIB 65 18 24

RECALL 24V-513: Check Drivers Air Bag (Conversion PSDI-5)

2025-12-17

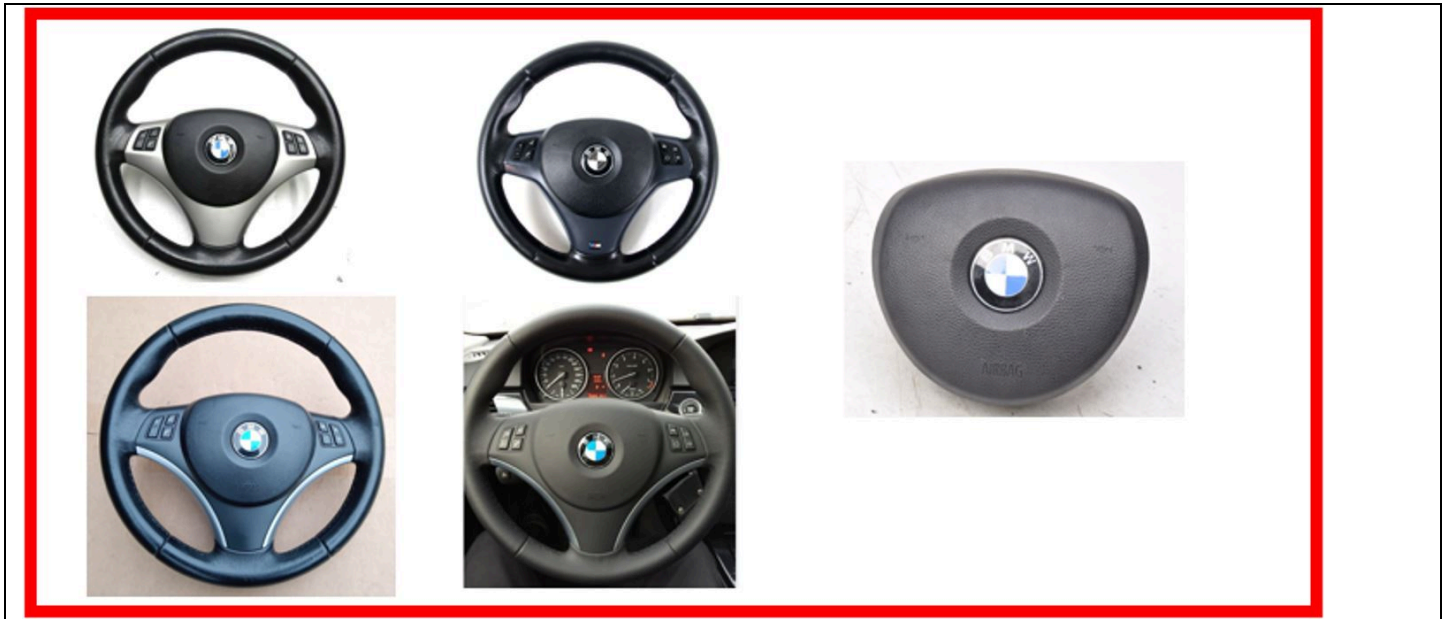
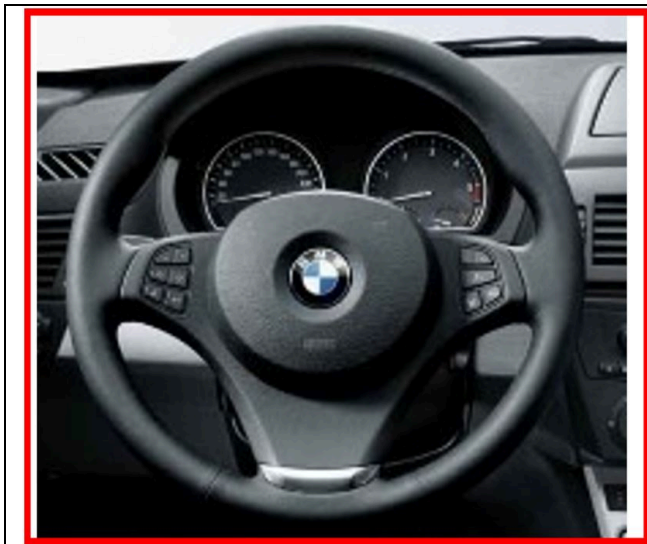
B- Here are pictures of the recalled Sport steering wheels to use for visual identification. If you have one of the following air bags installed it must be brought into the BMW dealer for inspection and possible replacement:

If one of the above Sport steering wheels is installed, then:

1-Please record exterior cosmetic condition of air bag/steering wheel assembly on the Repair Order prior to any repair. Take pictures of any existing cosmetic damage.

2-Remove air bag to check the parts label. Unless the air bag part number is:

then it must be replaced per **REP 32 34 030** - Removing and installing / replacing air bag unit (sport steering wheel) as outlined in this Service Information Bulletin including the claim submission.

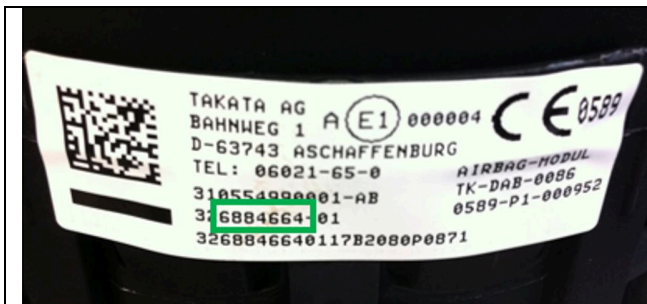
This is an E83 Sport air bag and may have been swapped into different vehicles.

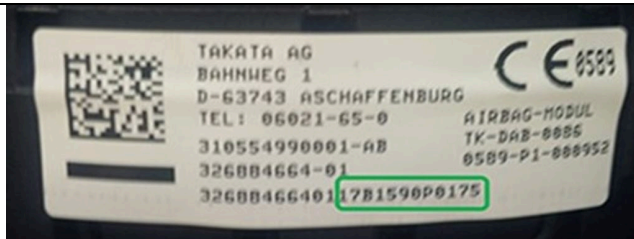
(E8x, E9x) 6884664 or 6884672

(E83) 6884661 or 6884669

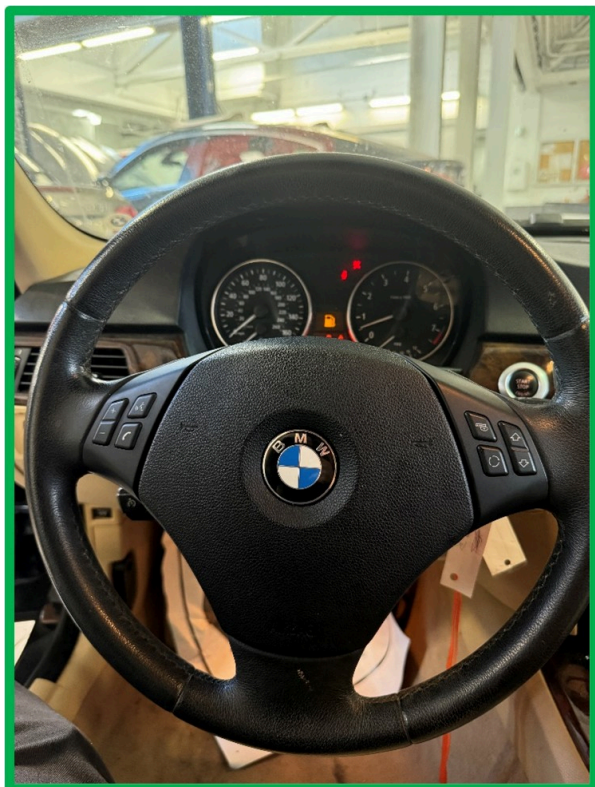
This is a TRW-manufactured air bag that may be installed and is not under this recall.
