SIB 65 19 24

2024-08-08

RECALL 24V-527: REPLACE DRIVER AIR BAG (PSDI-X)

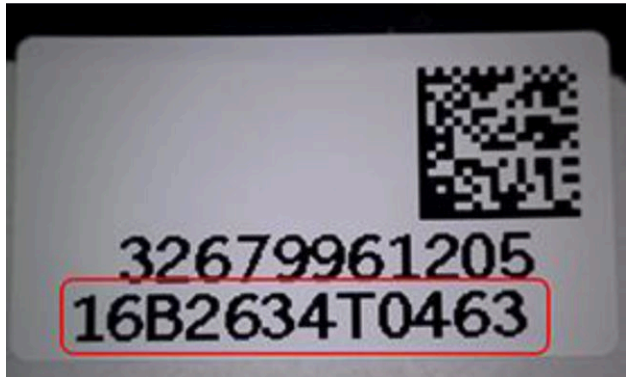
<p>It is necessary to document which air bag goes into which vehicle. Therefore:</p> <ul style="list-style-type: none"> • the technician is required to note on the repair order the serial number of the new air bag. • The serial number should also be entered into the warranty claims comment section.
--	---

2-Follow ISTA Repair Instructions for removal/installation of air bag assembly:

- **REP 32 34 020** – Removing and installing/replacing air bag unit.
- **REP 32 34 030** – Removing and installing/replacing air bag unit. (sports steering wheel)
