HYUNDAI
Technical Service Bulletin

GROUP RECALL	NUMBER 24-01-055H-4
DATE SEPTEMBER 2024	MODEL(S) SANTA FE (MX5A)

**INSPECTION FOR TRANSMISSION NOISE OR DAMAGE,
SUBJECT: TCU SOFTWARE UPDATE, AND TRANSMISSION REPLACEMENT
(RECALL 263)**

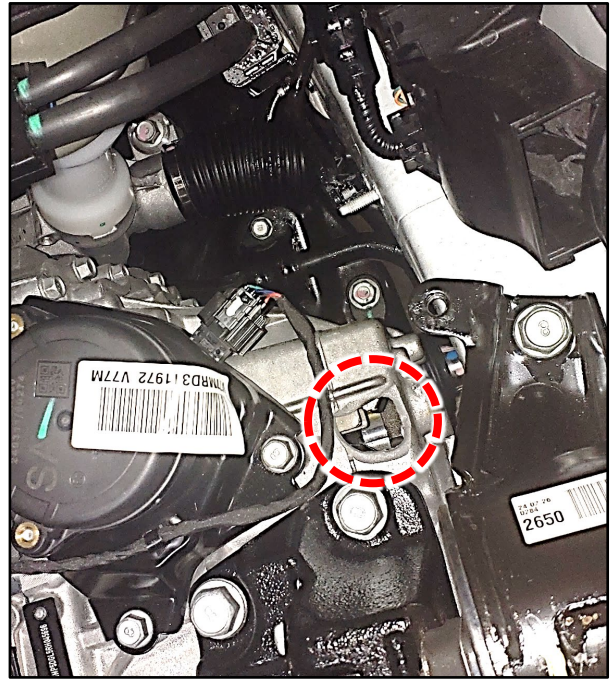
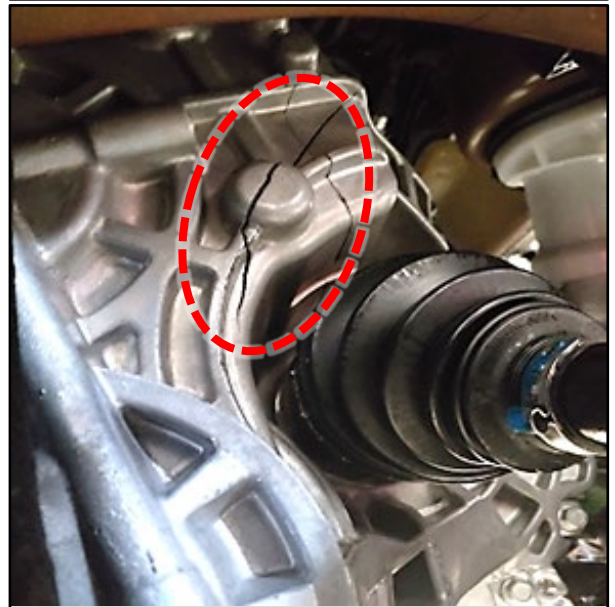
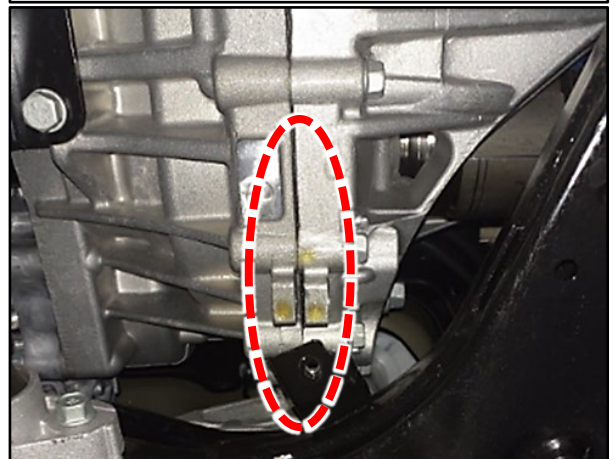
4. Inspect for damage, cracks, holes, or leaks on the transmission:
 - A. Remove the airbox, battery, and battery tray to inspect the **top of the transmission**.
 - B. Remove the engine room under cover to inspect the **bottom of the transmission**.

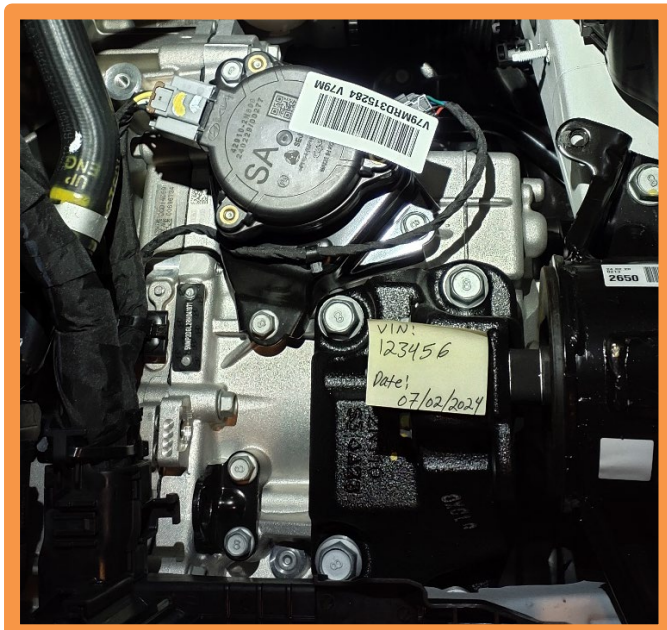
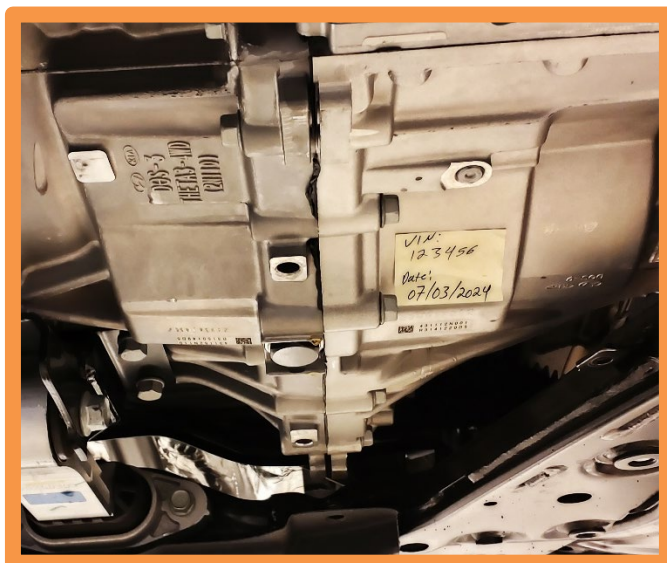
Using STUI, take a photo (NOT a video) of the current transmission housing, showing either damage or no damage, with the last 6 digits of the VIN and the date of repair on a piece of paper.

Show both the top and bottom of transmission housing.

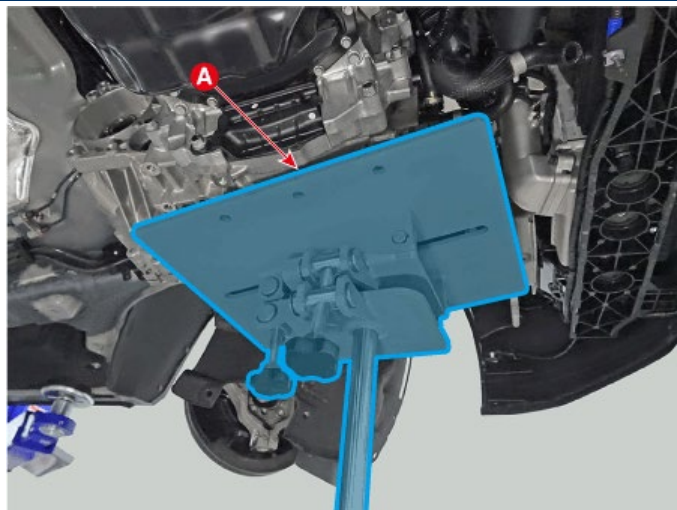
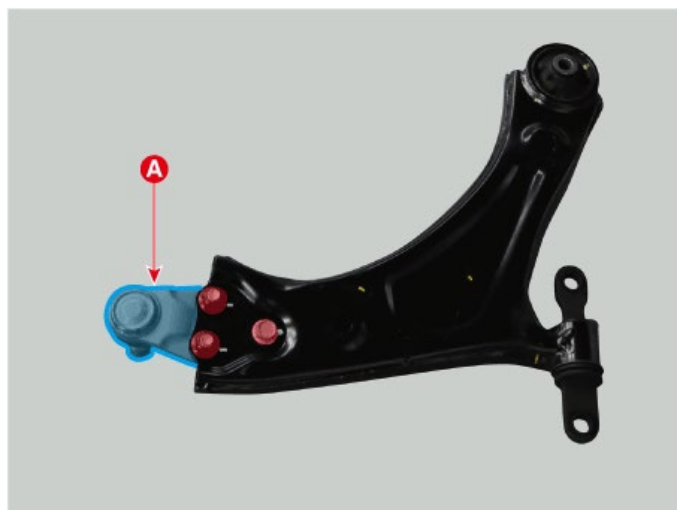
2. During the removal of the front subframe from the vehicle, loosen and unbolt the LH and RH lower control arm ball joint assemblies.

The lower control arm ball joints do **not** need to be removed from the steering knuckle as shown in the Shop Manual.

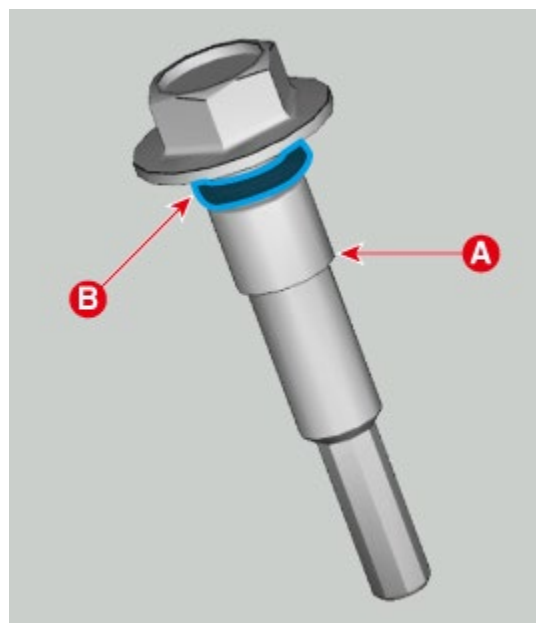
3. After replacing the DCT assembly, transfer the original TCU to the new DCT. When installing the TCU, a new TCM connector bolt (A) must be used. Apply oil to the O-ring (B) before tightening it.
