Technical Service Bulletin

GROUP RECALL	NUMBER 24-01-055H
DATE JULY 2024	MODEL(S) SANTA FE (MX5A)

SUBJECT: TCU SOFTWARE UPDATE & INSPECTION FOR TRANSMISSION NOISE OR DAMAGE (RECALL 263)

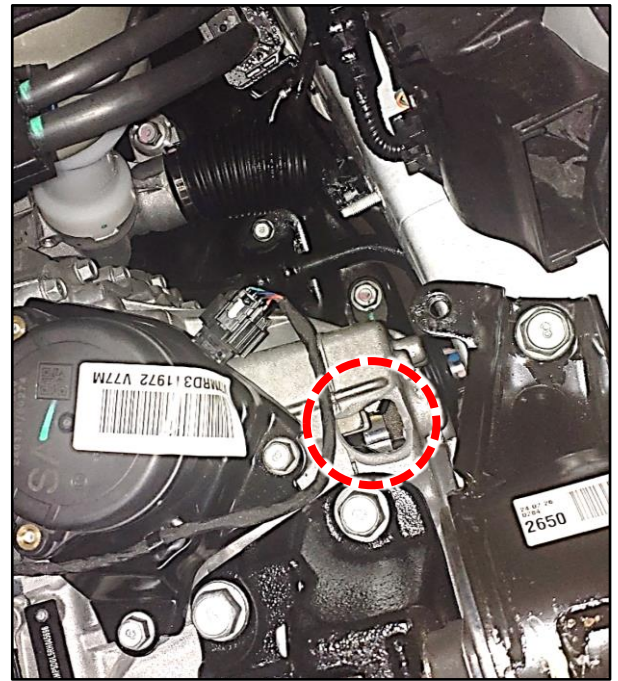
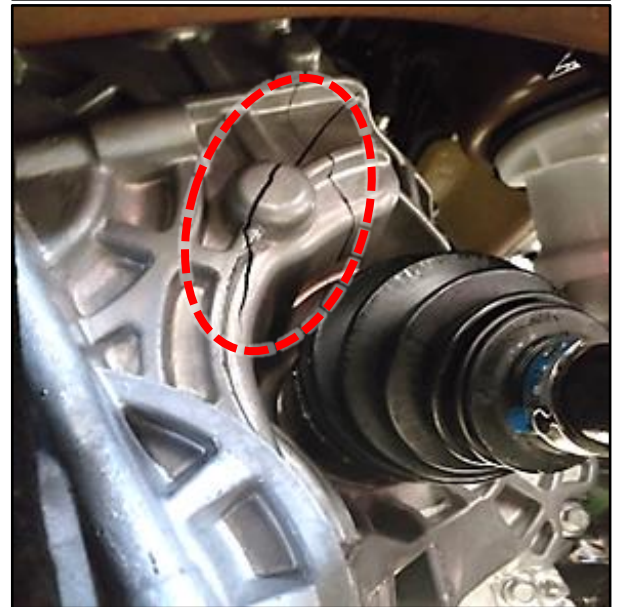
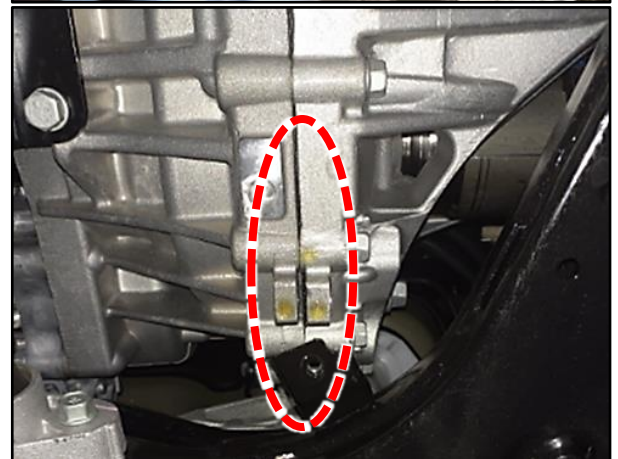
- 4. Inspect for damage, cracks, holes, or leaks on the transmission:
 - A. Remove the airbox, battery, and battery tray to inspect the **top of the transmission.**
 - B. Remove the engine room under cover to inspect the **bottom of the transmission.**

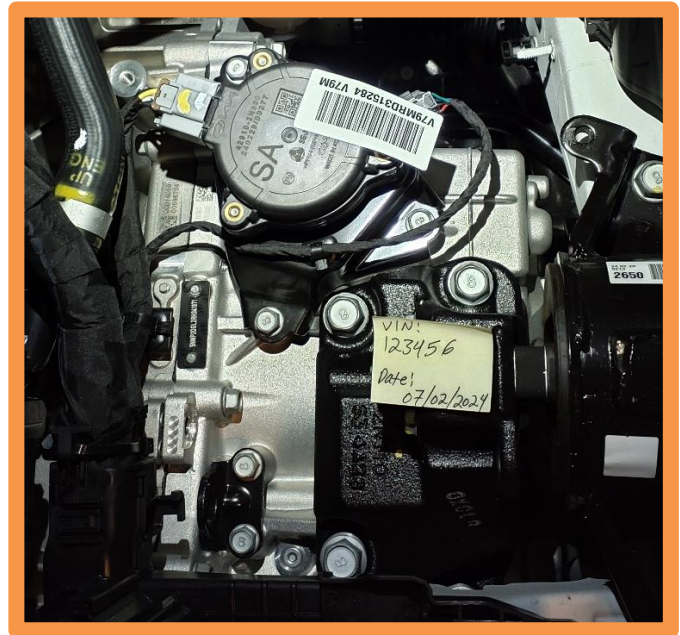
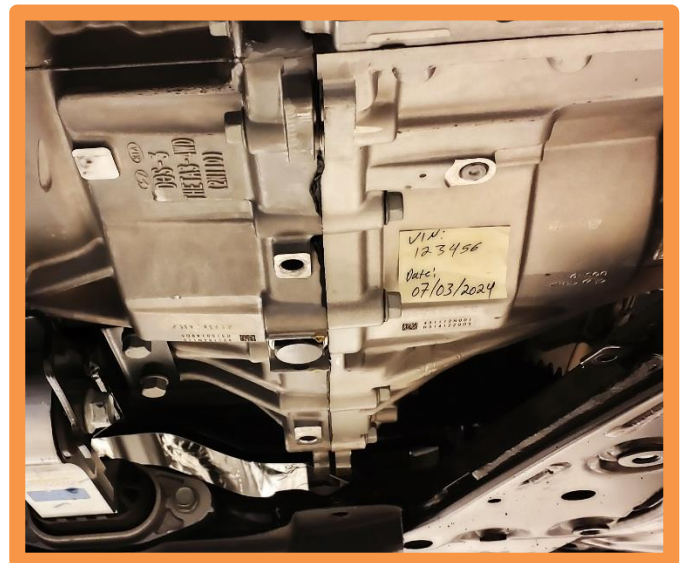
Using STUI, take a photo (NOT a video) of the current transmission housing, showing either damage or no damage, with the last 6 digits of the VIN and the date of repair on a piece of paper. Show both the top and bottom of transmission housing.
