**HYUNDAI**  
**Technical Service Bulletin**

| GROUP<br><b>RECALL</b> | NUMBER<br><b>24-01-055H-1</b> |
| DATE<br><b>AUGUST 2024</b> | MODEL(S)<br><b>SANTA FE (MX5A)</b> |

INSPECTION FOR TRANSMISSION NOISE OR DAMAGE,  
**SUBJECT: TCU SOFTWARE UPDATE, AND TRANSMISSION REPLACEMENT  
(RECALL 263)**

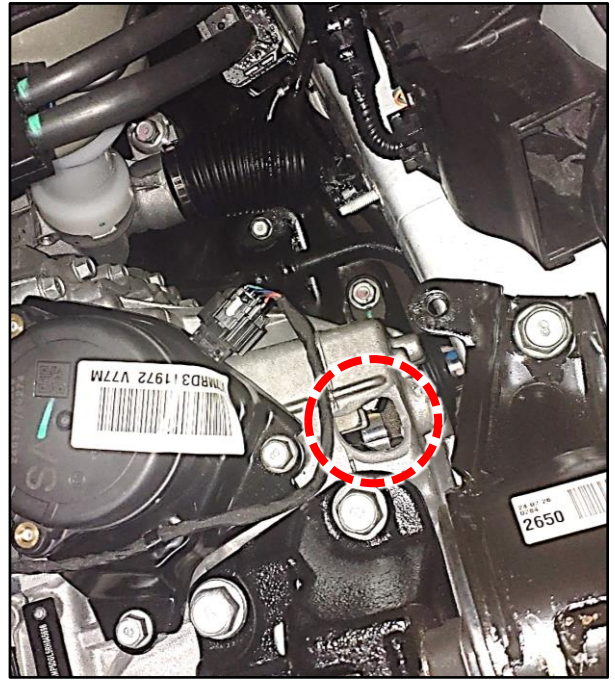
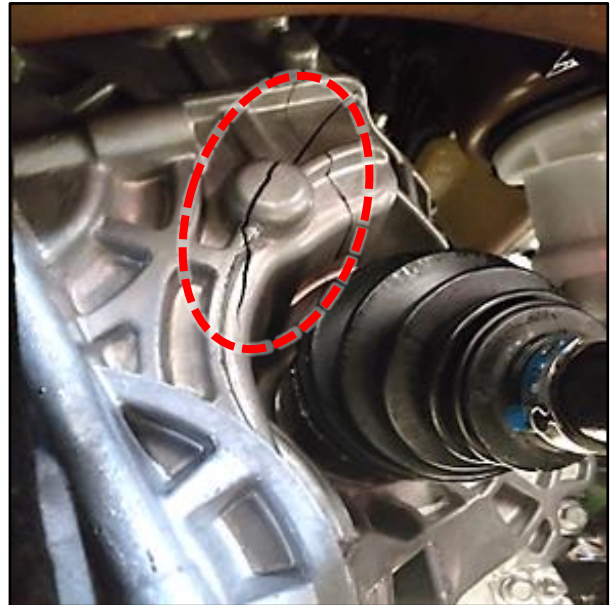
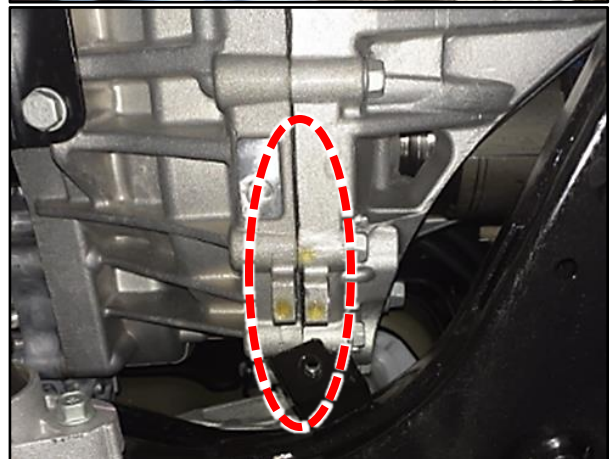
4. Inspect for damage, cracks, holes, or leaks on the transmission:
  - A. Remove the airbox, battery, and battery tray to inspect the **top of the transmission**.
  - B. Remove the engine room under cover to inspect the **bottom of the transmission**.

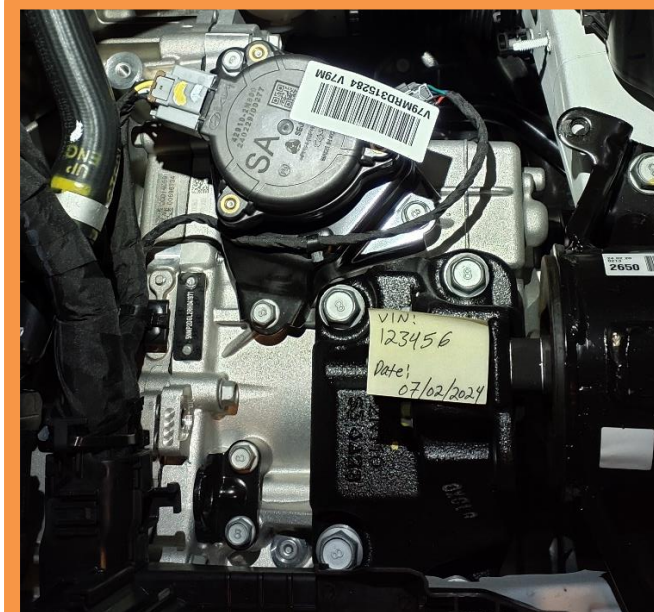
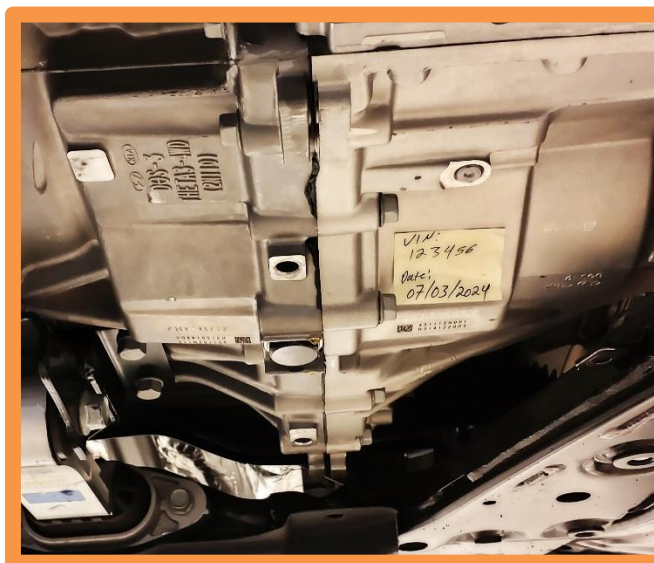
Using STUI, take a photo (NOT a video) of the current transmission housing , showing either damage or no damage, with the last 6 digits of the VIN and the date of repair on a piece of paper.

Show both the top and bottom of transmission housing.
