RECALL 24V531 / 2024-407 REMEDY INSTRUCTIONS

Recall Number:	24V-531		
Product:	Coupler	Labor	0.2 Hour (inspection per trailer)
Date:	July 17, 2024	Rate:	1.5 Hours (coupler replacement)

Purpose

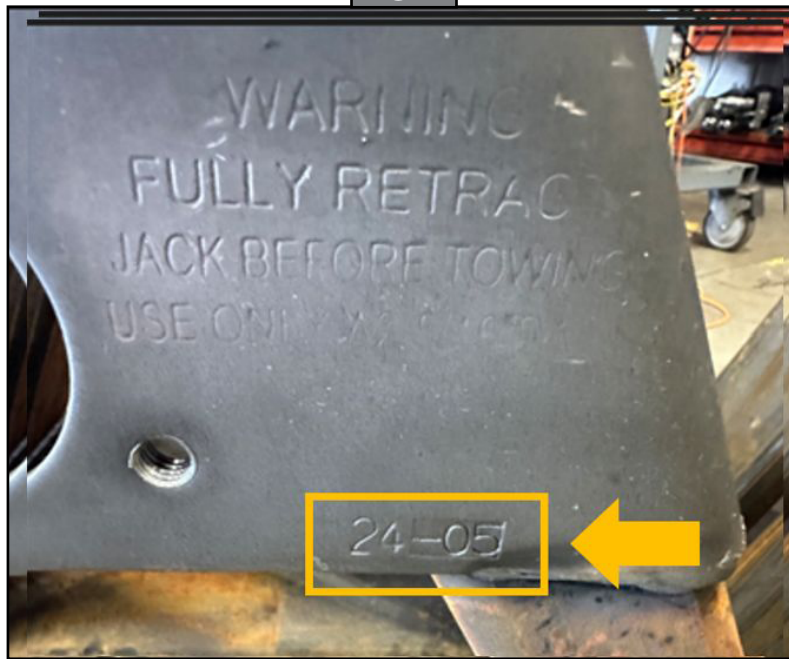
Fig. 1

Certain vehicles are equipped with Pacific Rim couplers with a weight rating of 14,000 pounds. However, when tested, the couplers only passed at 13,000 pounds using the SAE J684 testing with a 1.3 safety standard. Under certain conditions during travel, the latching mechanism could deform leading to an increased risk of vehicular crash. These vehicles should be inspected for an affected date code of 24-05 on the coupler. If the suspect vehicles have a coupler with the date code 24-05, the coupler should be replaced.

Inspect units over 13,000-pound GVWR (gross vehicle weight rating) potentially built with the involved (or suspect) coupler and look for a date code of 24-05 (Fig. 1). If the coupler has date code of 24-05, the remedy is to replace the coupler.
