**HYUNDAI**  
**Technical Service Bulletin**

NUMBER  
**24-01-059CV**

MODEL(S)  
**XCIENT FCEV (QZ)**

**SUBJECT:** STEERING GEAR PITMAN ARM NUT RETIGHTENING  
(RECALL 264)

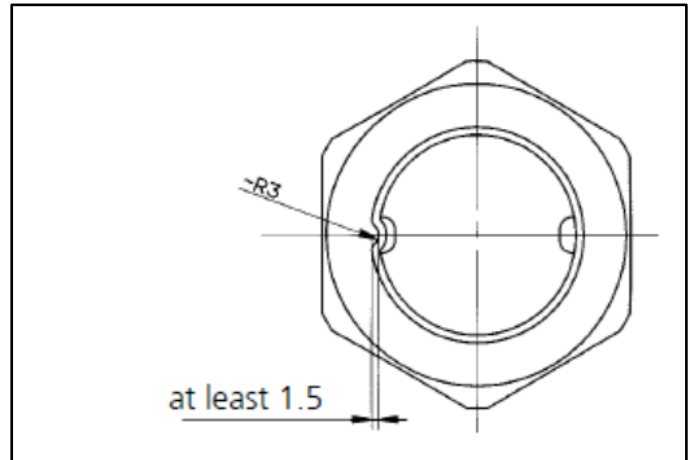
**Description:** The pitman arm nut in the subject vehicles may have been insufficiently caulked at the steering gearbox connection, potentially allowing the nut securing the joint to loosen over time. Detachment of the pitman arm from the gearbox will result in a complete loss of steering, increasing the risk of a crash and injury to occupants and bystanders. This bulletin provides the procedure to retighten and caulk the pitman arm nut.

4. Retighten the pitman arm nut by using a box-end or open-end torque wrench.

| lb-ft | 542 ± 26 |
| N.m | 735 ± 35 |
