Technical Service Bulletin

24-01-059CV

XCIENT FCEV (QZ)

STEERING GEAR PITMAN ARM NUT RETIGHTENING
(RECALL 264)

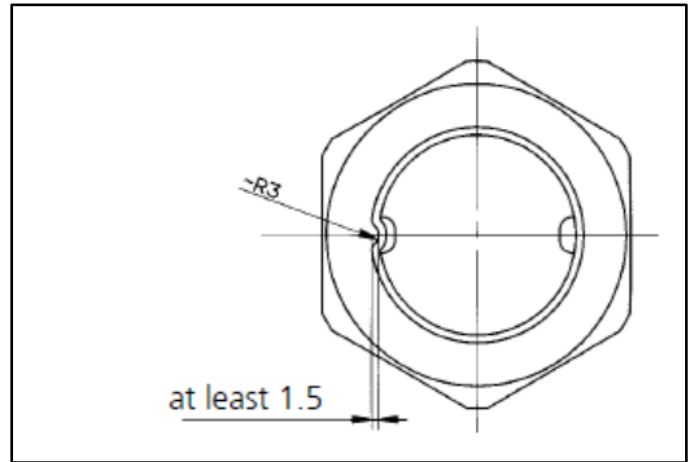
Description: The pitman arm nut in the subject vehicles may have been insufficiently caulked at the steering gearbox connection, potentially allowing the nut securing the joint to loosen over time. Detachment of the pitman arm from the gearbox will result in a complete loss of steering, increasing the risk of a crash and injury to occupants and bystanders. This bulletin provides the procedure to retighten and caulk the pitman arm nut.

4. Retighten the pitman arm nut by using a box-end or open-end torque wrench.

lb-ft	542 ± 26
N.m	735 ± 35
