SERVICE PROCEDURE

24511
September 2024

SUBJECT: SAFETY RECALL

Tie rod end ball studs on certain: 2025 HV™ Series trucks built 04/26/2024 through 07/02/2024, HX® Series trucks built 04/30/2024 through 06/25/2024, LT® Series trucks built 04/16/2024 through 07/02/2024, MV™ Series trucks built 04/26/2024 through 07/04/2024, and RH™ Series trucks built 04/17/2024 through 06/26/2024 with Meritor® MFS Series Front Non-Drive axles.

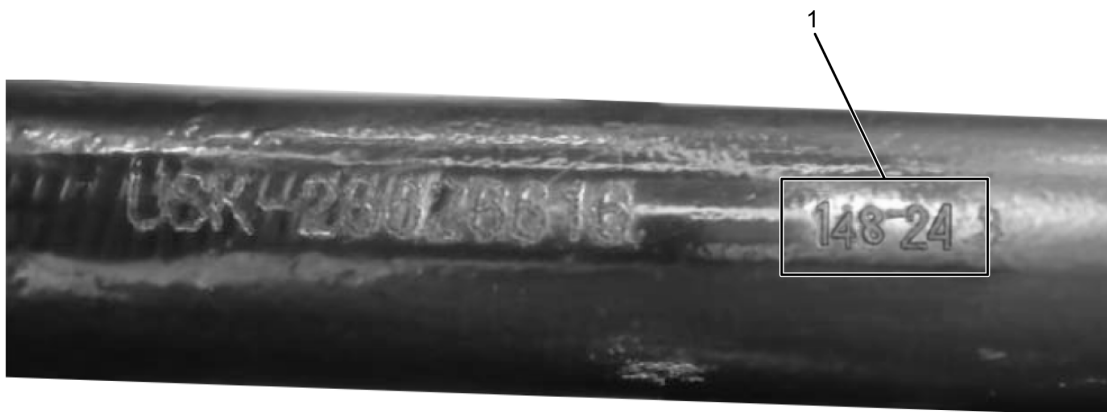
Figure 1. Tie Rod Julian Date Location

NOTE: Each tie rod cross tube has a Julian date code stamped as shown in Figure 1. If the date is not visible, remove paint from the area and cover the number with chalk for visibility.

4. On the front tie rod assembly, locate Julian date code (Figure 1, Item 1) stamped into tie rod cross tube.
5. Record the Julian date code.

6. Refer to Table 3 for suspect Julian date codes:
 - a. If component has a suspect Julian date code, replace both tie rod ends. Proceed to Step 7.
 - b. If component does not include a suspect Julian date code, no further action is necessary. Proceed to Step 27.

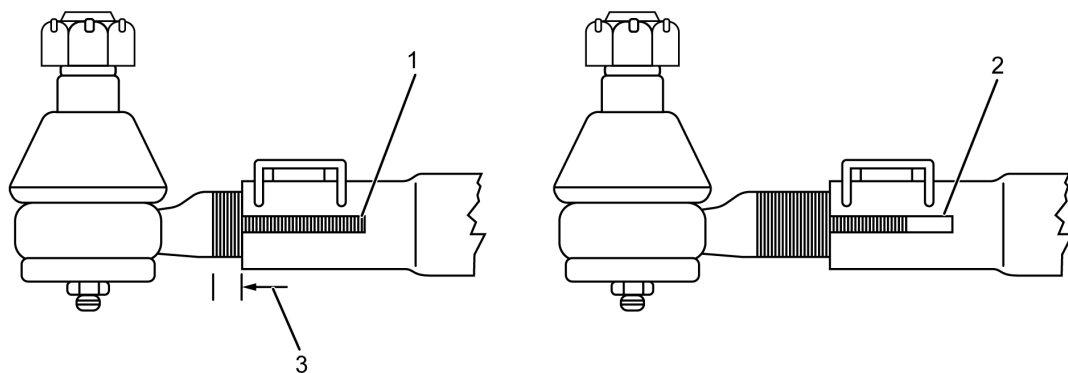
Figure 4. Tie Rod End into Cross Tube

1. Correct installation - tie rod end fully inserted
2. Incorrect installation - tie rod end NOT fully inserted
3. Exposed threads

NOTE: Threaded portion of tie rod must be fully inserted into cross tube.

15. Using cross tube split to inspect, ensure tie rod threads are fully inserted (Figure 4, Item 1). If any spacing between edge of cross tube and tie rod threads is visible (Figure 4, Item 2), the tie rod is NOT fully installed.
16. Using the prerecorded exposed threads (Figure 4, Item 3), ensure new tie rod end has the same number / length of exposed threads.
17. Ensure clamp (Figure 3, Item 5) is positioned over split located on cross tube.
18. Hand-tighten bolt and nut assembly (Figure 3, Item 2) on the clamp.
19. Position tie rod end (Figure 2, Item 3) into steering knuckle (Figure 2, Item 1).
20. Loosely install new castle nut (Figure 2, Item 2).
