Update: SIB 61 07 24 Recall 24V-557: Replace Starter Relay

SIB 61 07 24 RECALL 24V-557 Replace Starter Relay

This Service Information Bulletin replaces SIB 00 10 21 **dated Aug 20, 2024.**

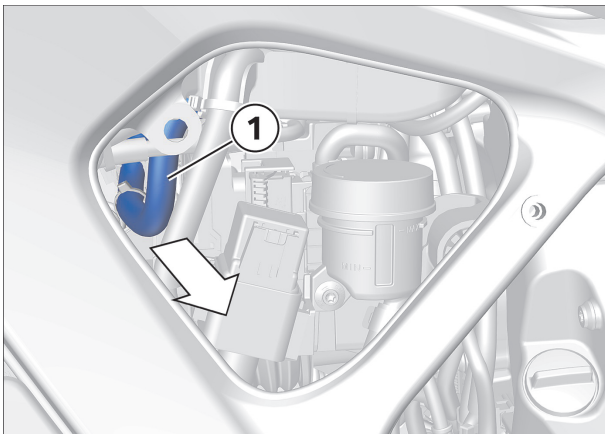
Wiring harness is damaged by chafing

Component damage, cable fire

- Ensure sufficient distance to frame and body parts.
- Route wiring harness accordingly and fasten it in place with cable straps.

- Pull the wiring harness **(1)** outwards slightly.

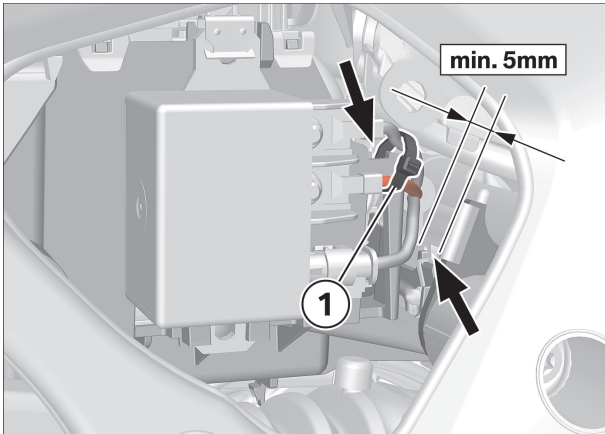
Minimum distance must be maintained under all circumstances, line continuous current!

- Cable shoes are located at the bottom of the limit positions.
- Install cable strap **(1)** but do **not tighten** it yet.
Only secure the upper cables on the equipment holder.
- Make sure that the wiring harness is not in contact with the frame eyelet or frame plate **(arrows)**.

- Tighten cable straps **(1)**.
- **If the minimum distance is not reached:** Create TSARA case and follow the instructions.
