GROUP	NUMBER	
RECALL	24-01-063H	
DATE	MODEL(S)	
JULY 2024	SANTA FE (MX5A) SANTA FE HYBRID (MX5A HEV)

FLOOR WIRING HARNESS INSPECTION, HARNESS SECUREMENT, AND HARNESS REPLACEMENT (RECALL 265)

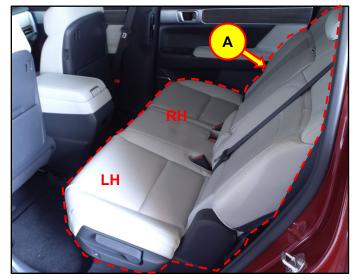
Slide second row seats forward as shown in figure (A) to get better view of the floor wiring harness.

- 2. Inspect the floor harness wiring under the seat for signs of damage. Please note that exposed wiring qualifies as damage here.
 - If wiring is **not damaged**, proceed to the next section to secure the floor wiring with a zip tie.
 - If wiring is damaged as shown (B), take a STUI photo of the damaged harness then proceed to replacing the floor floor wiring assembly and securing harness as shown in steps 3 and 4.
