SAFETY RECALL

Date	Number	Release	Page
09.2024	SC0469	01	1(8)

Rolltek Seat Installation AN, GR, PN

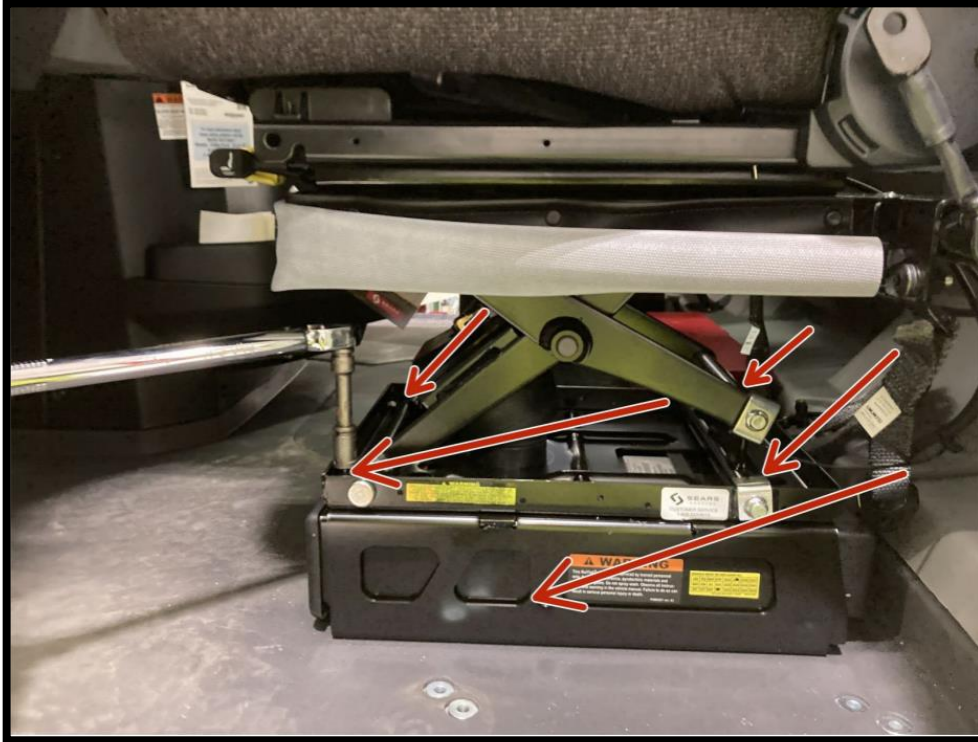
6. Locate the six (6) bolts on the seat pedestal. There are four bolts on top and one bolt on each side of the riser. Replace each bolt and torque to 23 ± 1 Nm.

Tightening Torque
23 ± 1 Nm

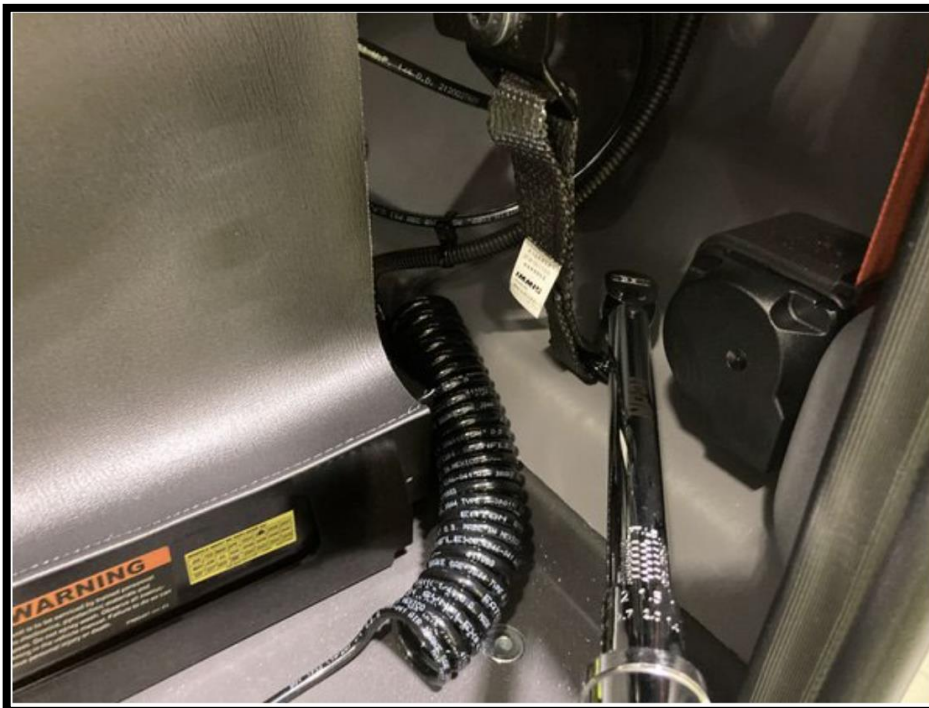
7. Locate, replace, and torque the two tether bolts attached to the cab floor behind the seat and torque to 65 Nm.

Tightening Torque
65 Nm

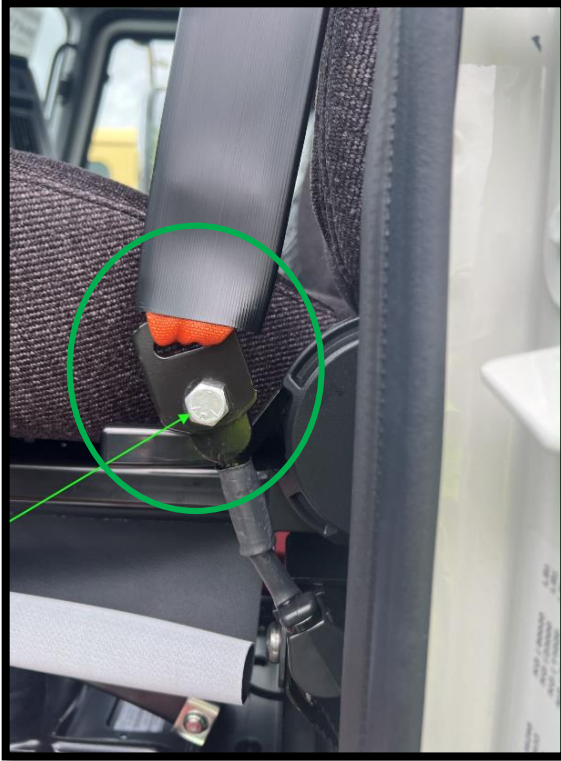
8. Replace the seat belt bolt ensuring that the mounting tab is angled towards the driver. Torque to 55 Nm.

*Angled towards driver

Tightening Torque
55 Nm

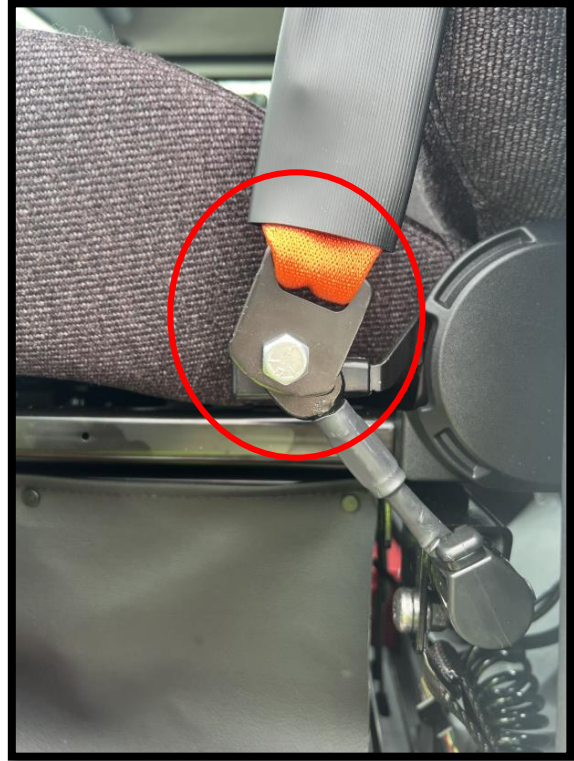
*Angled away from driver

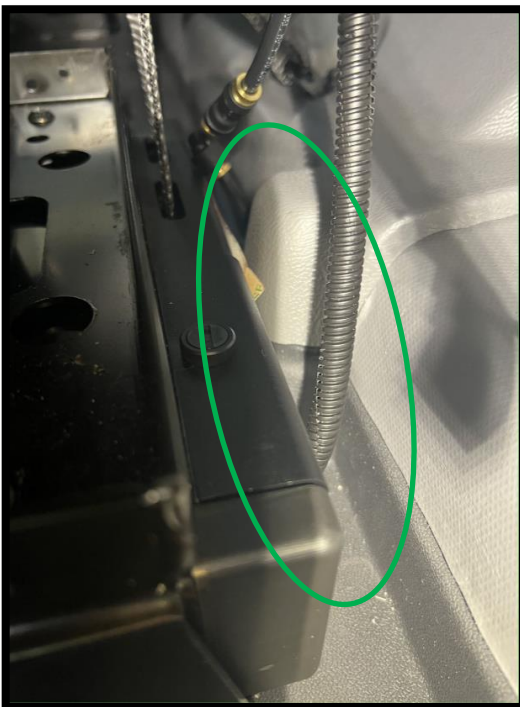
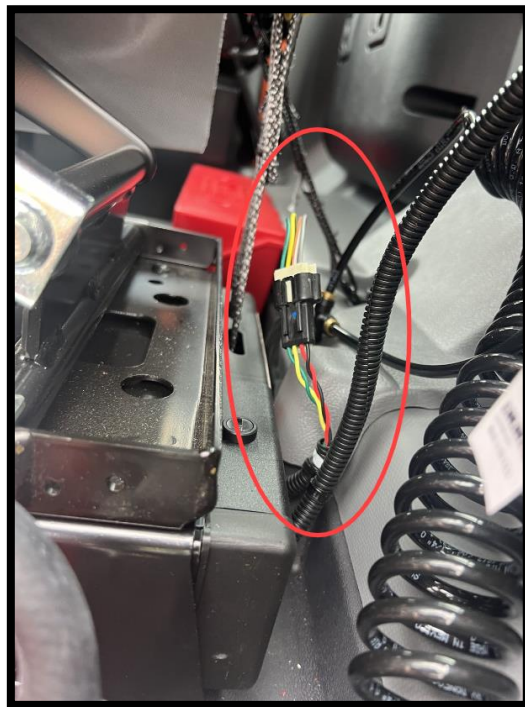
9. Wires should be secured in the box at the bottom backside of the seat. Secure wires inside if they are found outside of the box.

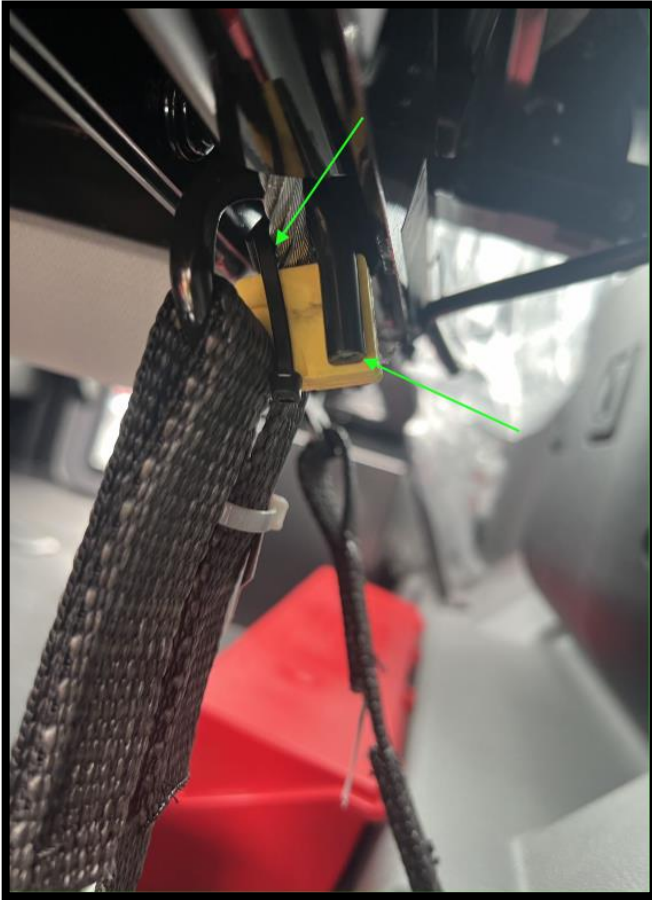
10. Check that the yellow locking tab is fully engaged between the metal hooks and zip tie is fed through the plastic housing on the cable to secure the yellow tab.

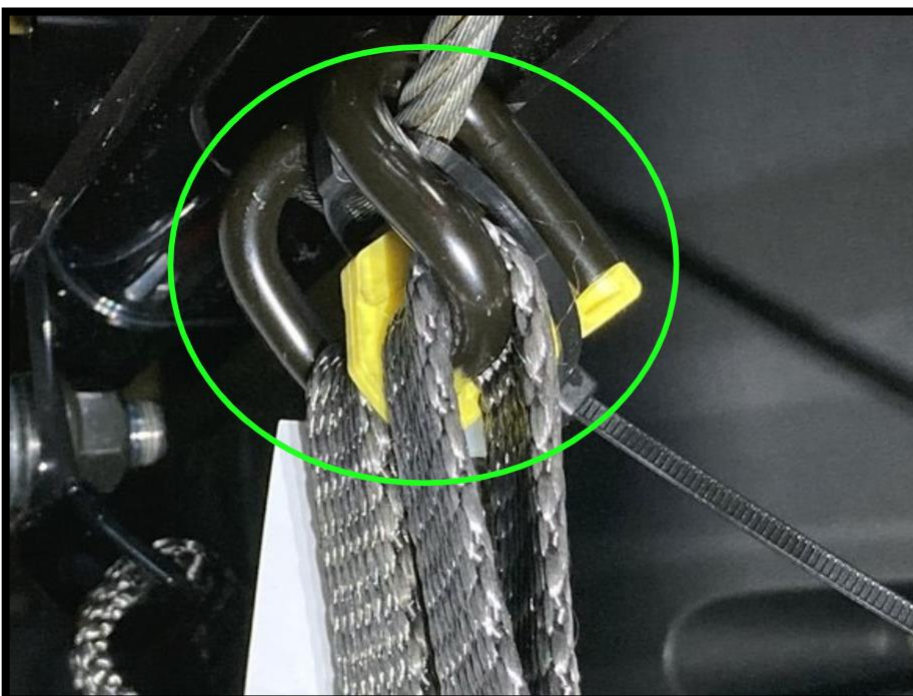
11. Straps from rear component box installed on lower seat bracket should not be twisted.

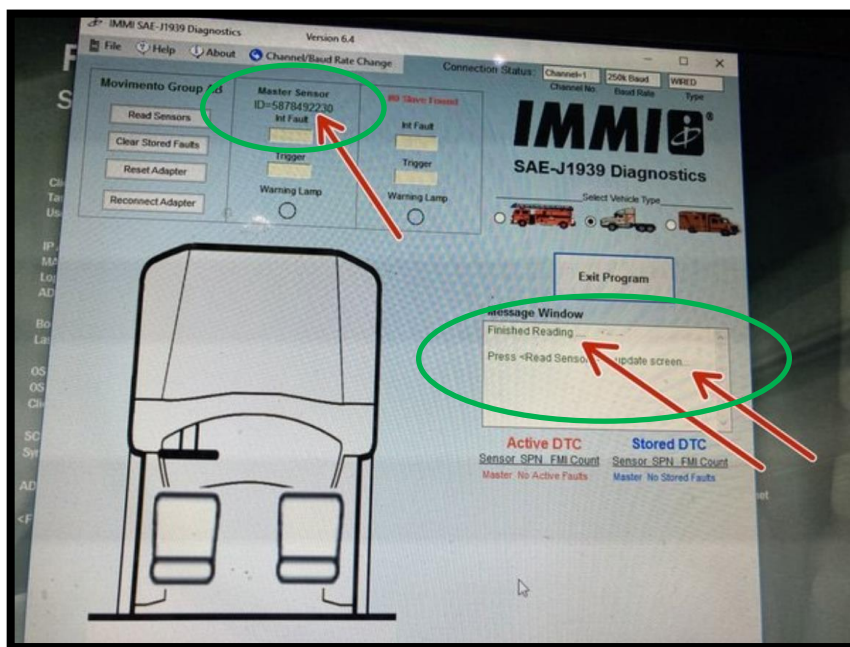
14. Plug computer into OBD port and run the diagnostic test. All three illustrations shown below should be green if RollTek seat is functioning properly. Ensure any stored DTC's are cleared.

- a. If you have active DTC's, follow the troubleshooting guide found on the link provided.
- b. If no active DTC's are present, unhook service tool and return truck to service.
