## Incorrect Coach Battery Cable Installation

<b>Bulletin Type:</b>	Recall	<b>Publication Date:</b>	September 2024
<b>Bulletin #(s):</b>	24V-577 USA 2024-442 Canada	<b>Make(s):</b>	Entegra
<b>Job Code(s):</b>	9903611	<b>Model(s):</b>	<b>Aspire</b> (44B,44D,40P,44R,44W,44Z)
<b>Flat Rate(s):</b>	9903611A .50 HR Inspect routing and re-torque of battery cables 9903611B .10 HR per battery cable replacement		<b>Anthem</b> (44B,44D,37K,44R,44W) <b>Cornerstone</b> (45B,45D,45R,45W,45Z) <b>Reatta</b> (39BH,39T2,37K) <b>Reatta XL</b> (40Q2,39BH,39T2,37K)
		<b>Model Year(s):</b>	2024-2025

<b>Incident:</b>	Battery cables may not be properly routed and torqued to specification
<b>Affected Units:</b>	2024-2025 units built between September 2023 to April 2024
<b>Parts List:</b>	N/A
<b>Misc. Tools &amp; Supplies:</b>	Torque Wrench with 12mm Socket

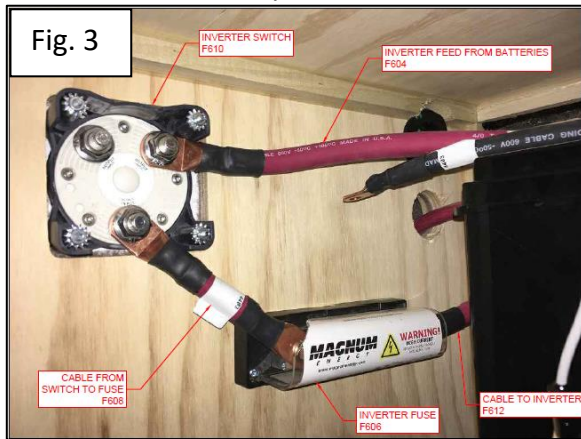
2. Verify cable connections at inverter fuse, inverter switch and battery disconnect terminals:
  - A. Inverter Switch (Figure 3) **Torque = 120 IN-LB**
  - B. Inverter Fuse (Figure 3) **Torque = 120 IN-LB**
  - C. Battery disconnect terminals within the battery box (Figure 4) **Torque = 50 IN-LB**

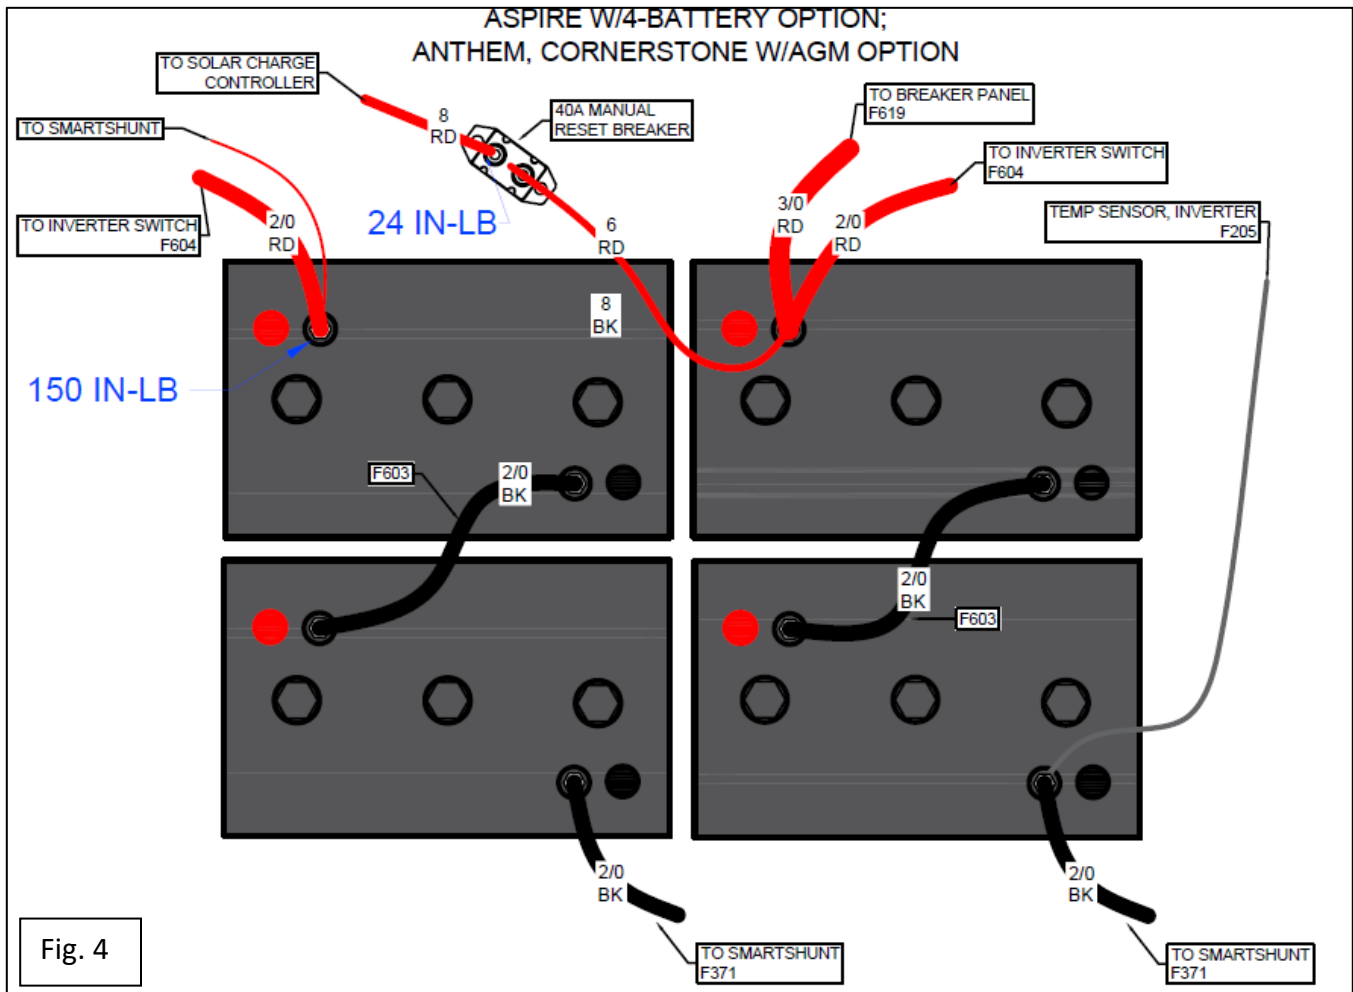
1. Verify battery cables are hooked up as shown and to proper torques specs.
  - A. Aspire with 4 Battery Option/Anthem & Cornerstone with AGM Option
    - i. Battery cable size (Figure 4)

- ii. Temp sensor wire location
- iii. House battery terminals (Figure 4) **Torque = 150 IN-LB**
- iv. 40A Manual Reset Breaker (Figure 4) **Torque = 24 IN-LB**

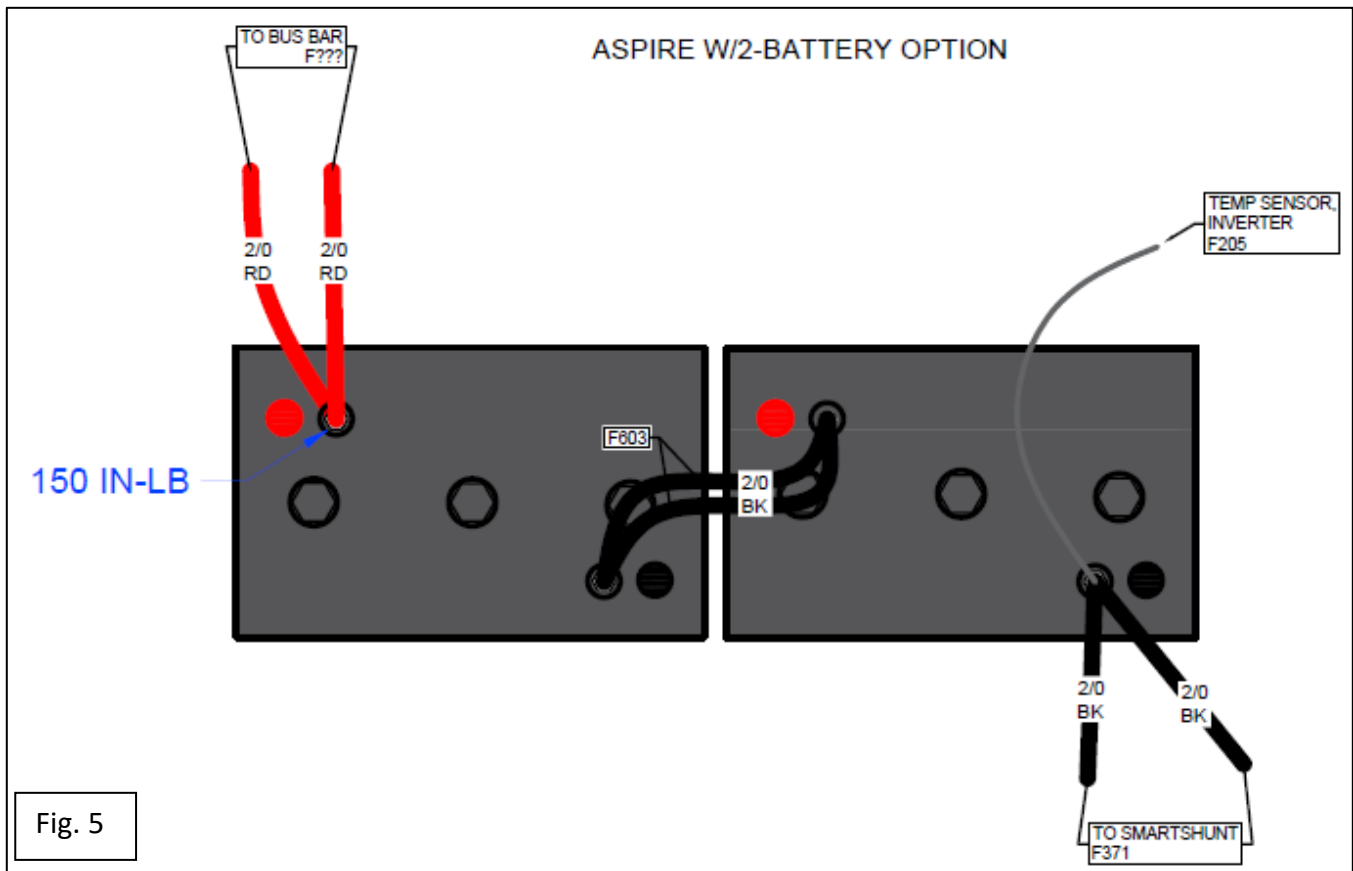
B. Aspire with 2 Battery Option

i. Battery cable size (Figure 5)

- ii. Temp sensor wire location
- iii. House battery terminals (Figure 4) **Torque = 150 IN-LB**
- iv. 40A Manual Reset Breaker (Figure 4) **Torque = 24 IN-LB**

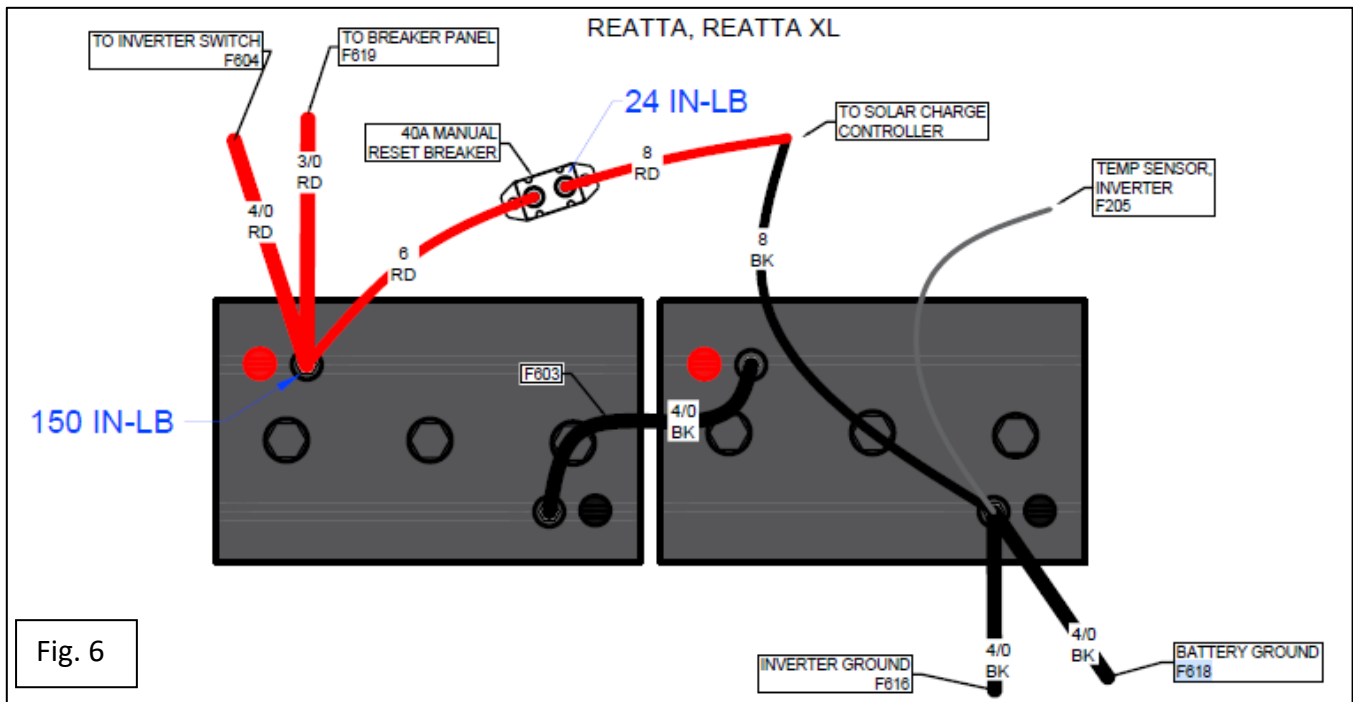
C. Reatta/Reatta XL

v. Battery cable size (Figure 6)

vii. House battery terminals (Figure 4) **Torque = 150 IN-LB**

viii. 40A Manual Reset Breaker (Figure 4) **Torque = 24 IN-LB**

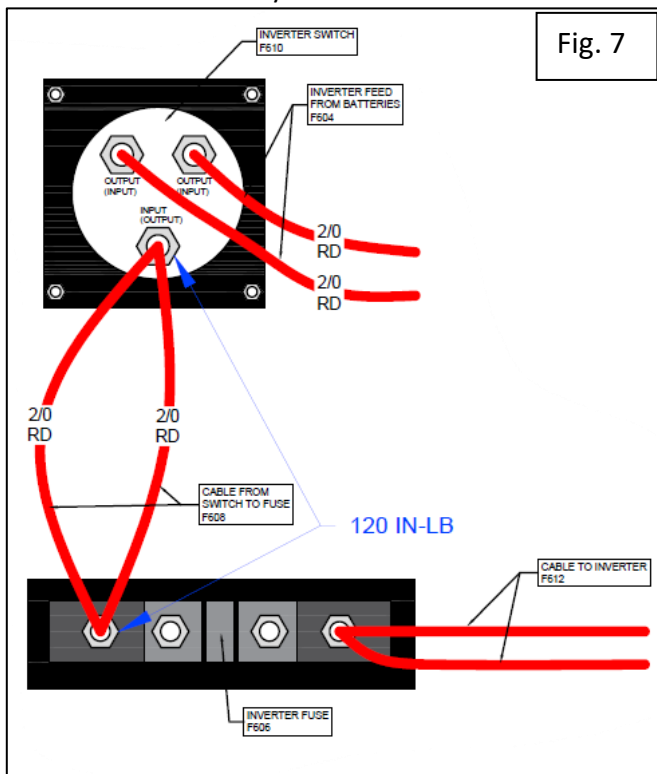
2. Verify cable connections at inverter fuse, inverter switch and battery disconnect terminals:
  - D. Inverter Switch (Figure 7) **Torque = 120 IN-LB**
  - E. Inverter Fuse (Figure 7) **Torque = 120 IN-LB**
  - F. Battery disconnect terminals within the battery box (Figure 8) **Torque = 50 IN-LB**
