Technical Service Bulletin

GROUP RECALL	NUMBER 24-01-065H-1
DATE OCTOBER 2024	MODEL(S) SONATA (DN8)

SUBJECT: ESC SOFTWARE UPDATE FOR EMERGENCY STOP SIGNAL (ESS) FEATURE DEACTIVATION (RECALL 267)

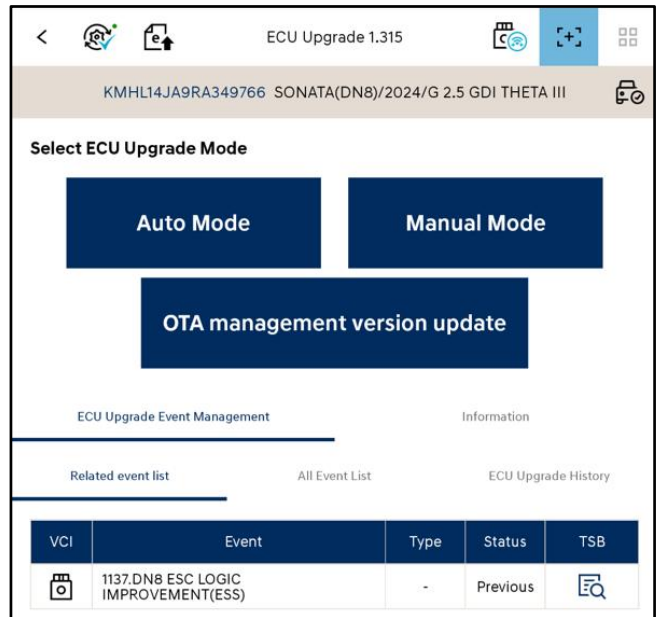
1. Perform the ECU update in **Auto Mode**.

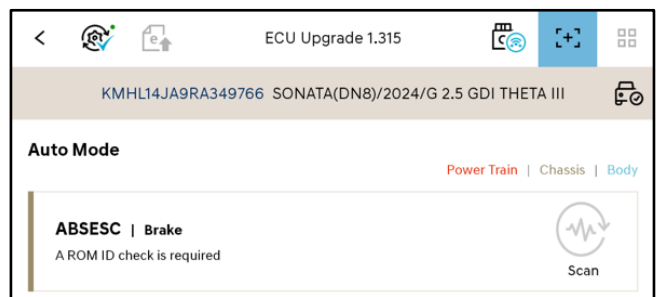
2. Under **ABSESC** system, select **Scan** to check the vehicle’s current ROM ID.

Check the current ROM ID version and compare it to the ROM ID Information table before attempting to perform the software update.

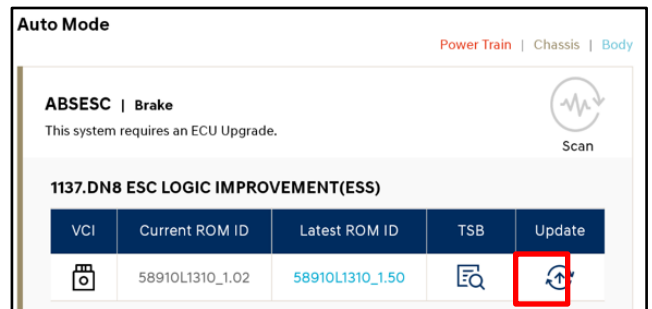
3. Under Event #1137. **DN8 ESC Logic Improvement (ESS)**, verify the current ROM ID and latest ROM ID. Refer to the **ROM ID Information** table for applicable ROM IDs.

Select the icon under “Update” to start update.

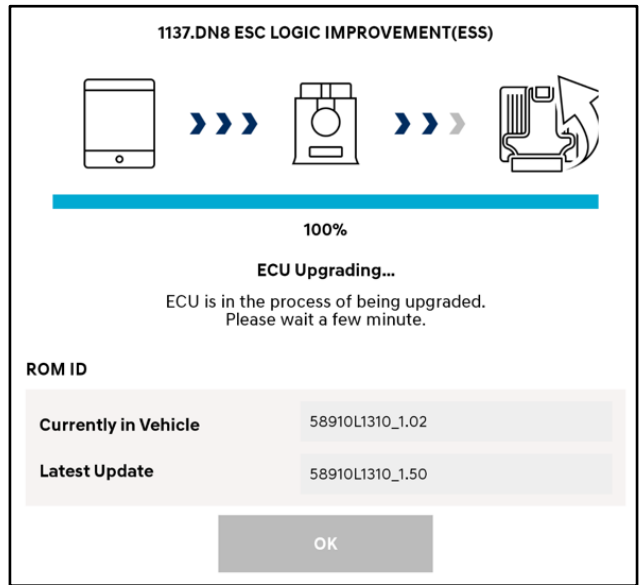
- 4. ECU update will start and progress to 100%.

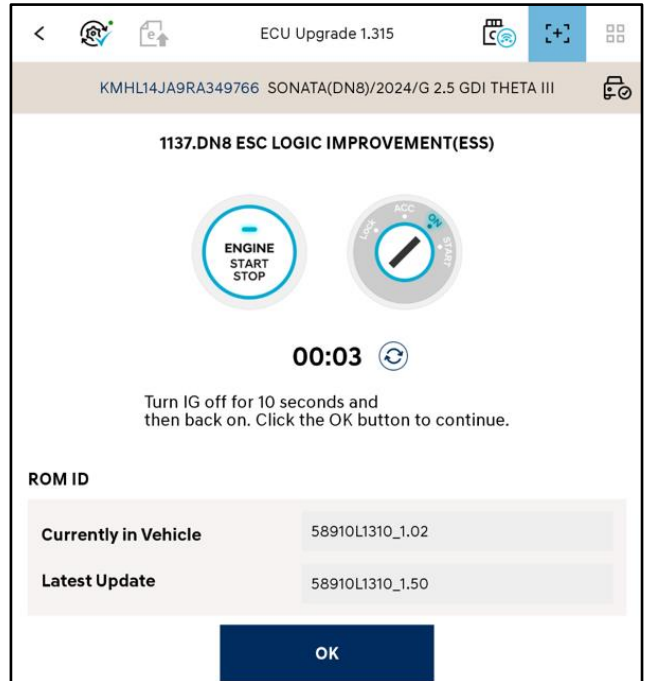
- 3. After the ECU update process shows 100% complete, follow the prompts on the screen to cycle the ignition **OFF** for at least **10 seconds** to reset the control unit.

Use the **Refresh** button to reset the timer.

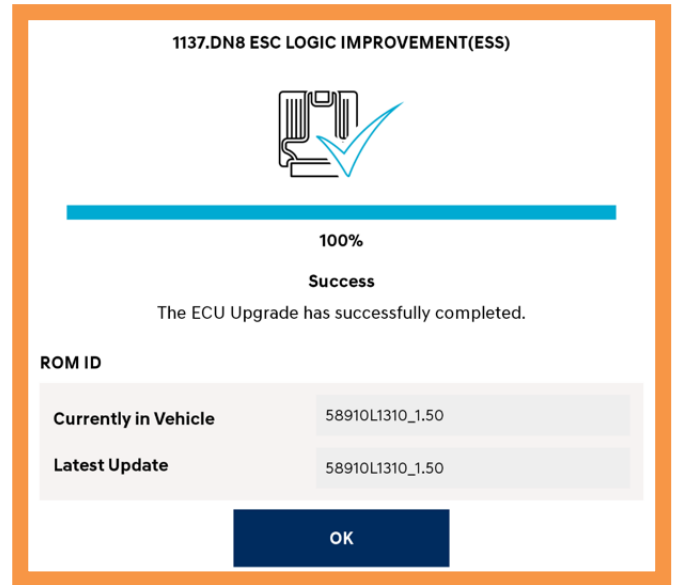
Take a screenshot of the ECU Update Complete screen using your tablet and upload to STUI.
