SAFETY RECALL

Tail Lamps

Reference: 90B / NHTSA 24V-585

Remedy available for
2024 (JL) Jeep Wrangler

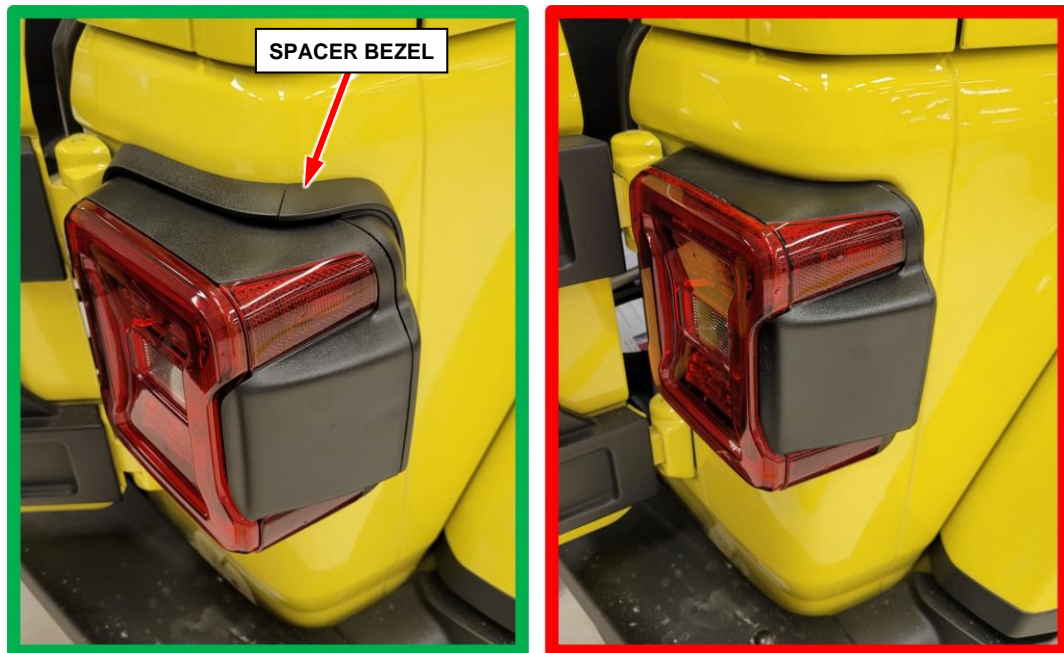
Figure 1 – Replace Both Tail Lamps with Lamps Including a Spacer Bezel

Correct Tail Lamp With Bezel

Incorrect Tail Lamp Without Bezel

1. Replace both tail lamps with **NEW** tail lamps which include a spacer bezel (Figure 1).

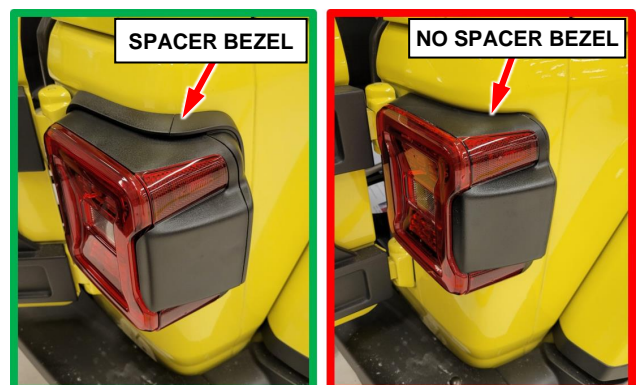
Figure 5 – Tail Lamps

NEW Lamp

OLD Lamp

9. **OLD** tail lamp assembly without spacer bezel (Figure 5).

10. Obtain the **NEW** tail lamp assembly with spacer bezel (Figure 5).

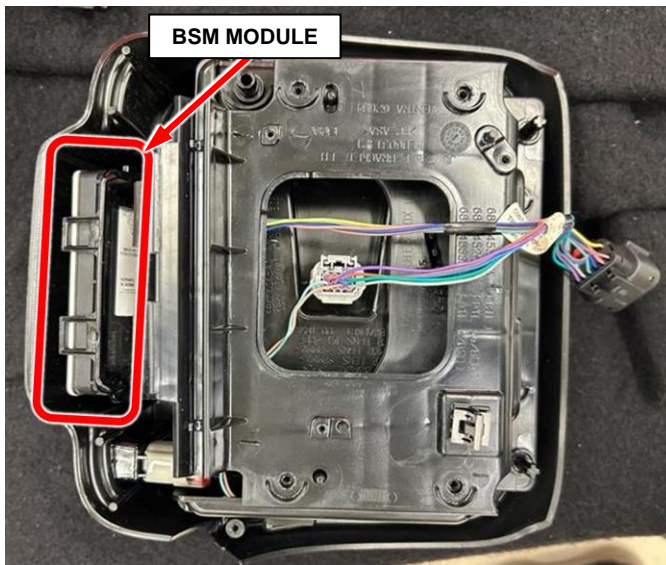
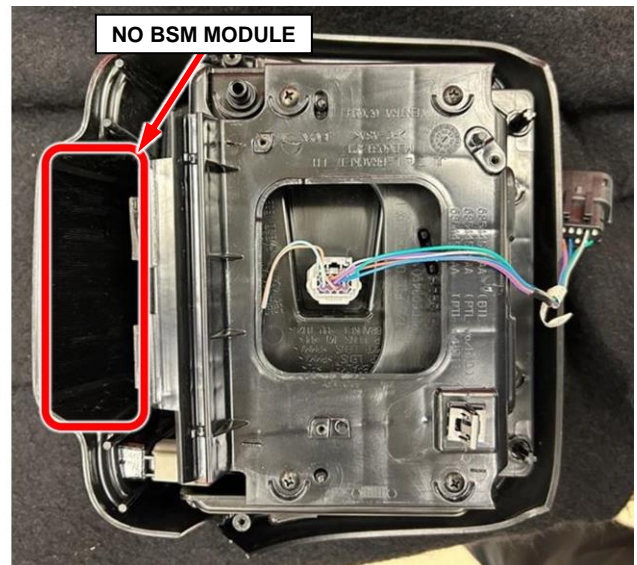
Figure 6 – Identifying Tail Lamp With or Without BSM Module

Tail Lamp With BSM Module

Tail Lamp Without BSM Module

IMPORTANT: If the **NEW** lamp does not come with the BSM module installed, the module and wire harness will need to be removed from the **OLD** lamp and installed in the **NEW** lamp (Figure 6).

- Depending on which version of the lamp you have received, the BSM module may need to be transferred from the **OLD** lamp to the **NEW** lamp (Figure 6).

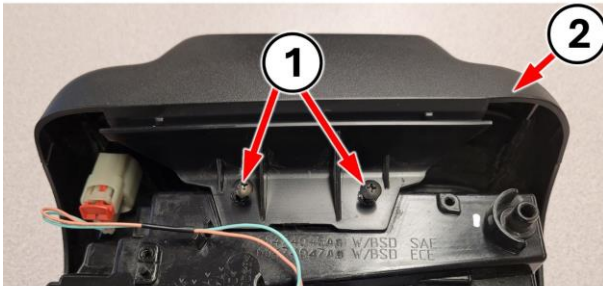
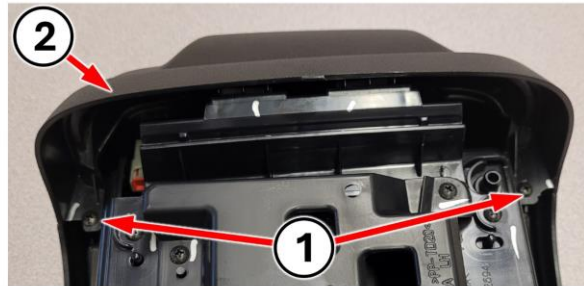
Figure 9 – Tail Lamp Close Out Panel

OLD Lamp without Spacer Bezel

NEW Lamp with Spacer Bezel

5. **Both NEW and OLD lamps:** Remove the two screws (1) securing the close out panel (2) to the lamp housing (Figure 9).
6. **Both NEW and OLD lamps:** Remove the close out panel (2) from the lamp housing (Figure 9).
7. **OLD lamp:** Disconnect all three electrical connectors (1) from the lamp and BSM module (Figure 10).
8. **OLD lamp:** Remove the two screws (2) securing the BSM module to the lamp (Figure 11).
9. **OLD lamp:** Remove the BSM module (1) from the lamp (Figure 11).
