SIB 11 05 24

RECALL 24V-588: CHECK EGR COOLER

E-Series	Model Description	Production Date	Engine
G30	540d xDrive Sedan	October 9, 2017 – June 25, 2018	B57O

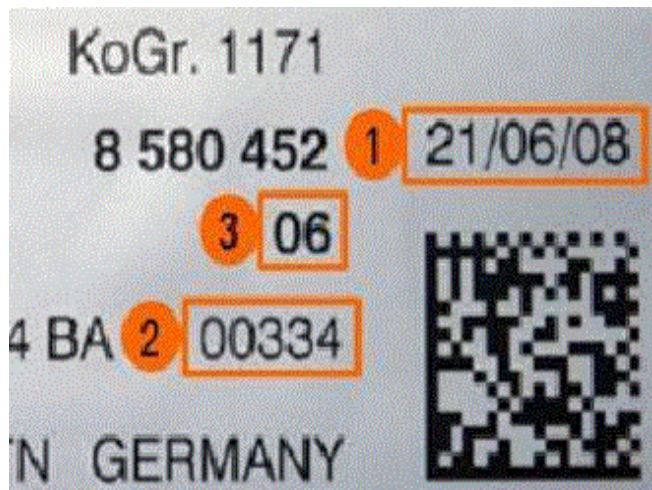
Using a borescope, access the label* on the EGR cooler. Note the production date, index number and serial number of the EGR cooler.

- Production date (1); format YY-MM-DD
- Serial Number (2)
- Index number (3)

If the index number is 20 or higher: There is no need to replace the EGR cooler. The inspected cooler (in the car) will still need to be registered with ISTA.

If the index number is below 20:

1. Replace the EGR cooler and clean the EGR intake pipe.
2. Perform an air intake system integrity test through ISTA and based off the results of the test plan, replace the intake manifold (if test failed).
3. Register the new EGR cooler through ISTA.

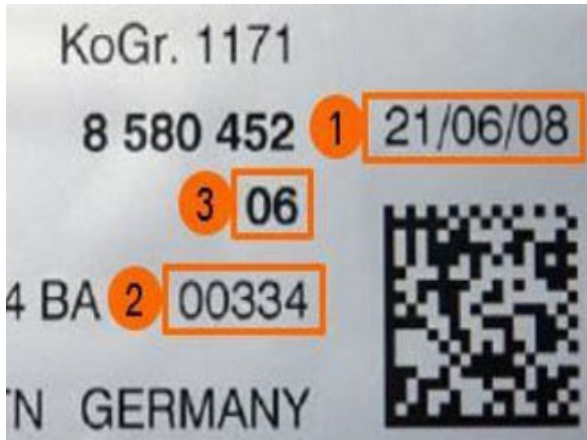
Record or take a photo of the following numbers on the new EGR cooler (1, 2 and 3). These numbers will be required later to register the new cooler in ISTA.

1. Production date [YY-MM-DD]
2. Revision index
3. Serial number

Replace the EGR cooler following Repair Instruction **11 71 100 Removing and installing/renewing exhaust-gas recirculation cooler.**

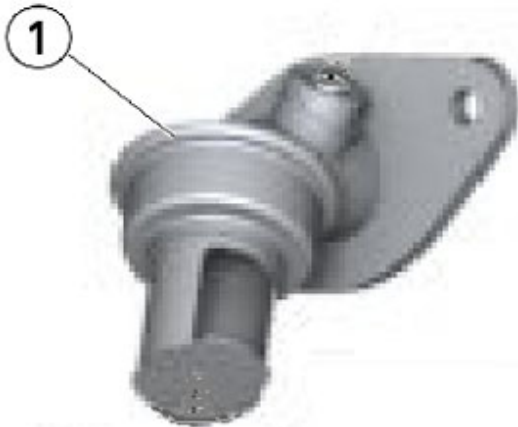
- Remove the EGR pipe from the intake venturi pipe (1)

- Inspect and clean (if needed) the EGR pipe. Wear protective equipment (eyes and hands) and clean out the excessive carbon using a degreasing agent and a brush (suitable brushes can be found in wheel brush kit 83 19 2 298 237).
- Reinstall the EGR pipe with new gasket and O-ring before installing the new EGR cooler
- Install the new EGR cooler following the repair instructions
