Recall Campaign Bulletin

Campaign No. 2024080002, August 2024

SUBJECT: **Model AMG GLB 35 (247 platform)**
Model Year 2024

Check Rear Axle Brake Hose

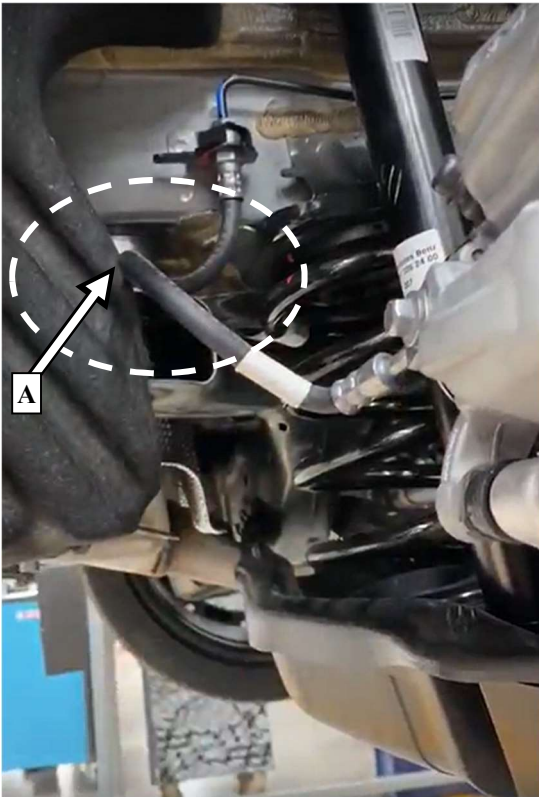
Figure 1

1. Lift vehicle.
2. Inspect the left and right rear brake hoses on the rear axle.
 - i** Left and/or right rear brake hoses could contact the felt wheel arch liner area (**Figure 1, A**) and this could cause the brake hose to rub against the rim or tire.
 - i** The left and right rear brake hose must be routed freely without any points of contact (**Figure 2**).
 - i** Even if the brake hoses are routed correctly, they must be checked for scuff marks/damage!
