Campaign Service Bulletin LCAB 0524

Document D716778

Subject: Inboard Lower Control Arm (LCA) Bolts

Applies To: **Fire Truck** IFS 20k, 22k and 24k Models

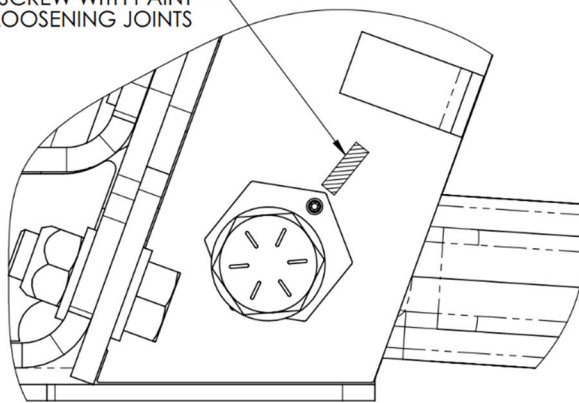
MARK POSITION OF ALL ECCENTRICS
IN LINE WITH SET SCREW WITH PAINT
PEN OR SIMILAR BEFORE LOOSENING JOINTS

2. **Mark the orientation of all 8 alignment eccentrics, shown below.**
