SIB 11 07 24

RECALL 24V-608: WATER PUMP ELECTRICAL CONNECTOR – RETROFIT SPLASH PROTECTION CAP

2026-01-16

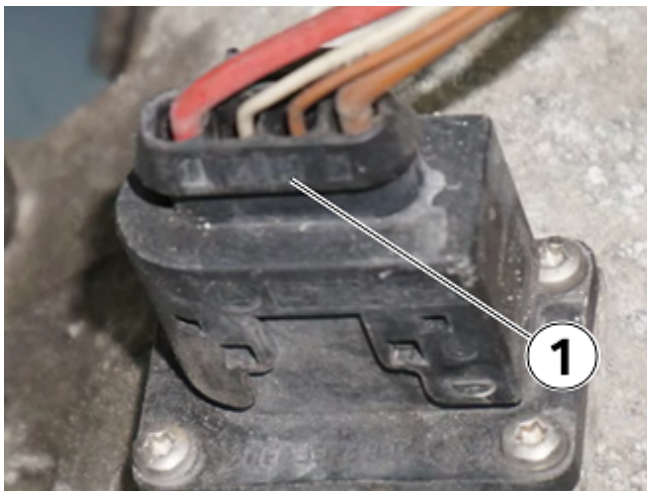
**Vehicles with this style pump/connector (shown below) do not require any type of connector shield retrofit or repair.**

The 200-W electric water pump engine harness socket and plug connector (1).

For these vehicles, reinstall the components that were removed to perform the required engine harness socket and plug connector inspection.

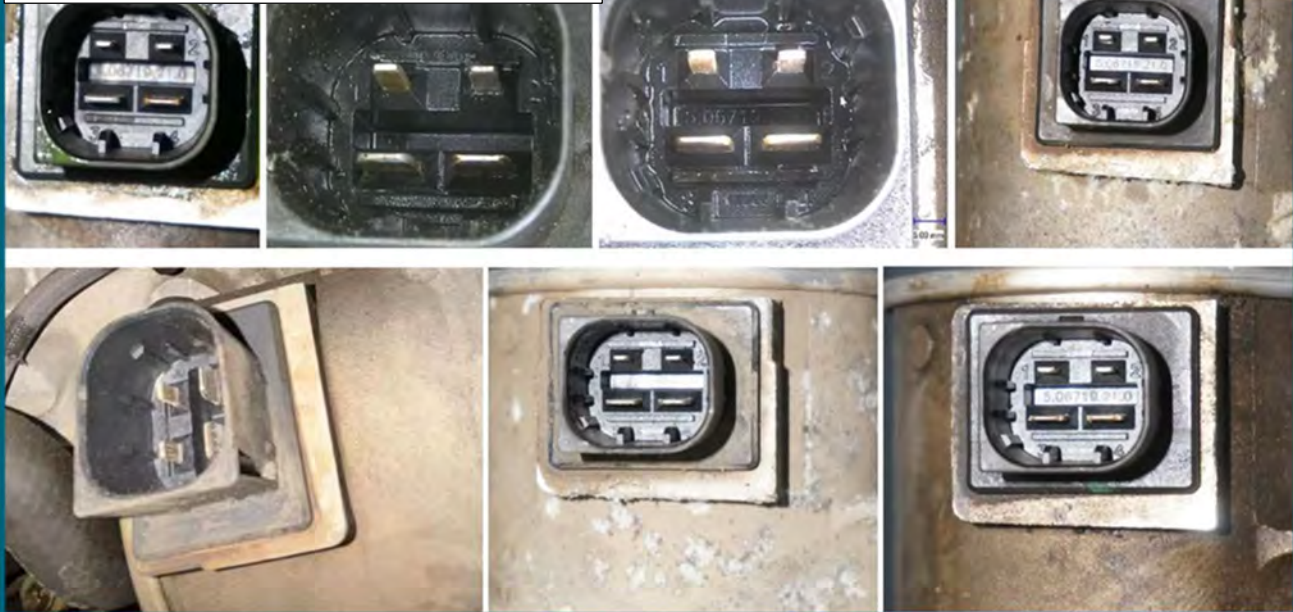
Coolant Pump Pins Oily but no Corrosion

Oil contamination on the connector or oil residue has made it into the connector on the coolant pump:

Replace the connector housing and the pins on the coolant pump connector (wire harness side).  
Follow Repair Instruction **REP 6113 4-pin in-line connector, DFK ELA system**.

Clean the connector pins on the coolant pump with a suitable spray cleaner (electronics spray cleaner or spray brake cleaner).
